OLMSTED ENVIRONMENTAL SERVICES, INC.

Date: December 26, 2020

Subject: **School Inspection**
School 29 Rochester, NY
88 Kirkland Rd, Rochester, NY

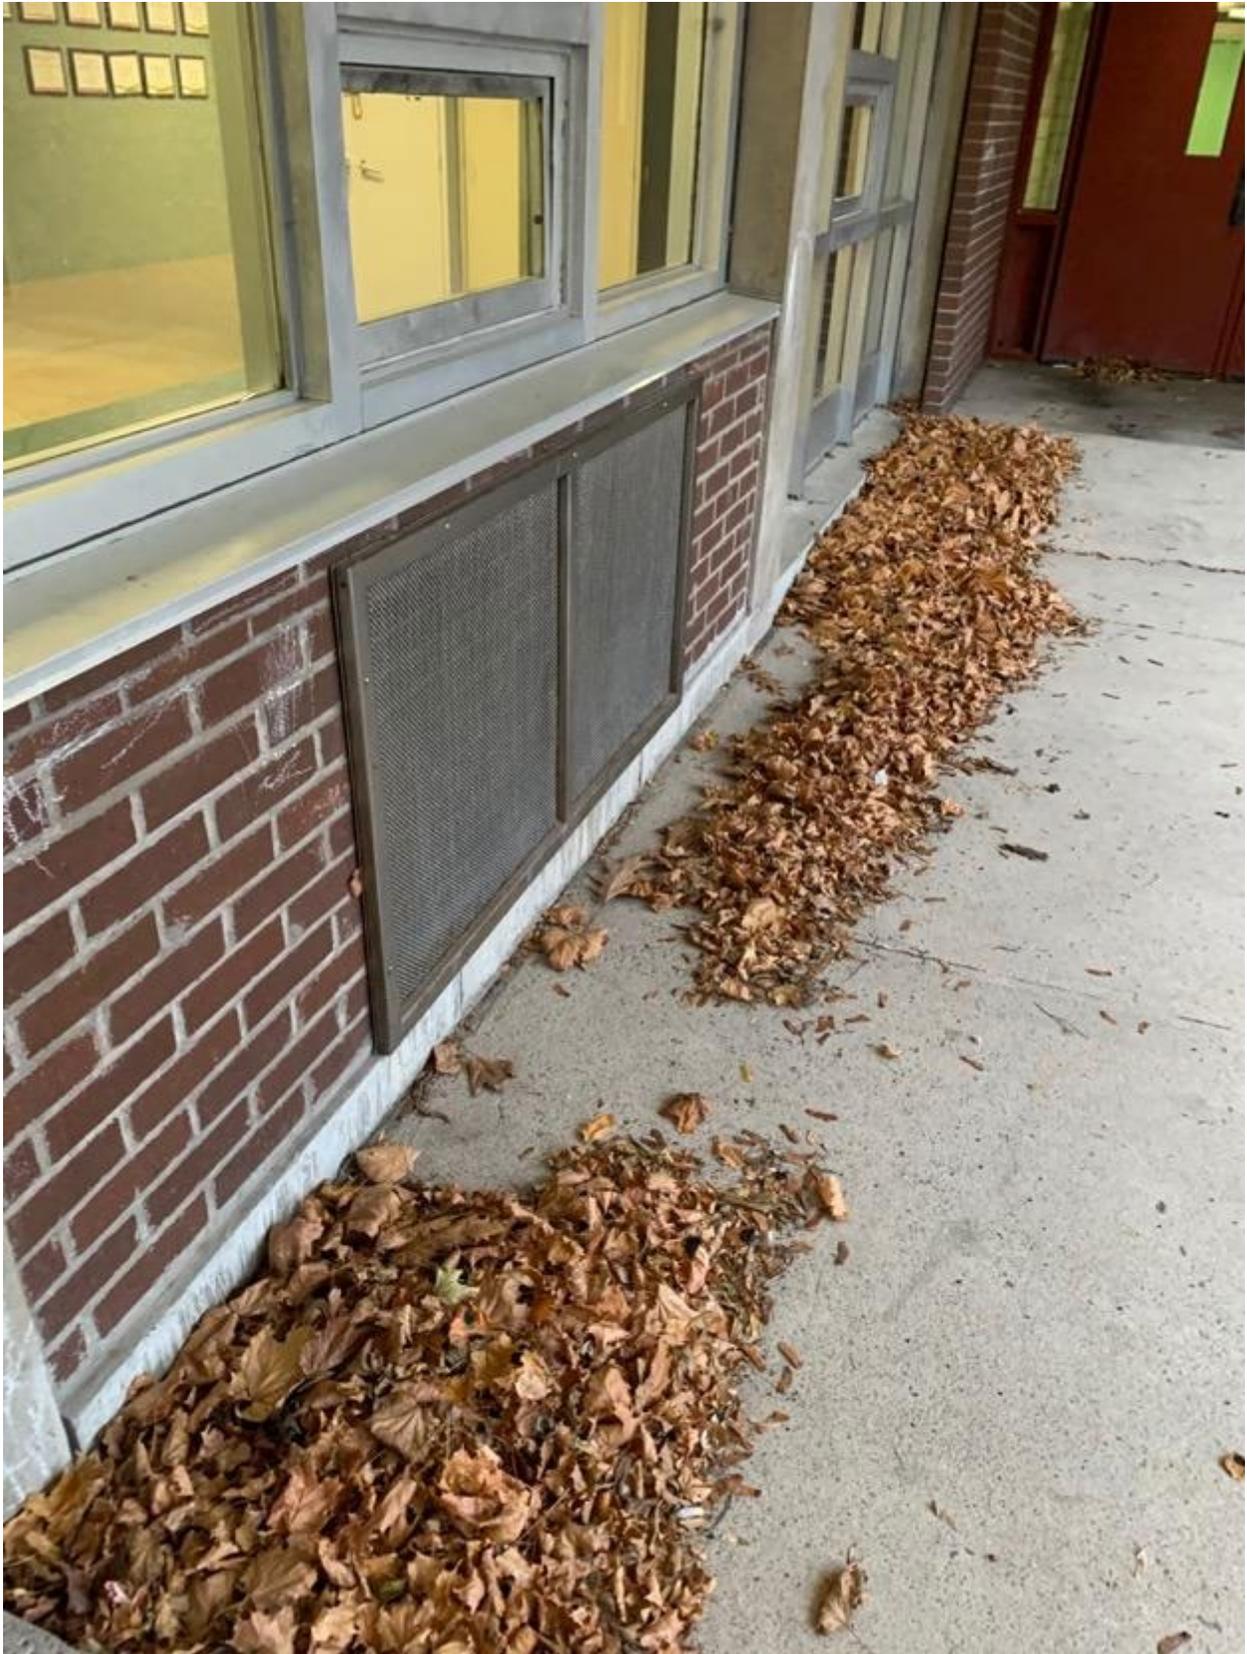
1. The univent located under the window in each classroom draws return air through the base of the unit and also draws outside air through a sleeve that penetrates through the wall to the outside. These units have a heating coil and are direct cooled. The units have a filter installed at the base that have the maximum MERV rating for the equipment. The filters inspected indicated MERV 10 but a mechanic reported that there are MERV 13 filters for the univents and fan coil units.

Univents draw outside air through the wall

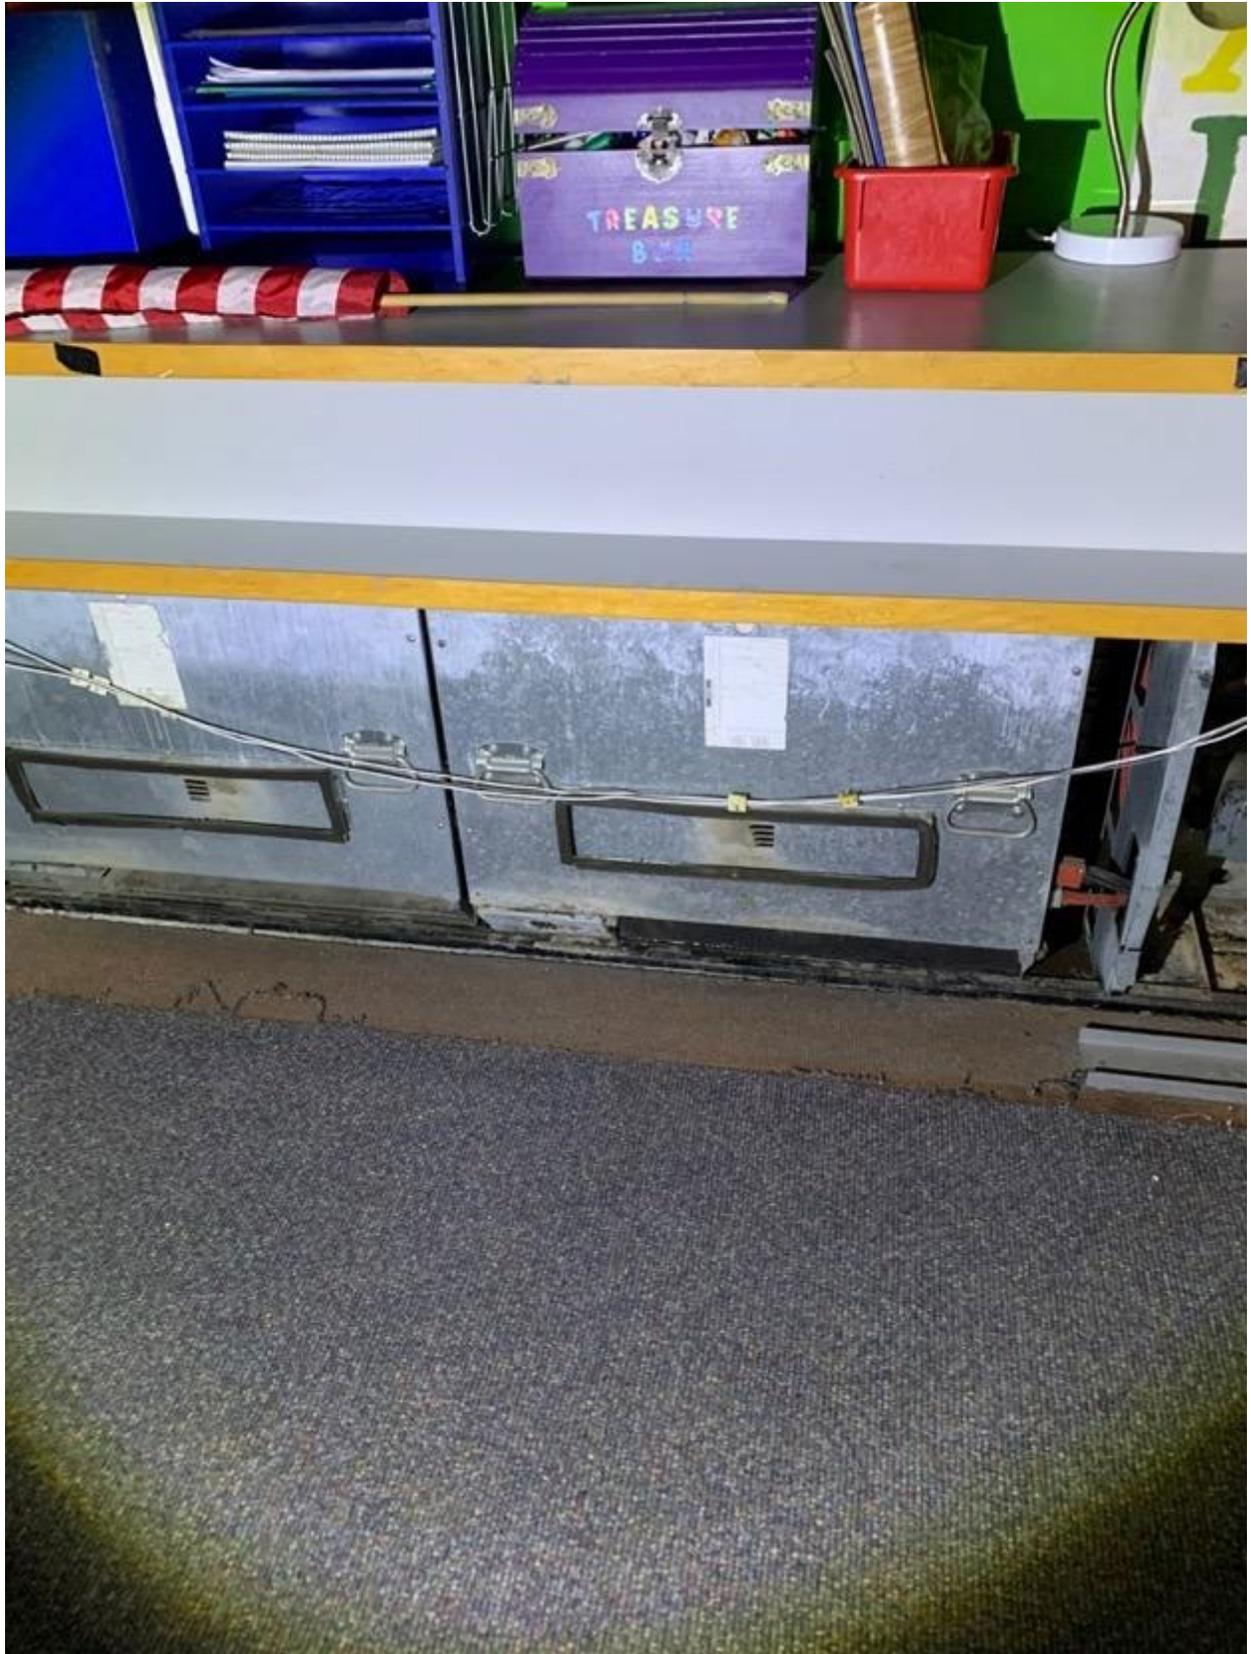
8. In some rooms, teachers stacked many materials on the univent outlet. This blocks airflow.

Typical uninvent is blocked by stored materials.

The school has operable windows in the classrooms and this is sufficient to provide natural ventilation. The classrooms also have univents that provide outside air. The classrooms have sufficient ventilation capacity to be occupied. If necessary, teachers can open two windows in each room to an opening of two inches. This will provide natural ventilation without causing the room to become cold. Opening the window at the top is adequate to provide sufficient ventilation to the room. The air moves through the open windows with the classroom door either open or closed. Teachers should be instructed to not store materials on the univent.
