Date: December 27, 2020

Prepared by: Ed Olmsted, CIH, CSP  
Jennifer Long, MS

Subject: **Ventilation System Screening**  
**School 45, 1445 Clifford Ave, Rochester, NY**

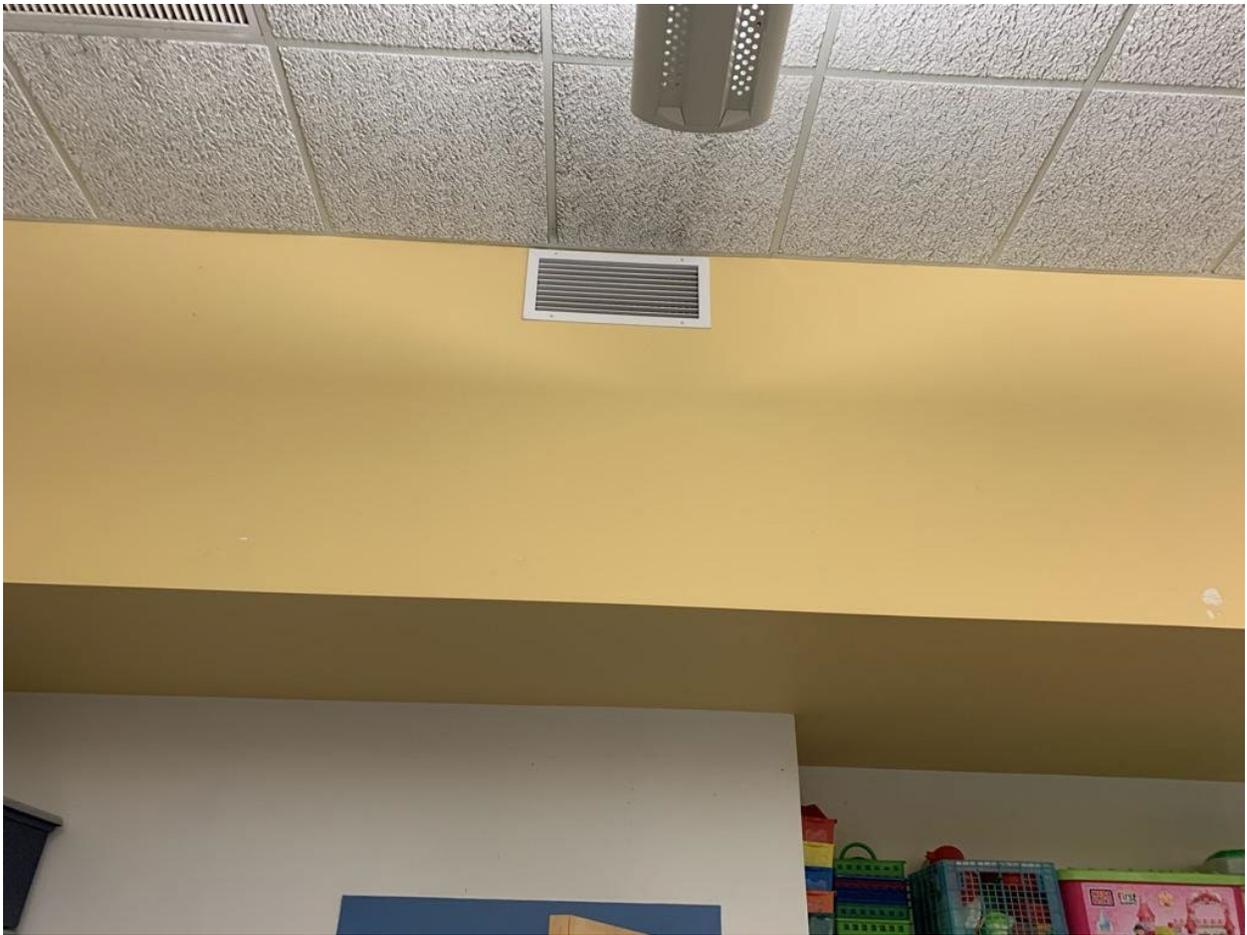
Supply vent in a typical classroom
