OLMSTED ENVIRONMENTAL SERVICES, INC.

Date: February 7, 2021

Prepared by : Ed Olmsted, CIH, CSP

Subject: **Ventilation System Screening**
School of The Arts (SOTA), 45 Prince Street Rochester, NY

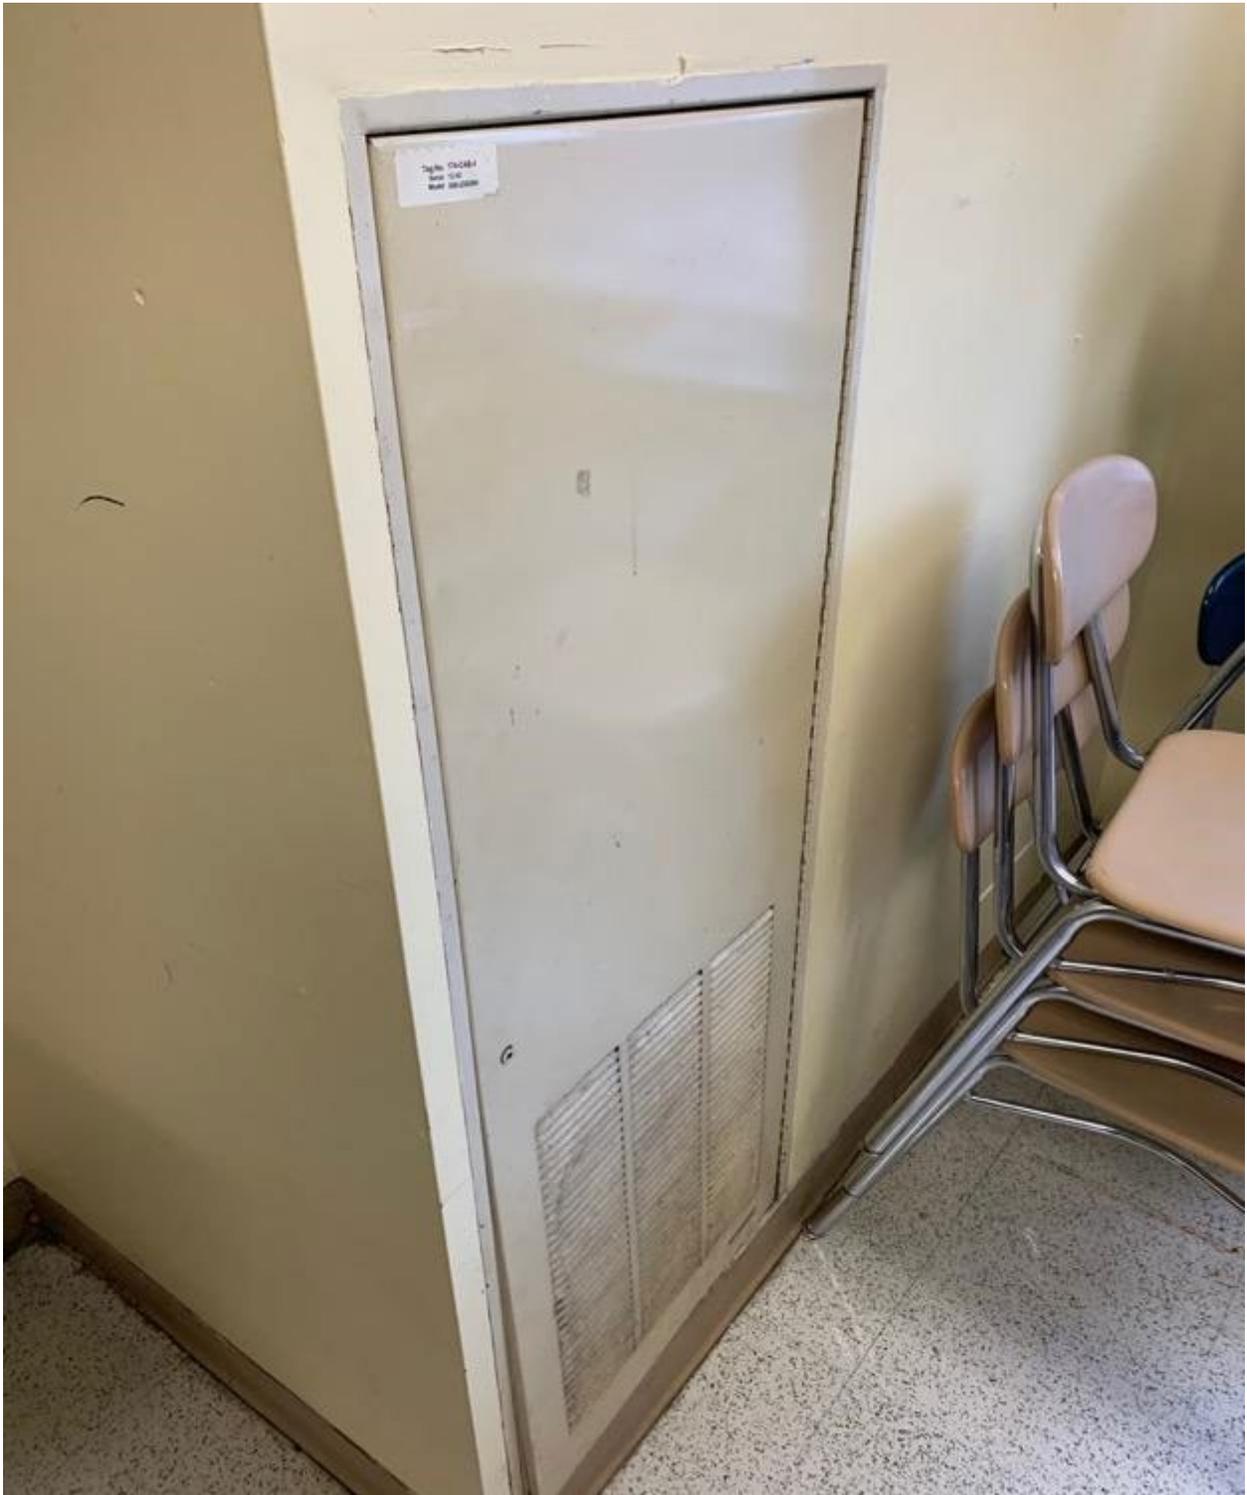
2. There is a perimeter heating system that provides heating that is supplemented by the fan power boxes.
3. Fan power boxes were found to be off in most of the rooms inspected. Facilities Management indicated that the fan power boxes will all be serviced and MERV 13 filters installed before the school is opened for occupancy.

Fan power box in the classroom

1. Service all the fan power boxes and operate them.
2. Install MERV 13 filters in the fan power boxes.
3. Repair the broken exhaust fans in the attic.

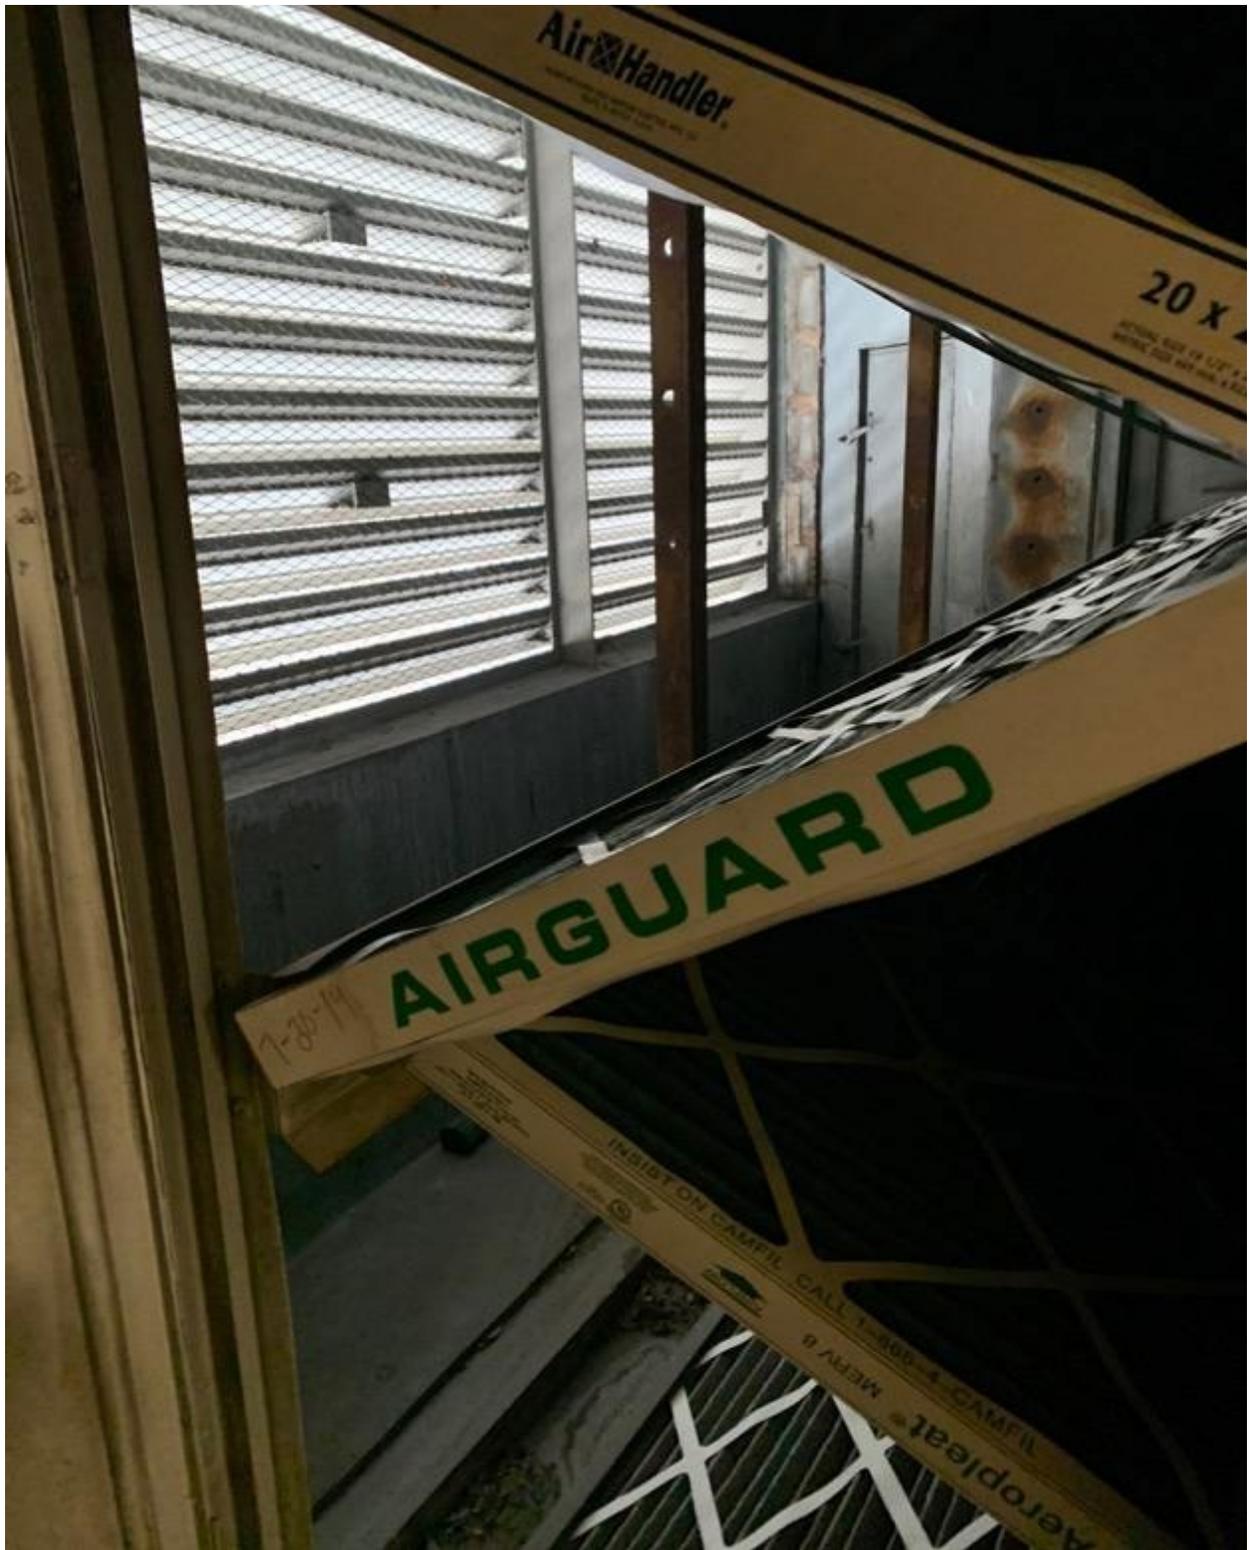
1. SOTA is a pre-war landmark building and has been partially renovated over the years. The school building has a masonry exterior and is of concrete, wood and steel construction. The attic has wood roof trusses and a wood deck. There is a mechanical room in the attic that houses the exhaust fans and outside air supply fans. The outside air fans deliver fresh air throughout the building to the fan power boxes located in each room and common hallways. Fresh air is ducted to each of the fan power boxes. The fan power boxes have a supply duct that distributes air throughout the classroom. Each classroom has an exhaust grill connected to one of the exhaust fans in the attic. All exhaust air is discharged to the roof. Each classroom has operable windows that can be opened for outside air. The fresh air fans in the attic have MERV 8 filters. These units provide all outside air and higher efficiency filters are not required. The fan power boxes also have MERV 8 filters, which will be upgraded to MERV 13.

Outside air fan with MERV 8 filters

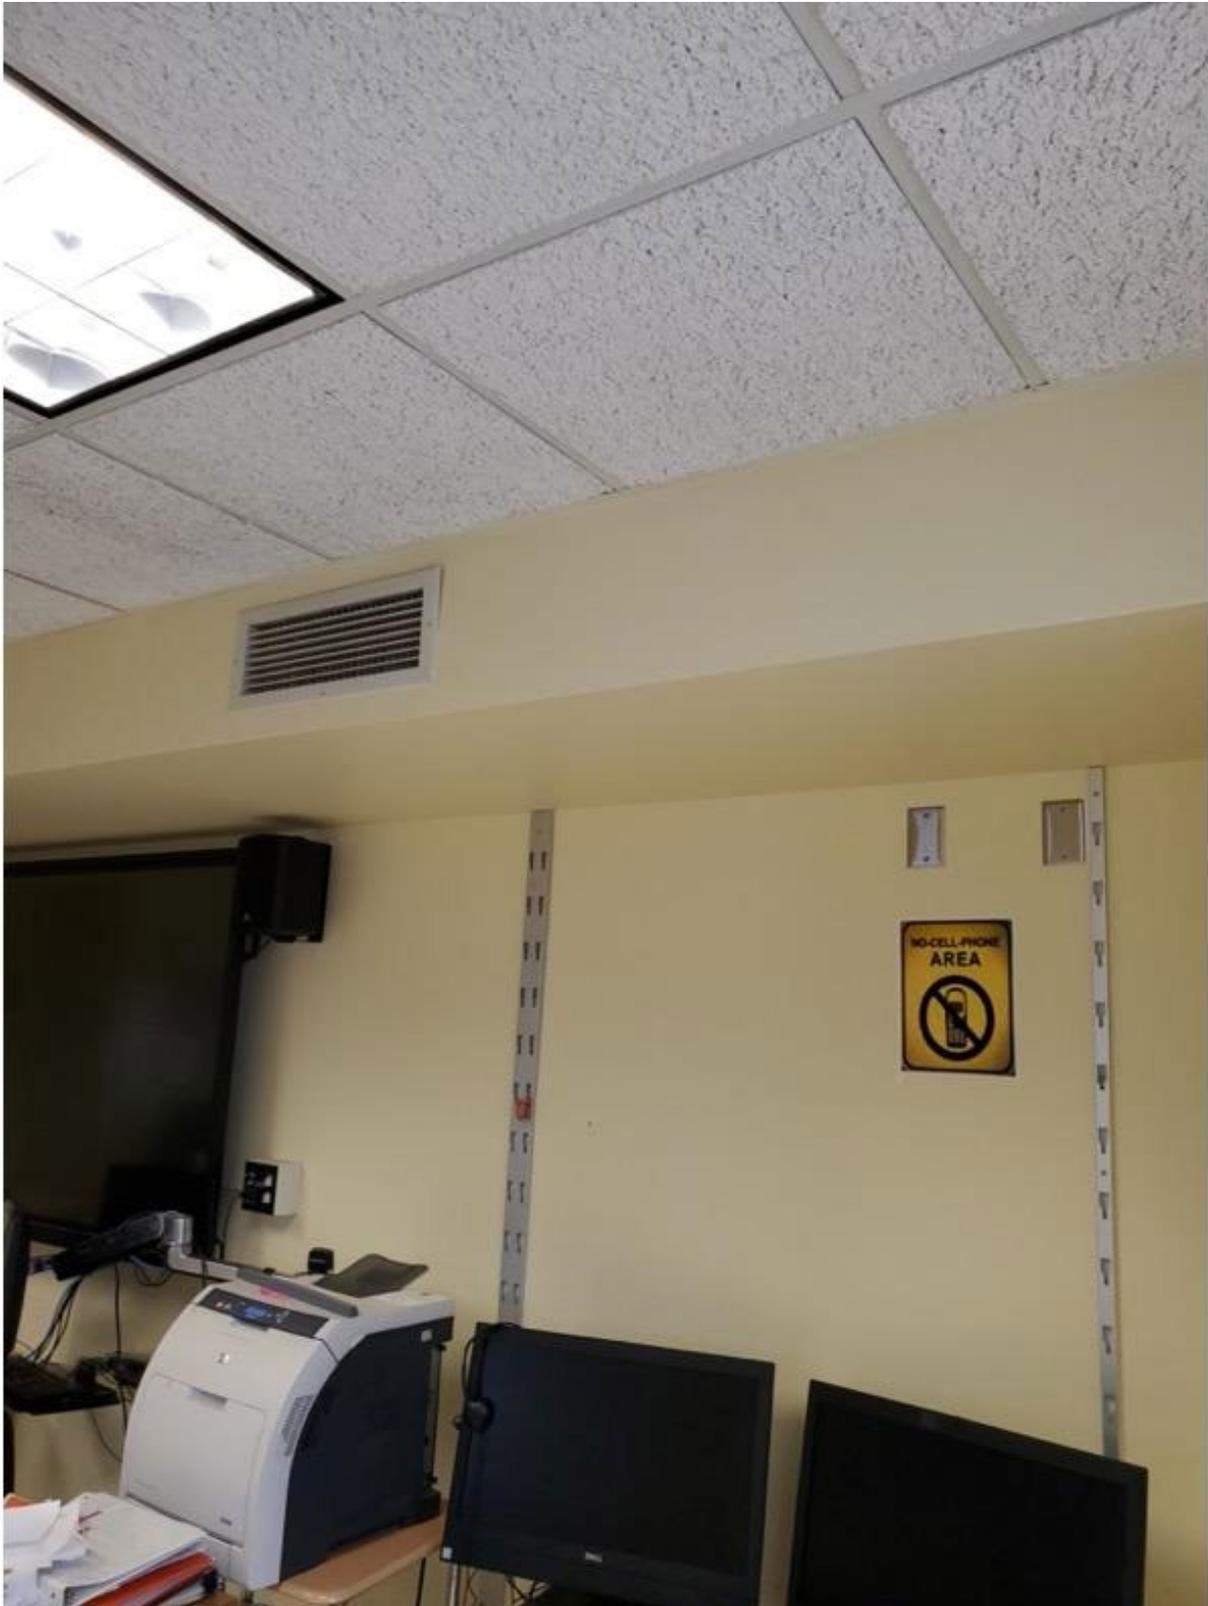
Supply vent from the fan power box

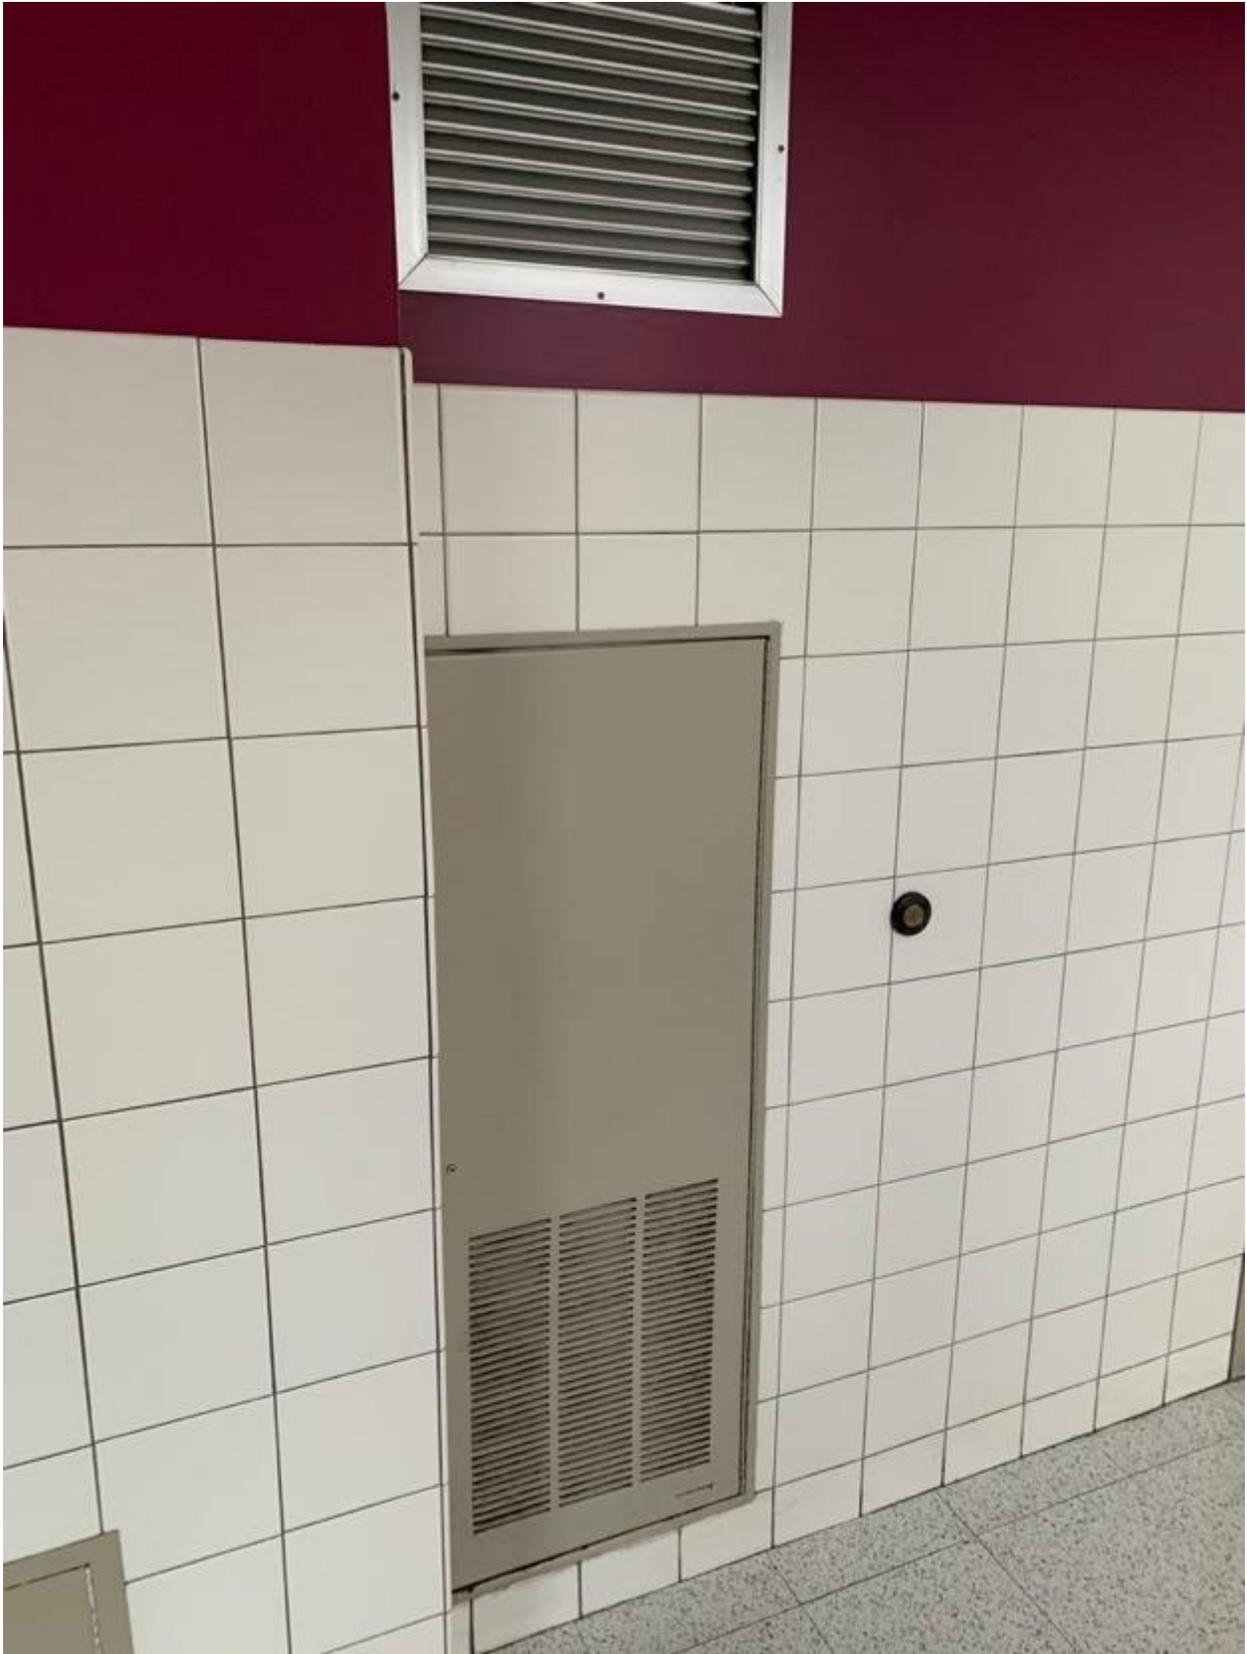
Fan power box in the common hallway
