OLMSTED ENVIRONMENTAL SERVICES, INC.

Date: February 2, 2021

Prepared by: Ed Olmsted, CIH, CSP

Subject: **Ventilation Screening**
Dr. Charles T. Lunsford School No. 19 Rochester, NY
465 Seward Street, Rochester, NY 14608

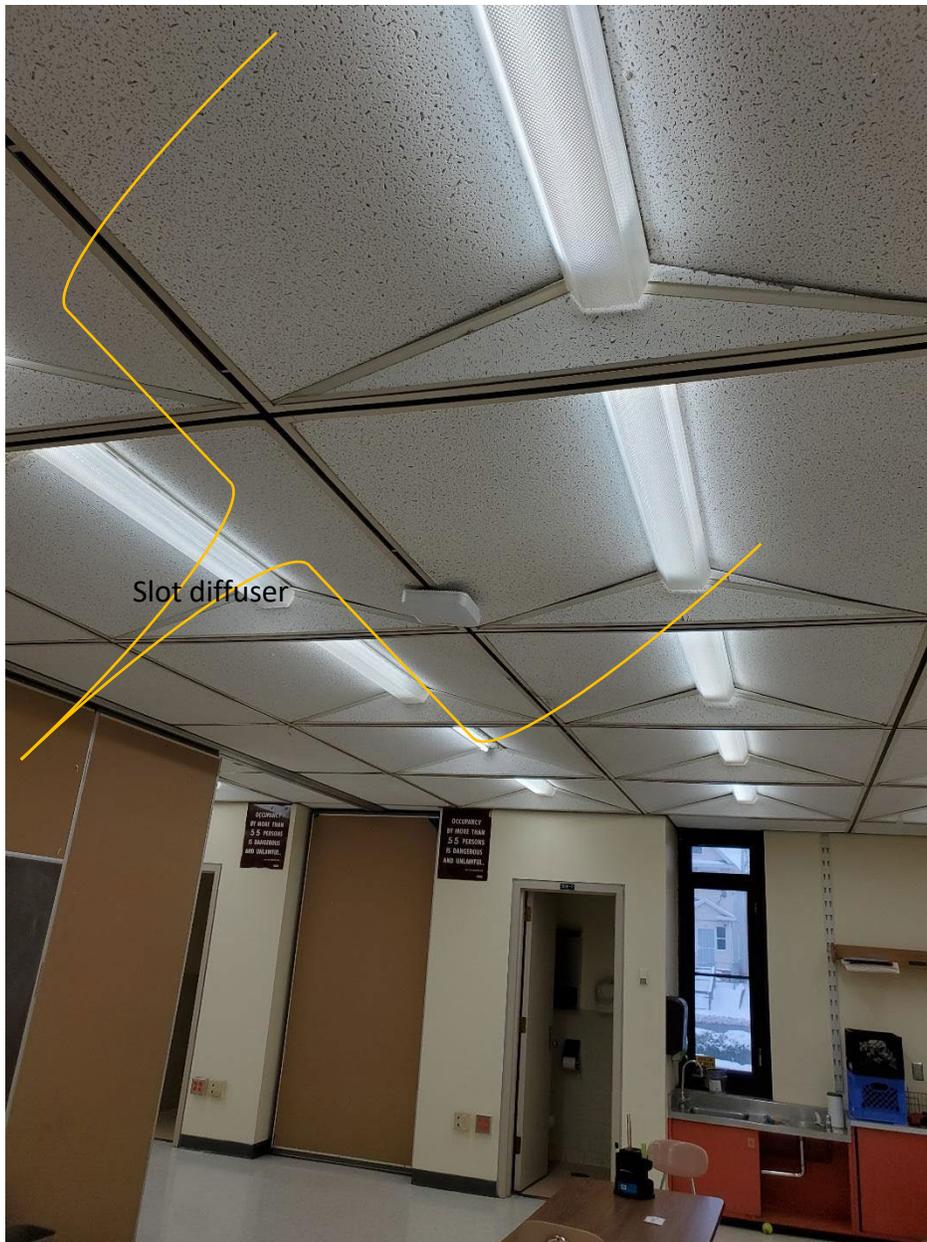
Linear slot diffuser located in Cluster Room 328. Typical of many classrooms visited.

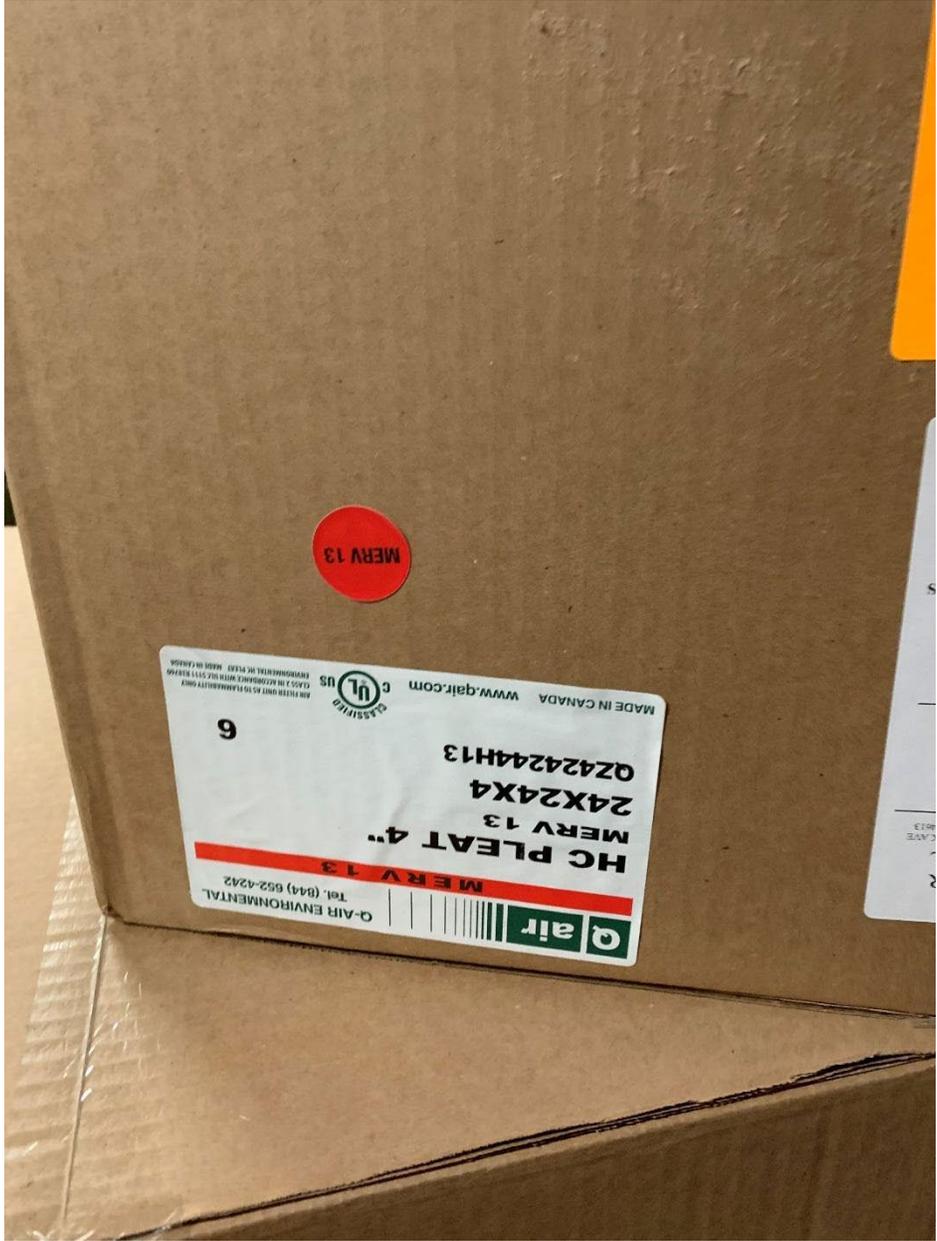
2. The central air handler units are designed to provide a mixture of outside air and return air modulated by dampers. Each supply fan has an associated return fan. Mixed air is filtered through MERV 13 filters and heated or cooled in fan coils in the unit. Filters with MERV-13 or higher ratings are recommended for HVAC systems due to their ability to filter smaller particles, including viruses.

New shipment of MERV-13 filters installed in air handler units

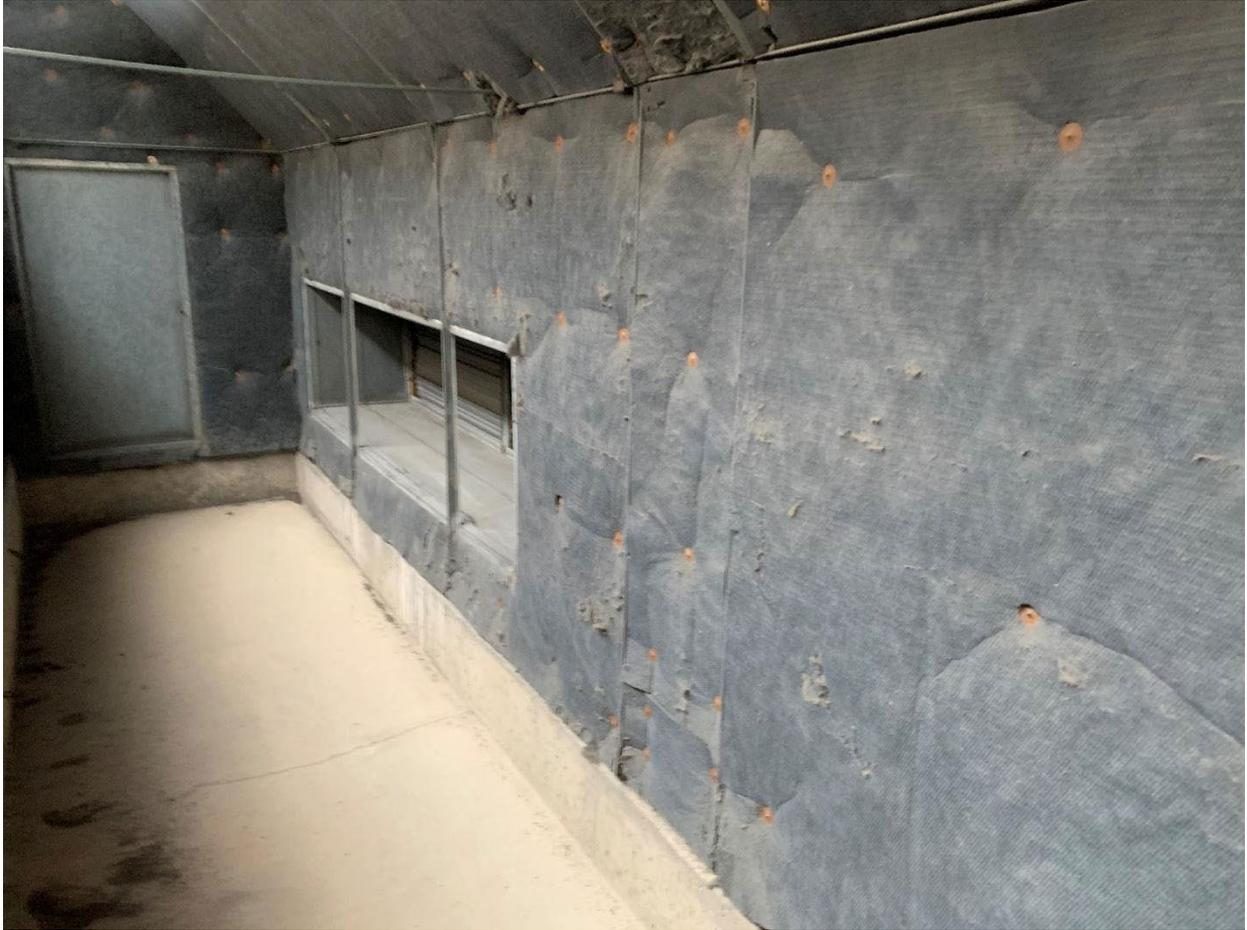
Outside air plenum in an air handler unit. The outside air dampers is minimally open due to temperature constraints.
