OLMSTED ENVIRONMENTAL SERVICES, INC.

Date: February 5, 2021

Subject: **Ventilation Screening**
Dr. Martin Luther King Jr. School No. 9
485 N Clinton Ave, Rochester, NY 14605

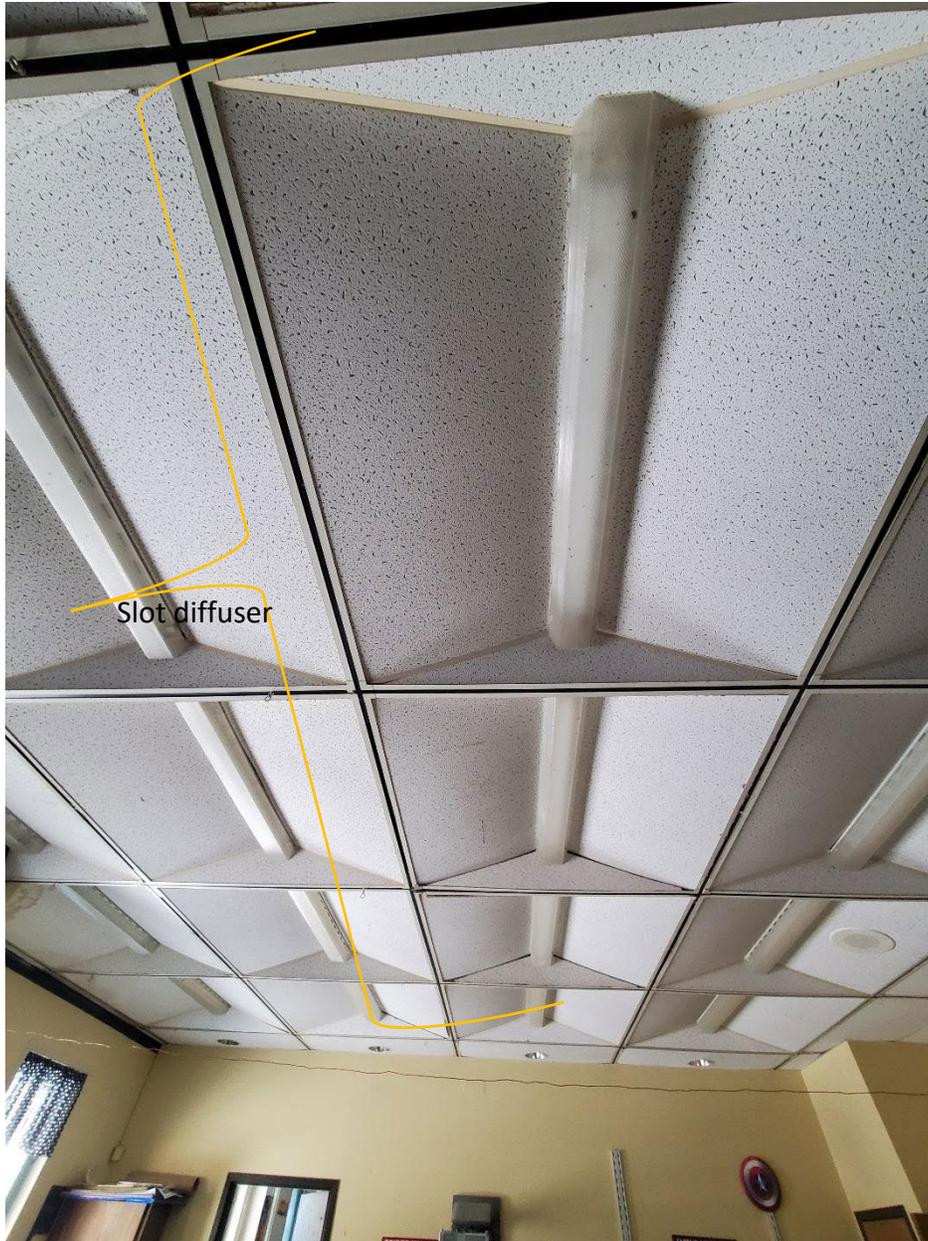
Linear slot diffuser located along the ceiling tiles. This is typical of many classrooms visited.
