OLMSTED ENVIRONMENTAL SERVICES, INC.

Date: February 7, 2021

Subject: **Ventilation System Screening**
School 7 - Virgil Grissom School, 31 Bryant Street, Rochester, NY

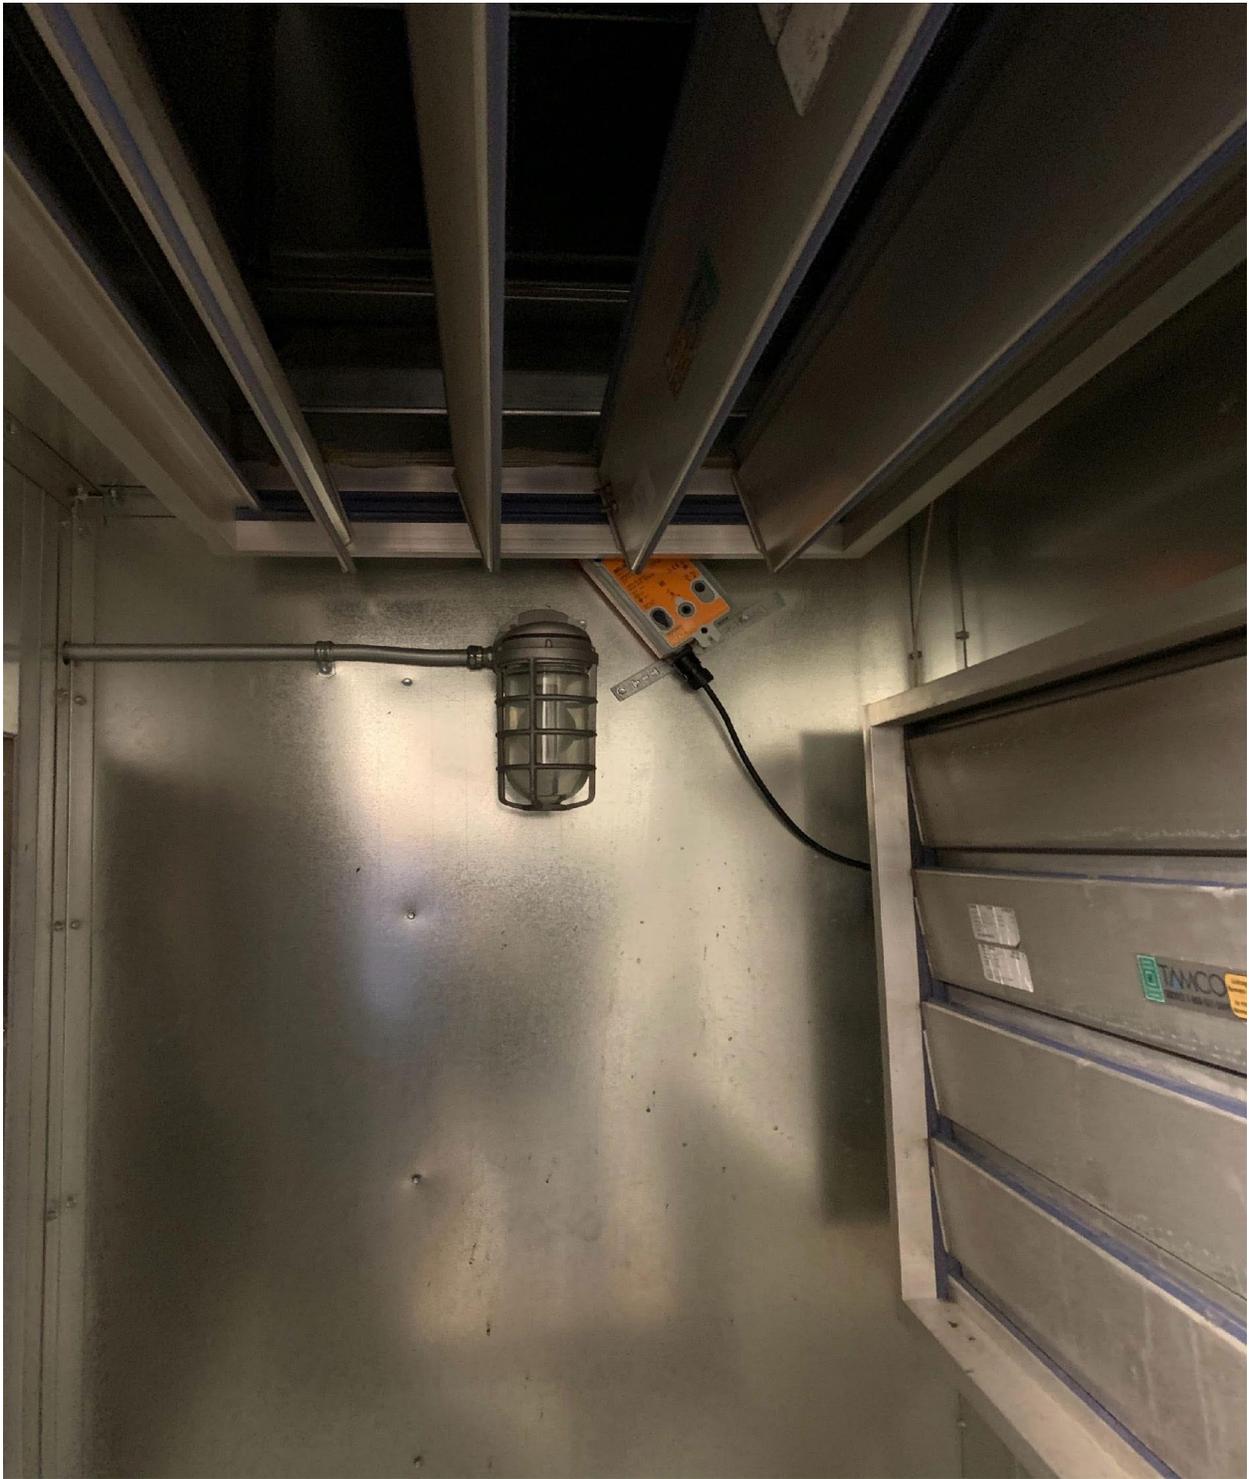
Air handler has outside air damp full open

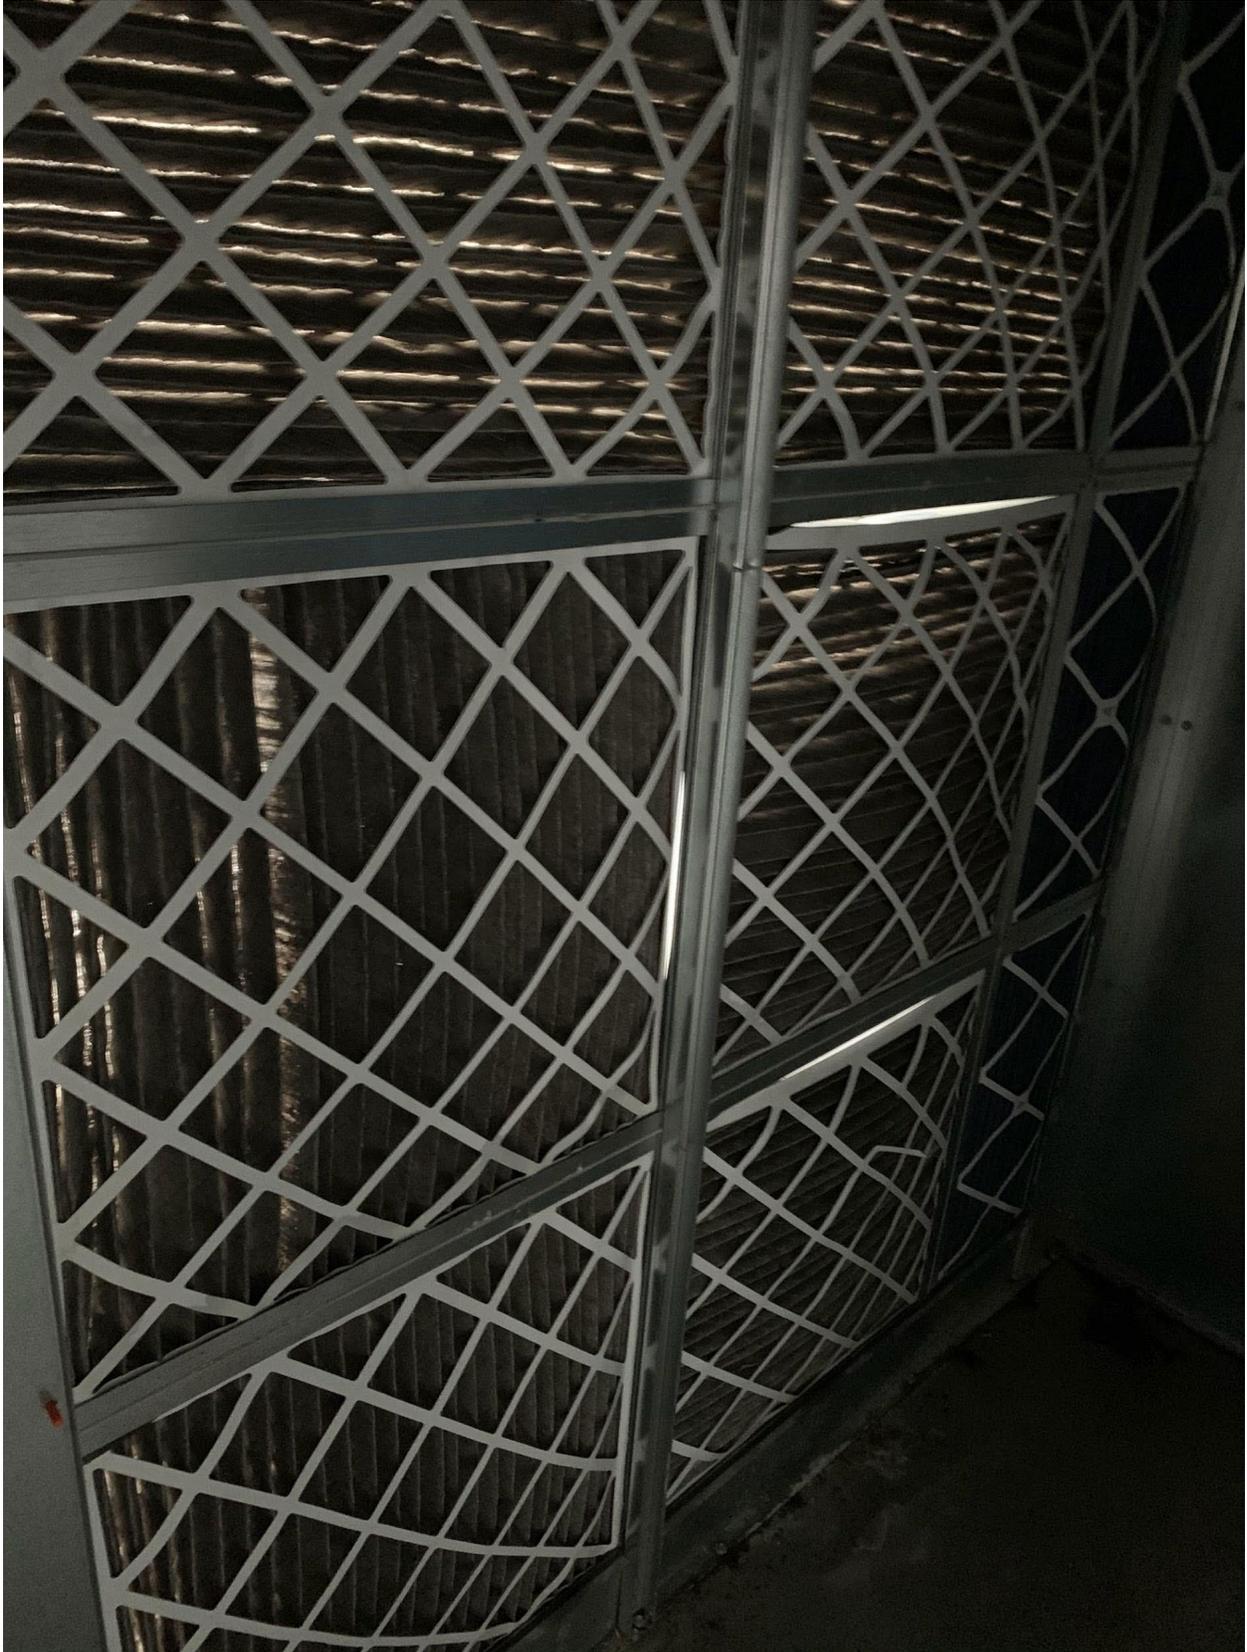
Currently MERV 8 filters

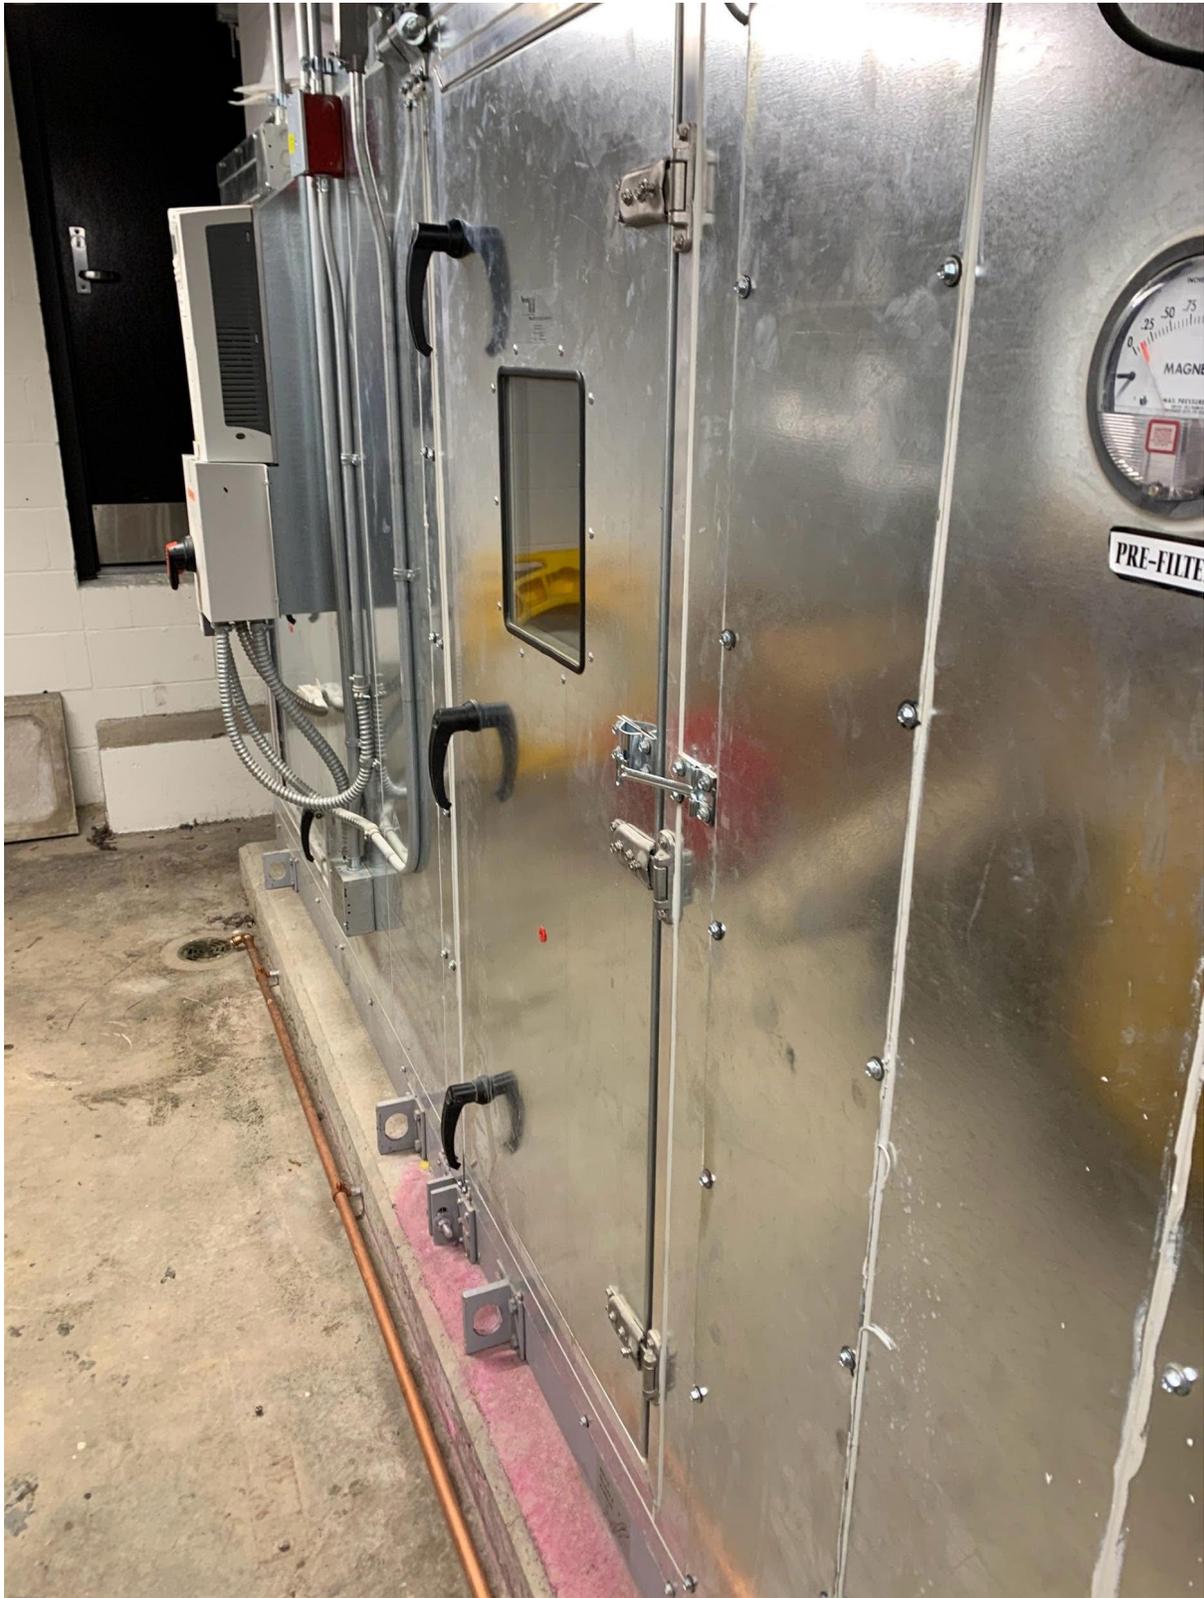
New air handler
