**OLMSTED ENVIRONMENTAL SERVICES, INC.**  
**1992 Route 9, Garrison NY 10524**

phone 845 424 4077 • fax 845 424 3482 • email [Olmsted.mac@me.com](mailto:Olmsted.mac@me.com)

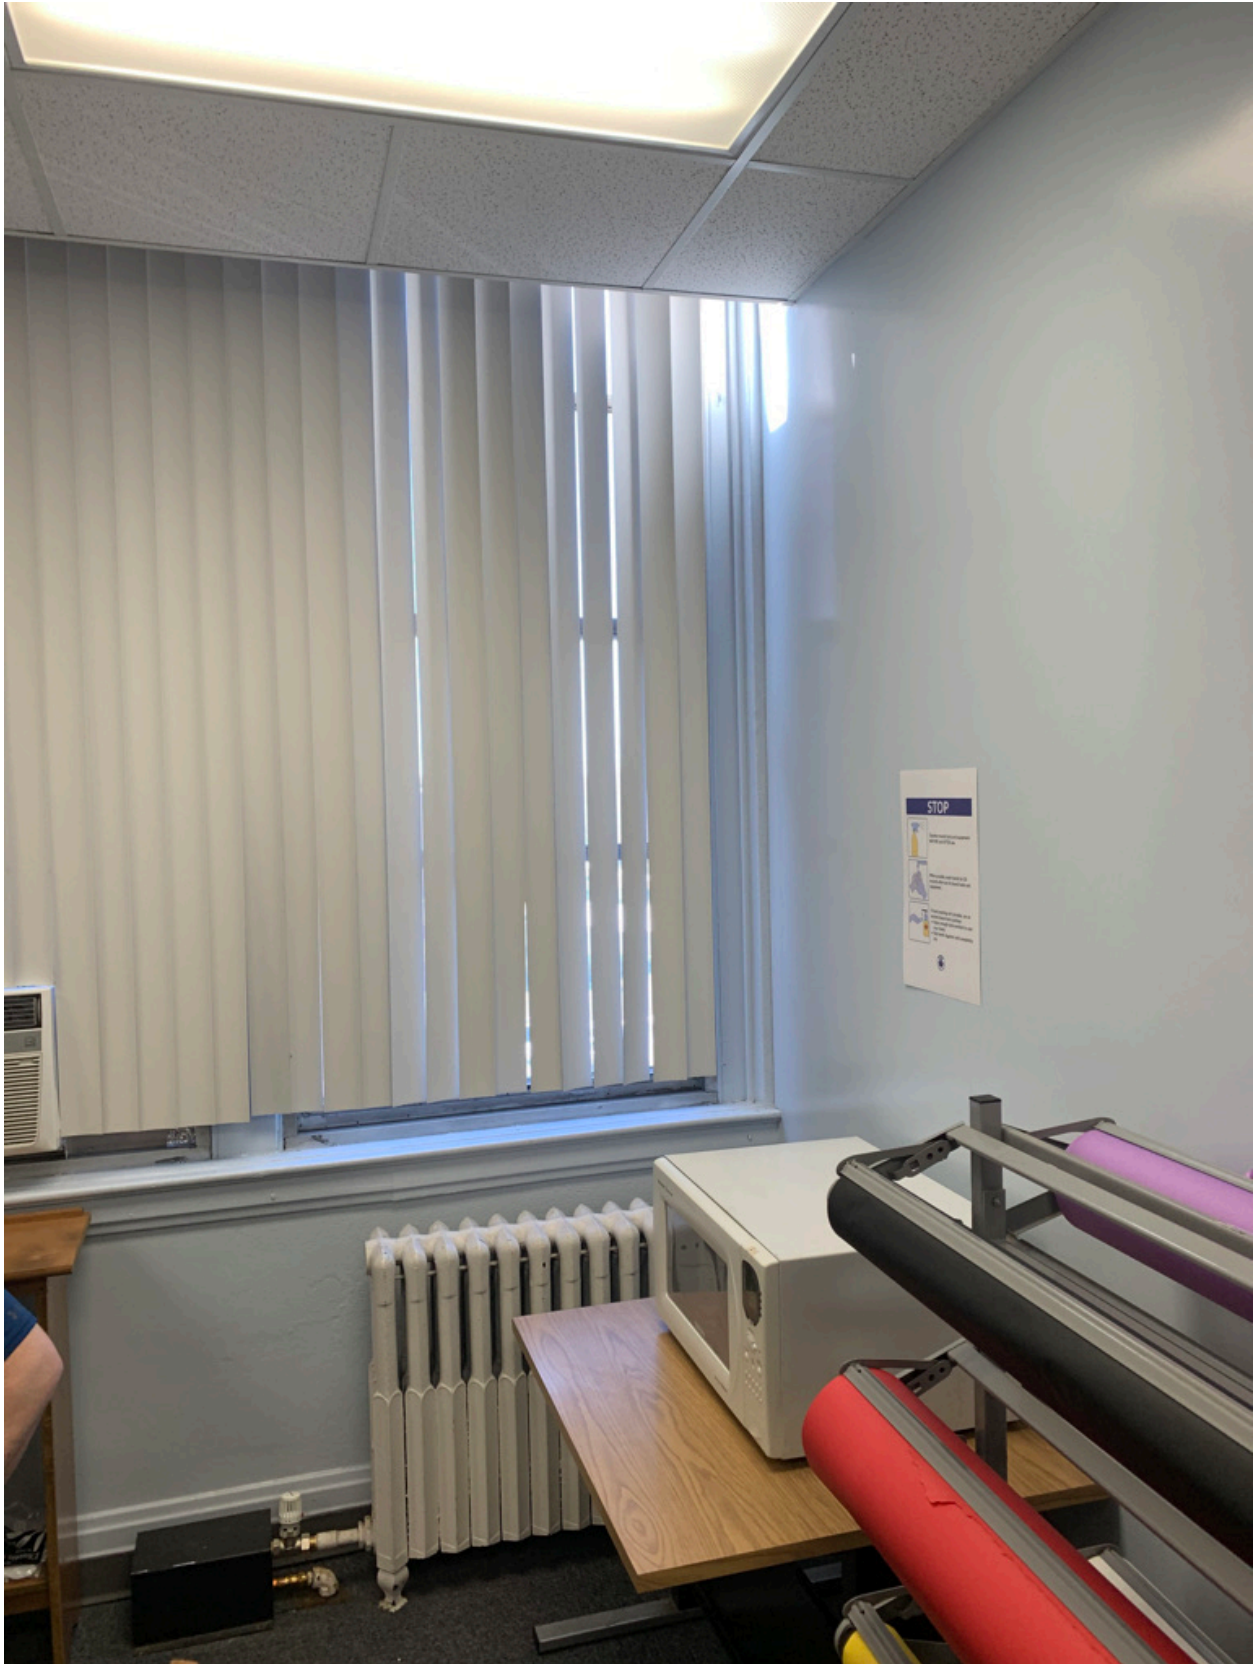
Radiators provide heat and the windows provide natural ventilation

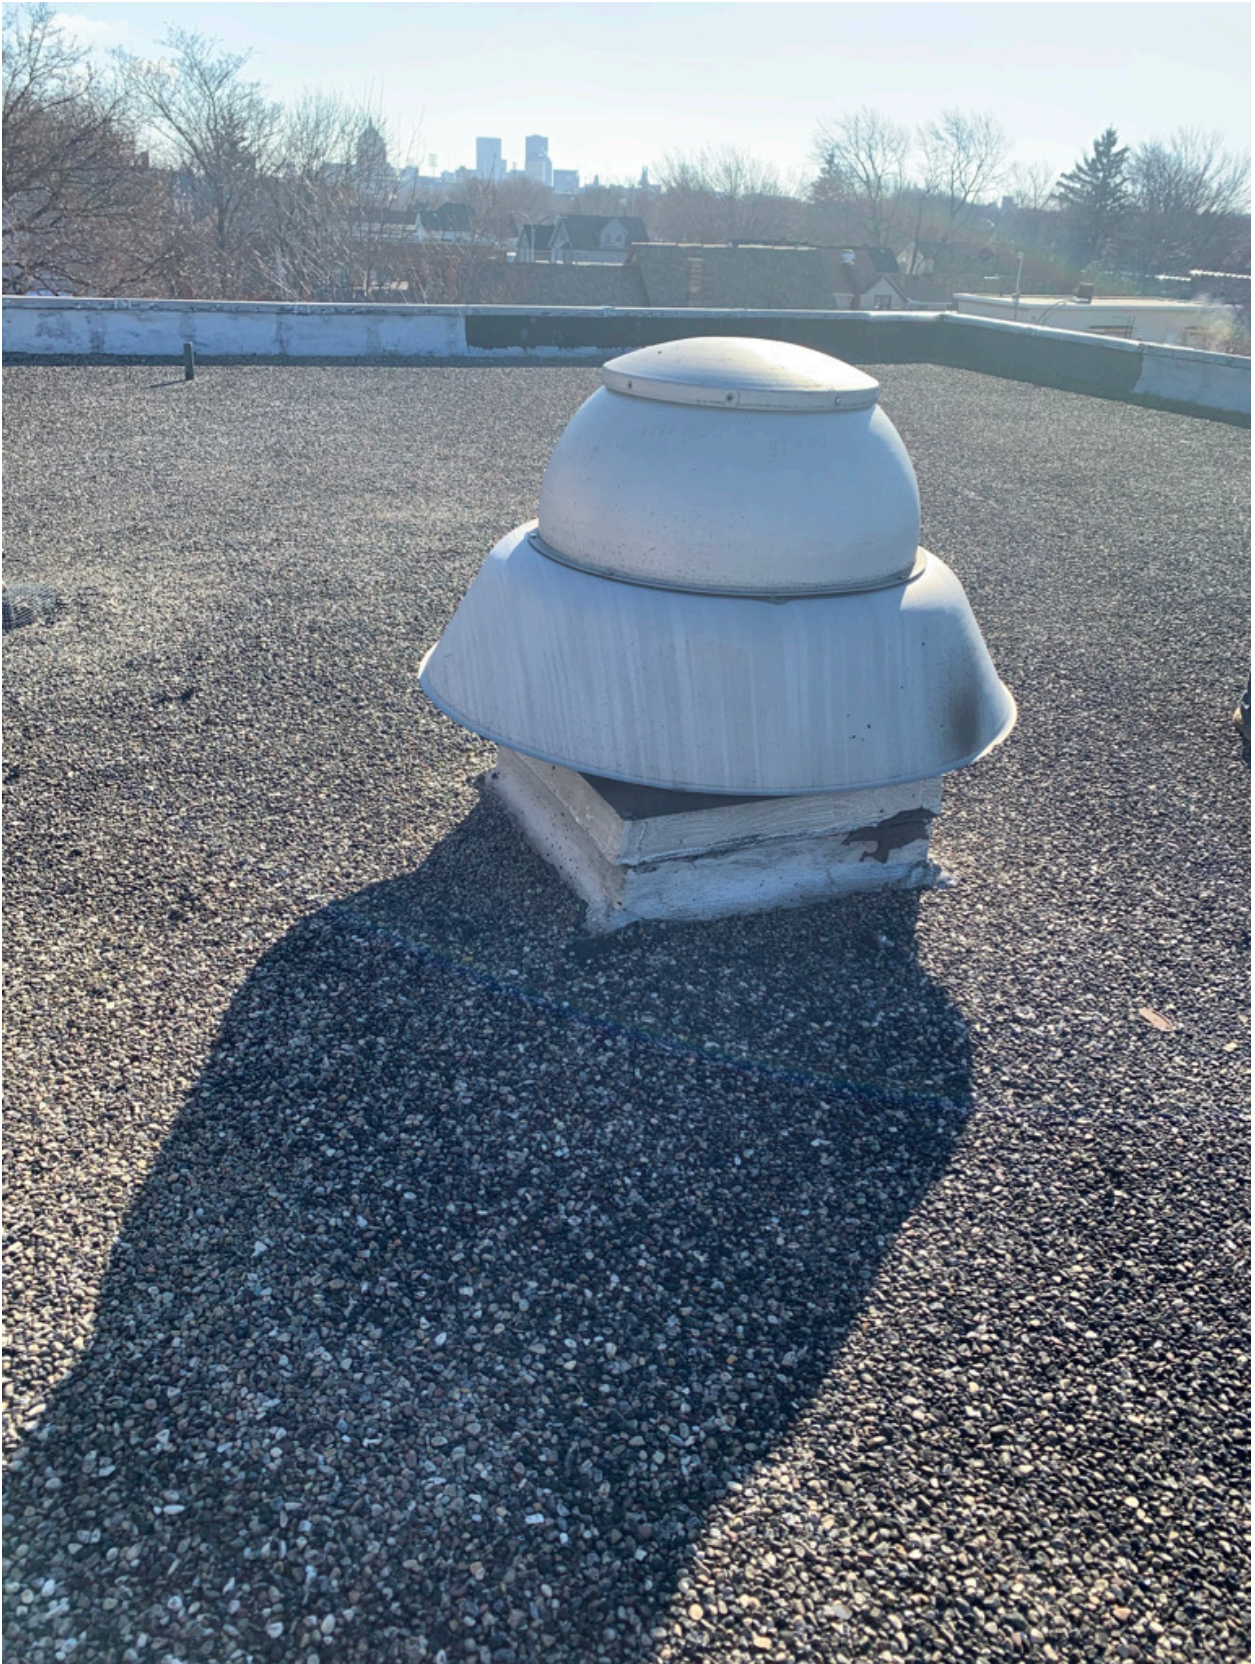
The roof top exhaust fans should be inspected and repaired where not working

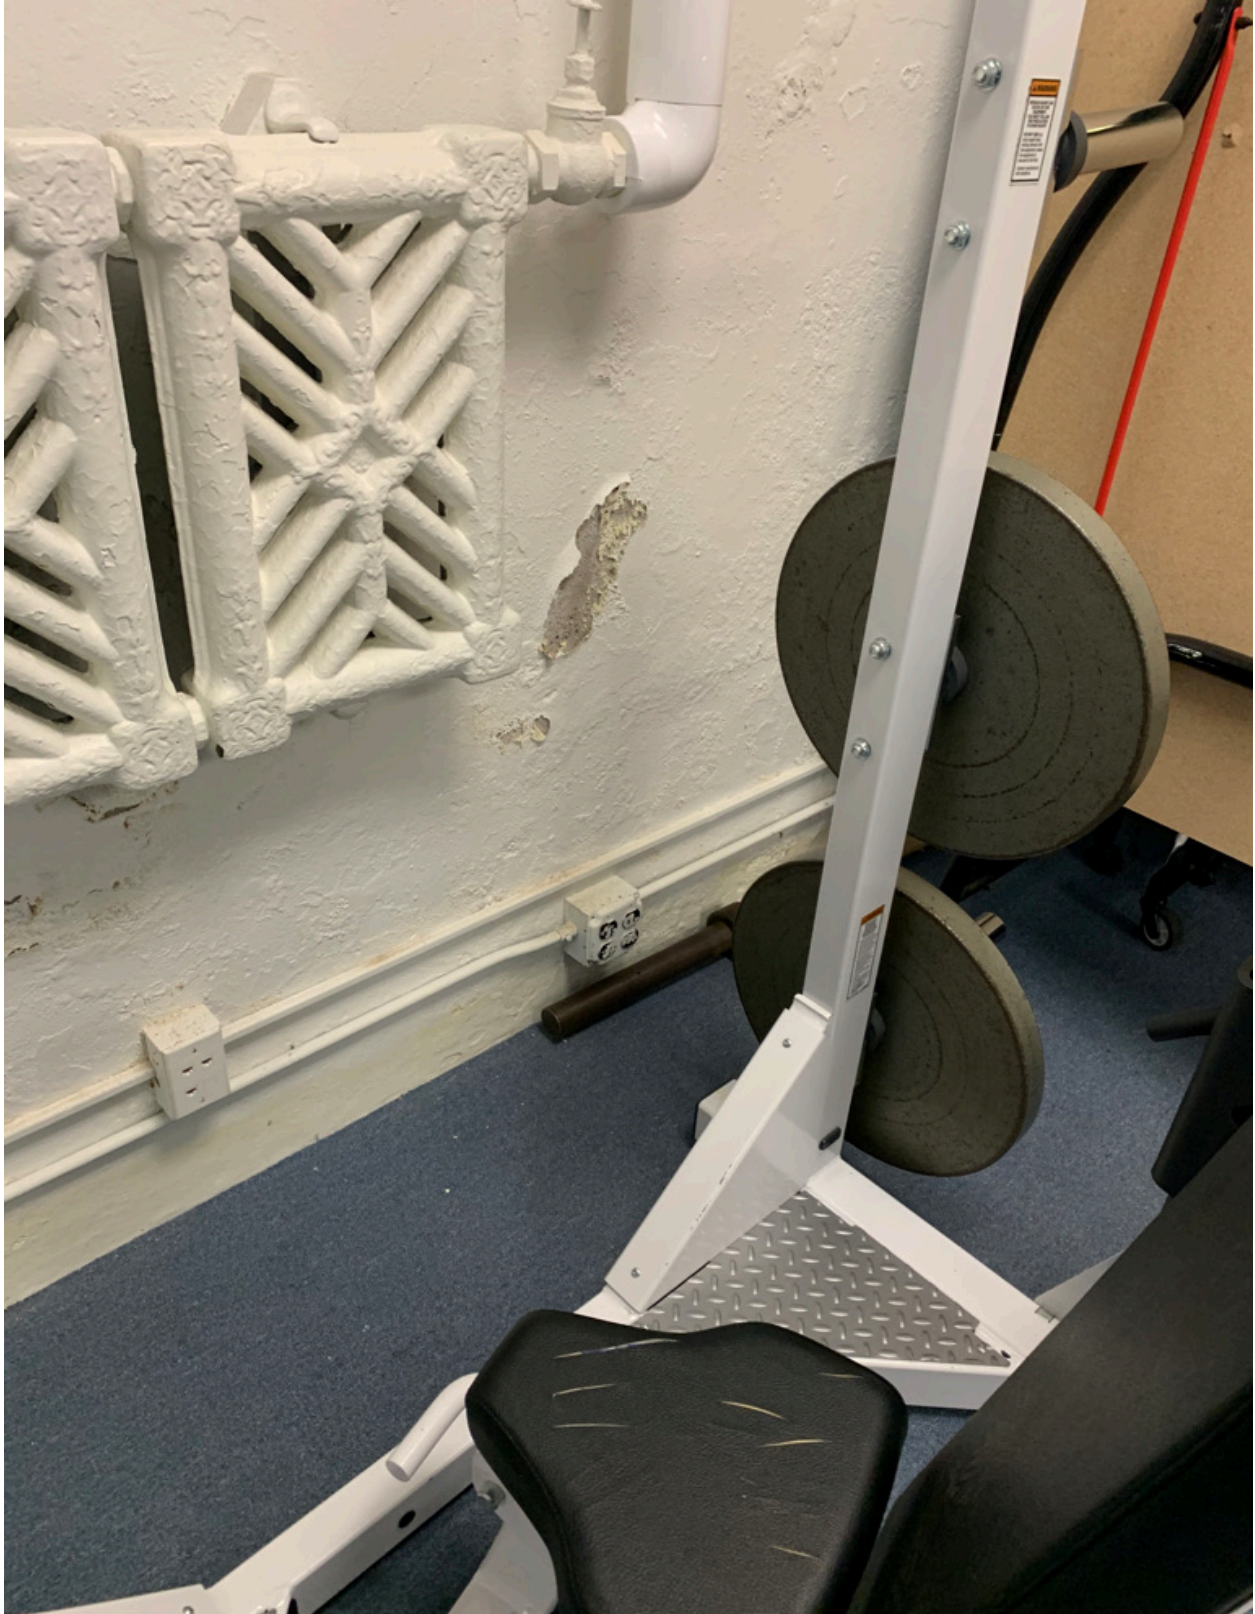
there is dampness in the foundation wall in the weight room and this has caused a musty odor in the carpet.
