# **OLMSTED ENVIRONMENTAL SERVICES, INC.**

Date: December 28, 2020

Subject: **School Inspection**  
**School 12 Rochester, NY**  
**999 South Ave, Rochester, NY 14620**

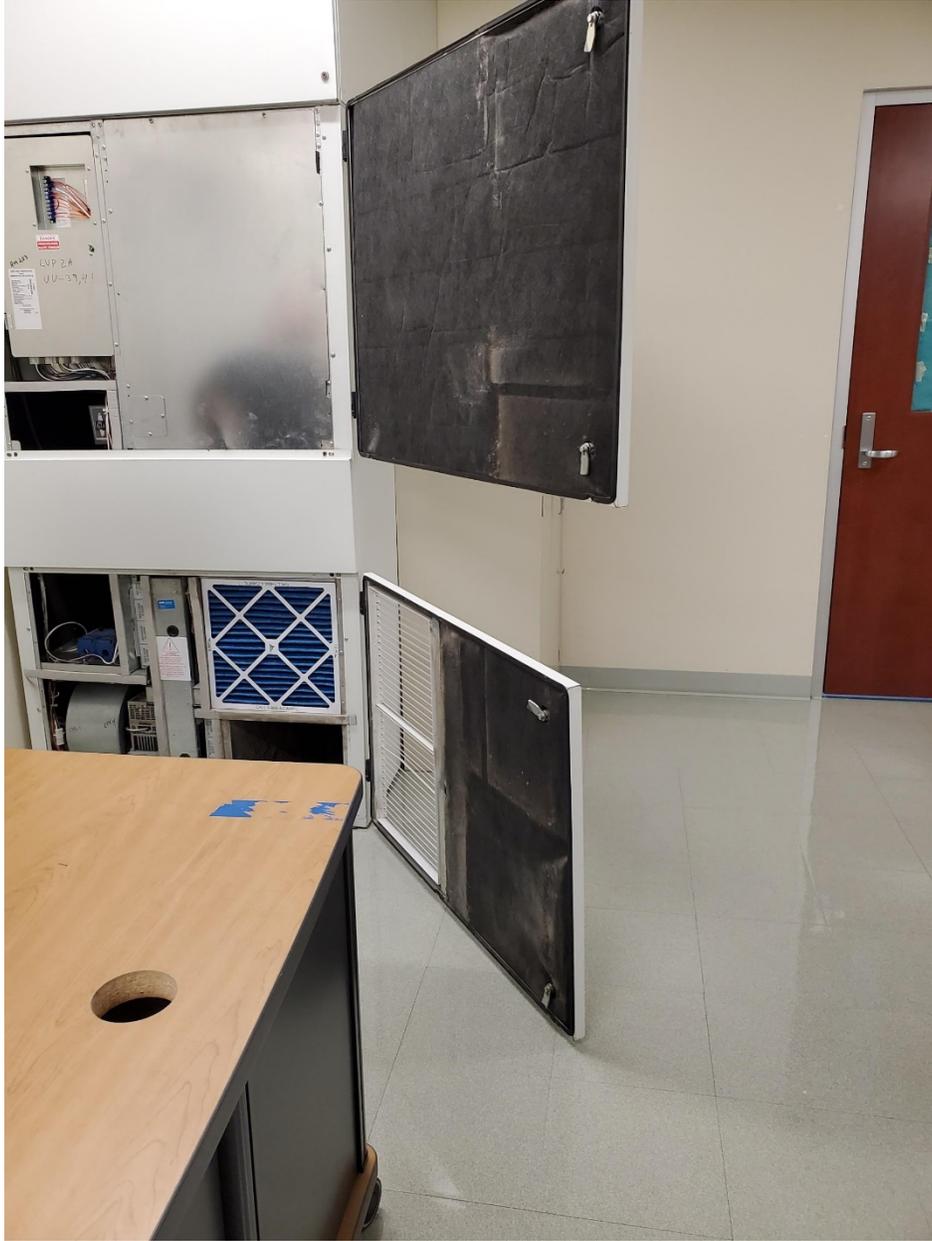
1. School 12 has a centralized HVAC system, but most classrooms and offices are served by vertical univents. They were found in both the classrooms, Room 203 and 205, that are planned to be in-use during the early January reopening. The univents are standalone units that have a heating and cooling coil and outside air inlet. The units also have a filter installed at the base that have the maximum MERV rating for the equipment. The filters inspected indicated MERV 10. It was reported that these units cannot accommodate MERV-13 without significant static pressure lose. They would significantly diminish these units' ability to bring in any outside air.

Inside vertical univent in Room 203

The classrooms have univents that provide outside air. The classrooms have sufficient ventilation capacity to be occupied. Where possible and if necessary, teachers can open two windows in each room to an opening of two inches. This will provide natural ventilation without causing the room to become cold. Opening the window at the top is adequate to provide sufficient ventilation to the room. The air moves through the open windows with the classroom door either open or closed. Staff should be advised to minimize storage around the vertical univents in their room.
