OLMSTED ENVIRONMENTAL SERVICES, INC.

Subject: **School Inspection**
School 15
85 Hillside Ave, Rochester, NY 14610

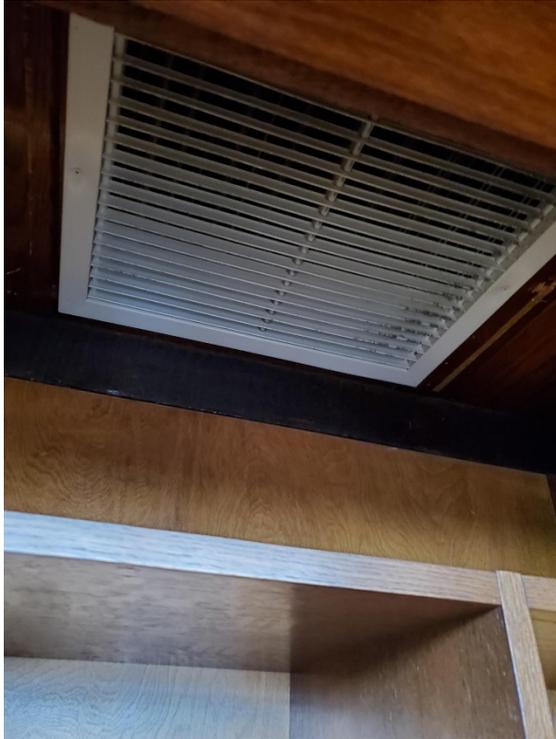
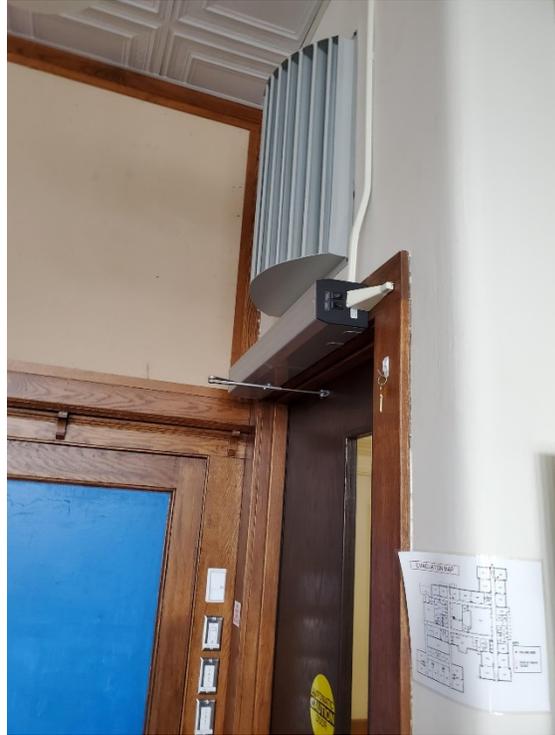
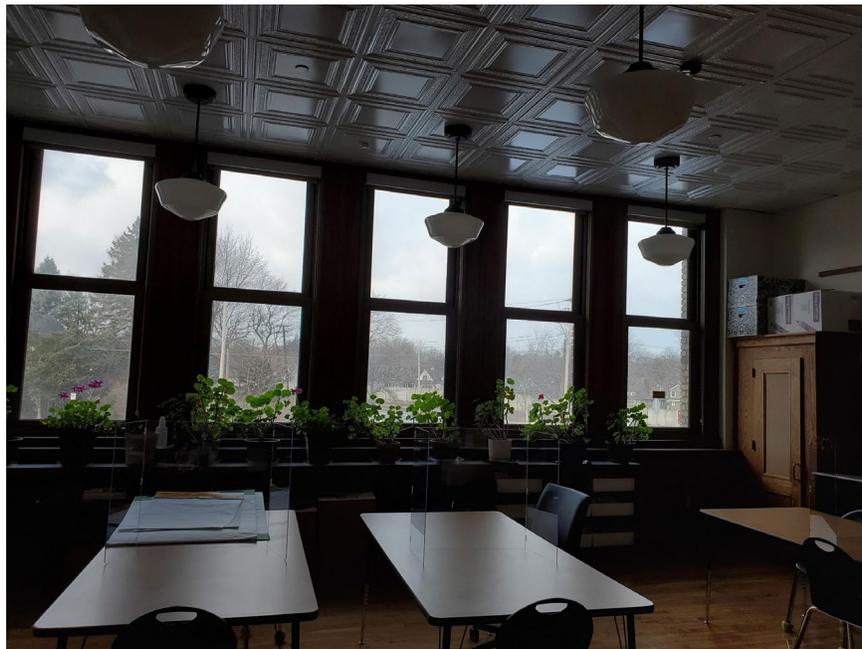
Typical ventilation in classroom in School 15. Top left and clockwise, 1) return on the ceiling or closet, 2) supply diffusers near the ceiling, 3) windows for supplement outside air, and perimeter heaters at the base of the windows

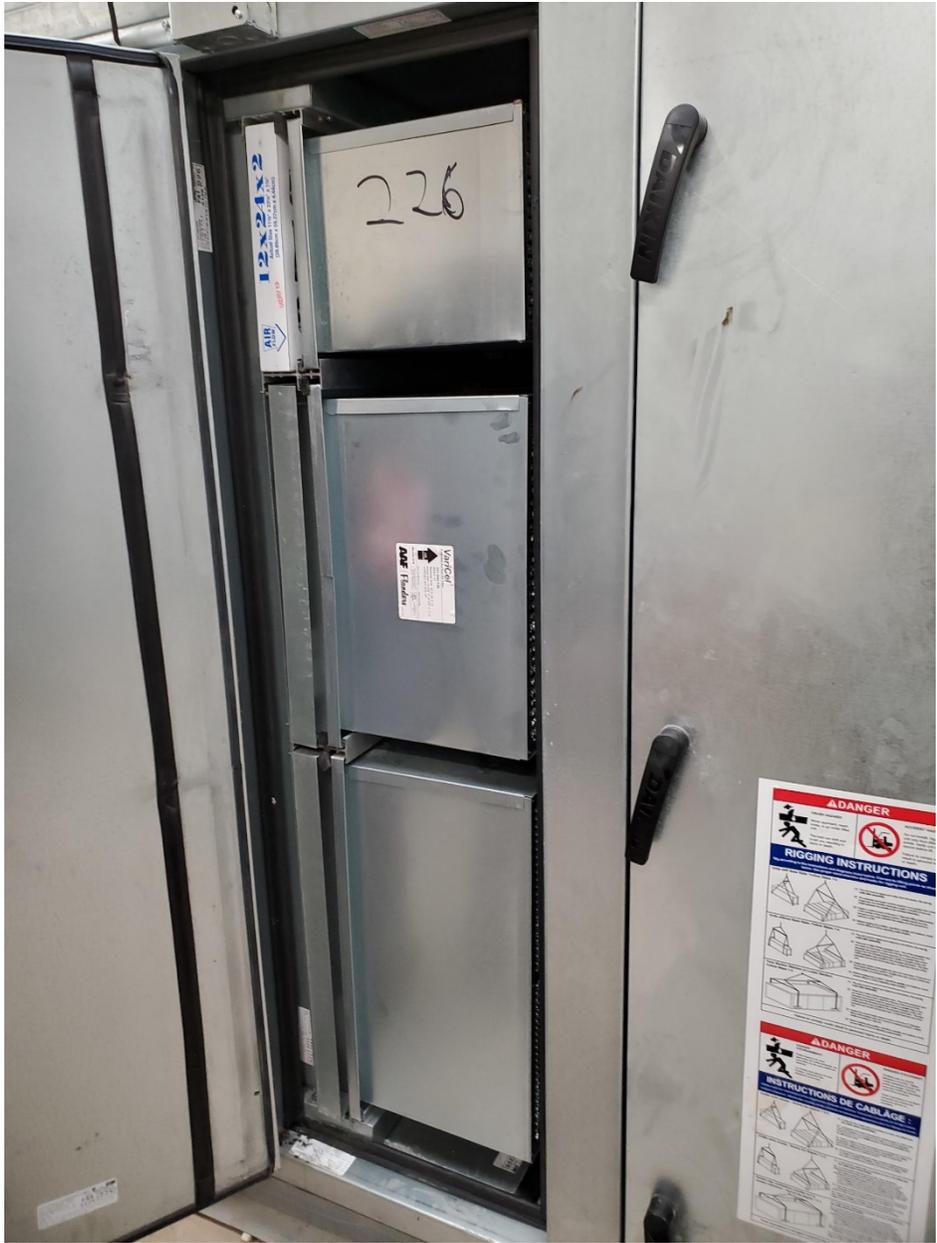
MERV-8 prefilter and MERV-13 filters in air handler unit
