OLMSTED ENVIRONMENTAL SERVICES, INC.

Date: December 28, 2020

Subject: **School Inspection**
School 33 Rochester, NY
500 Webster Ave., Rochester, NY 14609

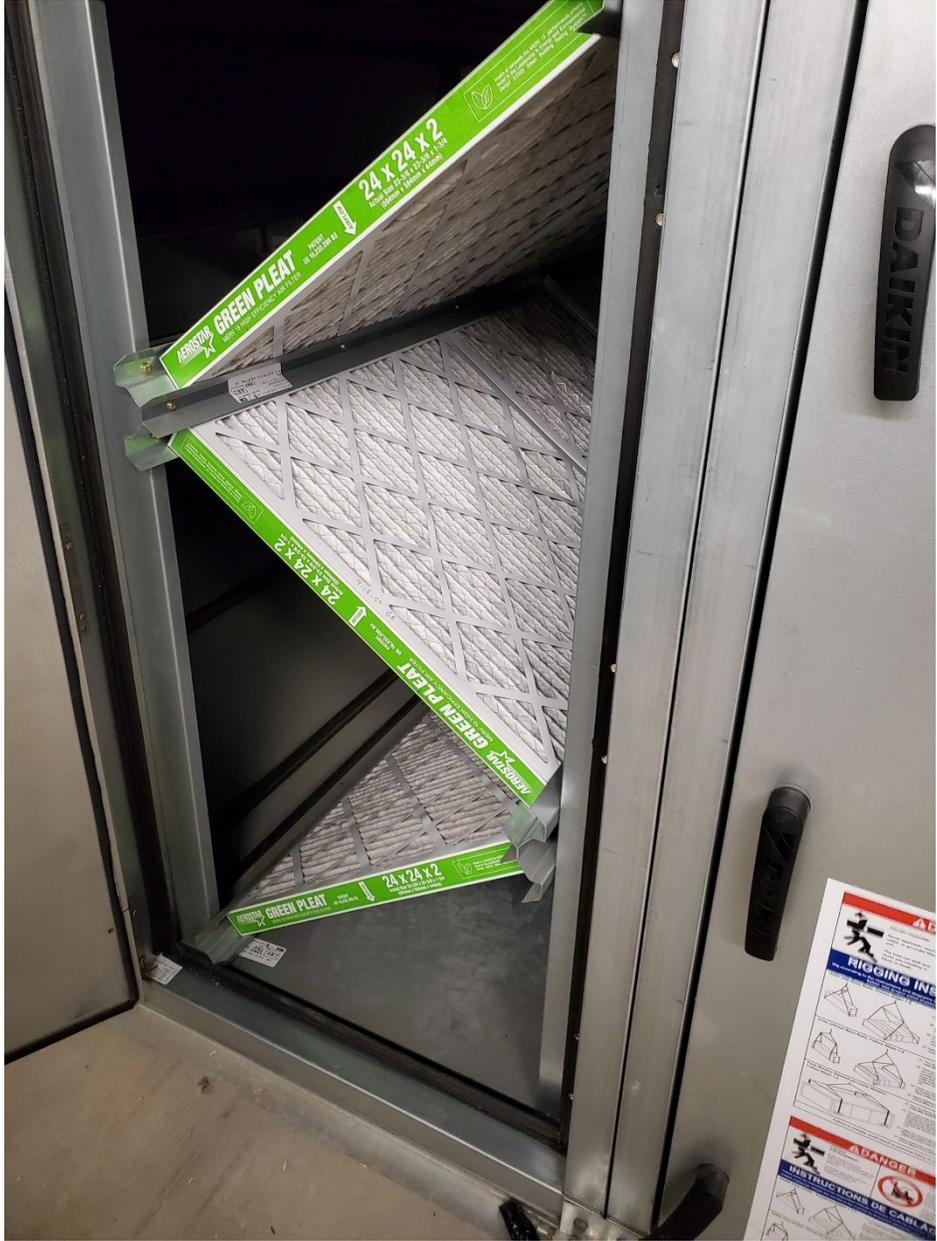
- a. The air handler units that serve the public assembly spaces, such as the gym, auditorium, and atrium, are in good condition. The air handlers provide outside air that is preheated using a heat wheel. Each supply fan has an associated return/exhaust fan. Supply air is filtered through MERV 13 filters and heated or cooled in fan coils in the unit. Filters with MERV-13 or higher ratings can trap smaller particles, including viruses.

MERV-13 Filter bank in air handler unit.

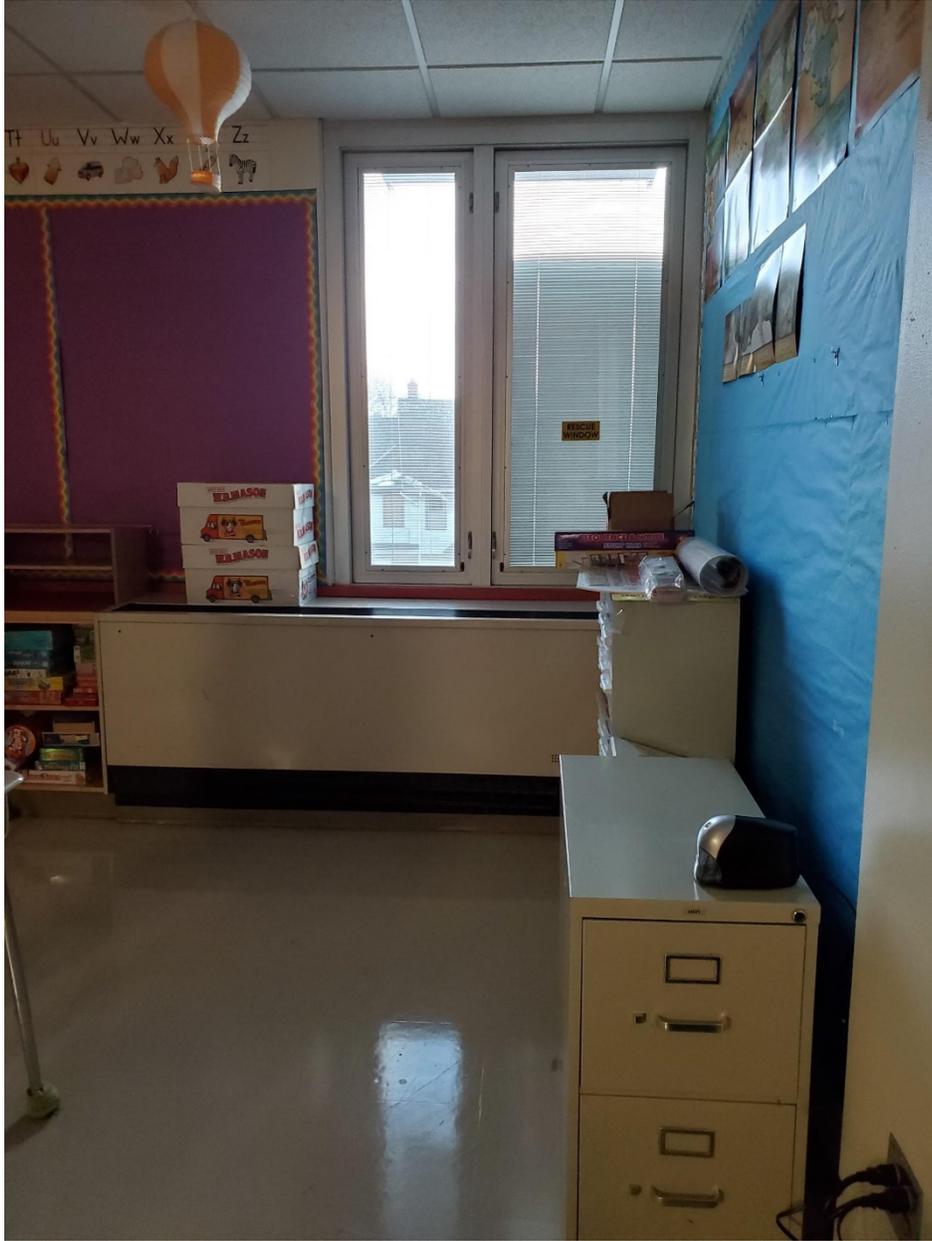
- b. The stand-alone univents found in most classrooms have a heating coil and outside air inlet and are located under the windows in each classroom. These univents are direct cooled and have a heating coil that is provided hot water by the boiler. In addition to the univents, each classroom has a bank of windows on the exterior walls that can be opened for outside air.

3. Room 309 is a classroom to be used in early January. This room is served by operable windows, a functioning univent, and 2 ducted exhaust. The adjoining bathroom also has a working exhaust. With the window open 2 inches the flow of outside air into the room through the window was measured at 1,000 feet per minute. This provides good air exchange and ventilation.

Univent in Room 309

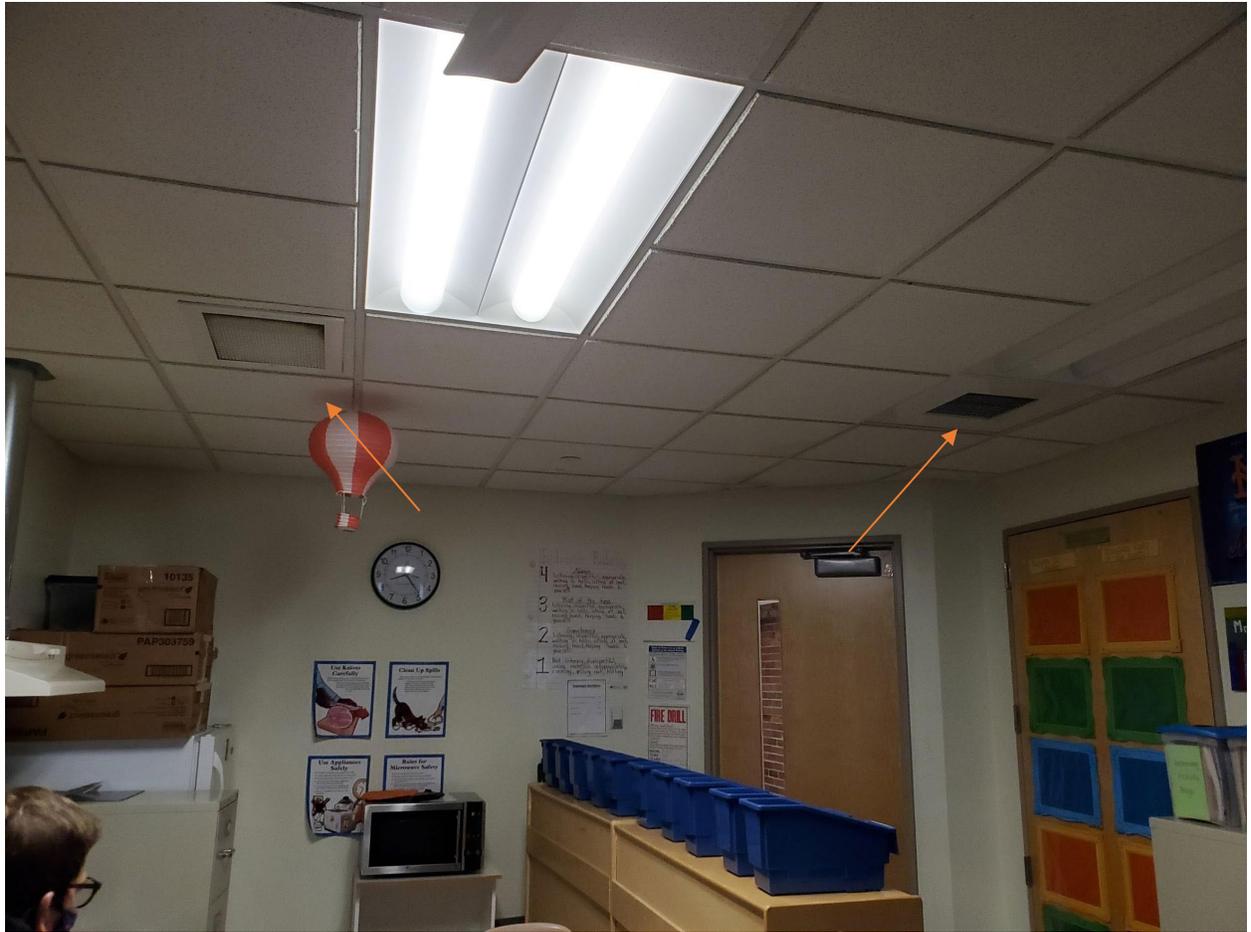
Exhaust and relief exhaust located in Room 309.
