OLMSTED ENVIRONMENTAL SERVICES, INC.

Date: February 7, 2021

Subject: **Ventilation System Screening**
OACES - 30 Hart St, Rochester, NY 14605

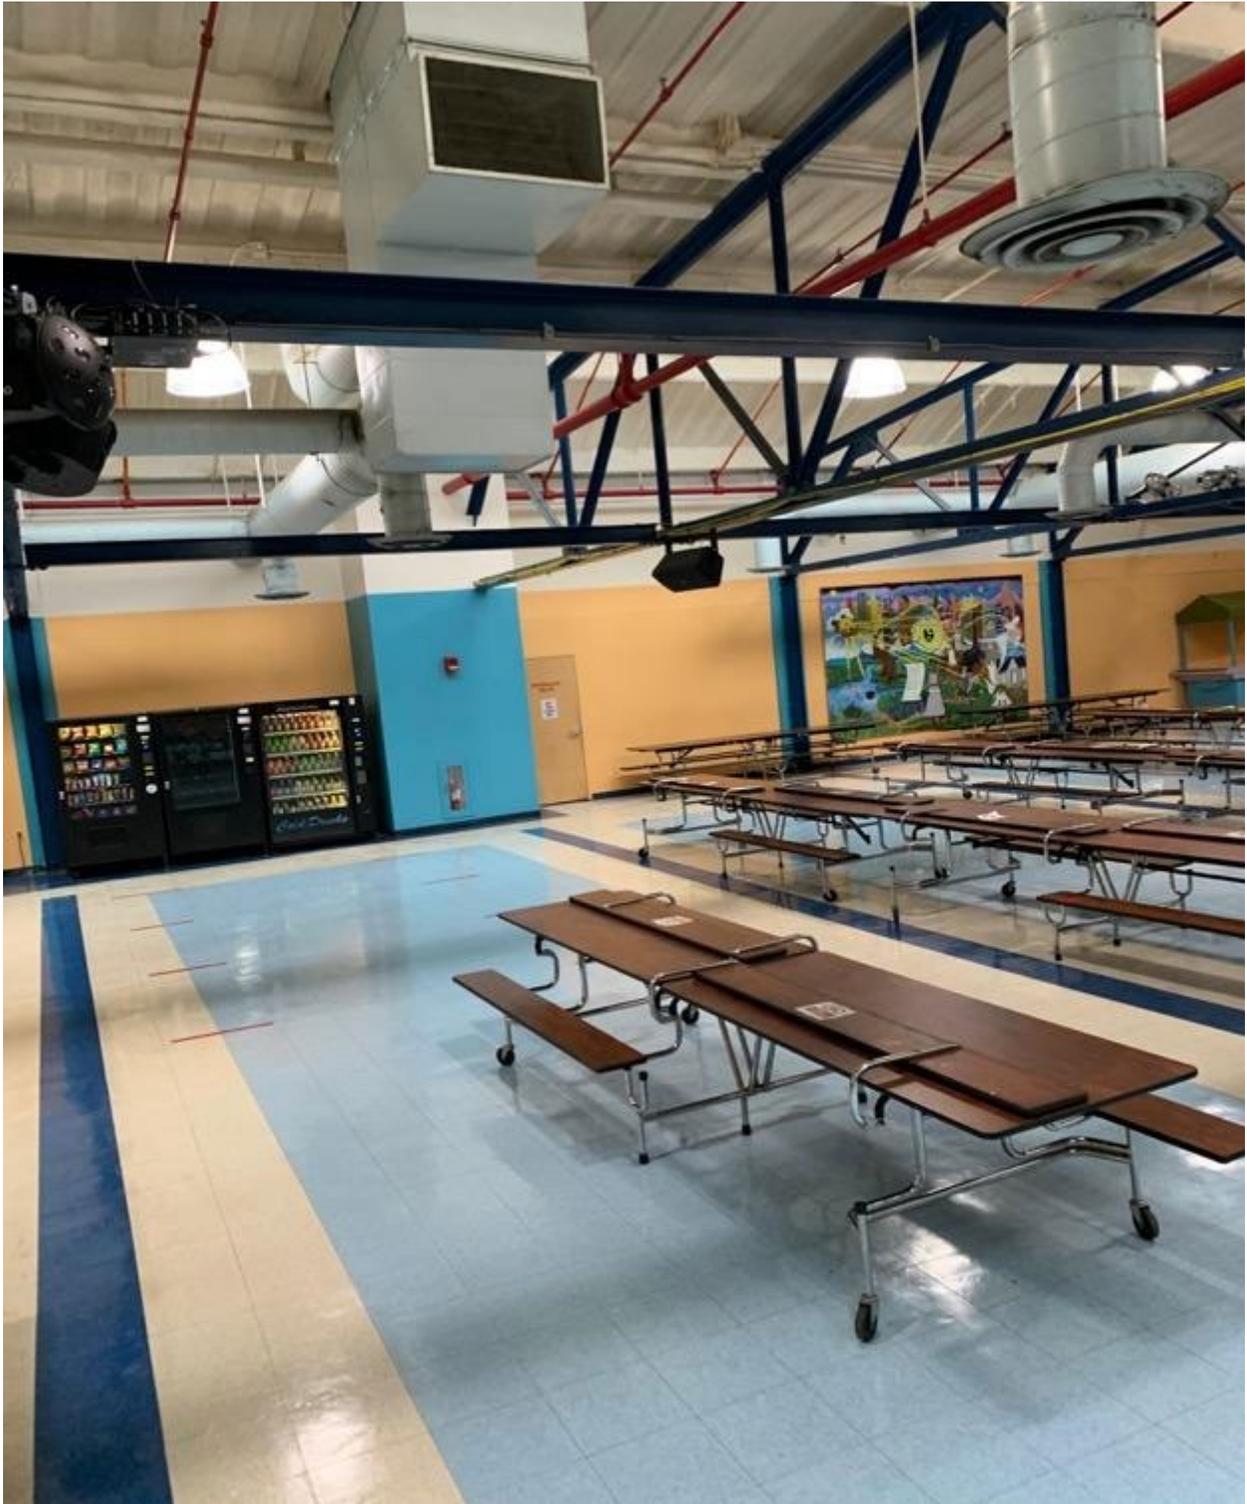
Cafeteria is well ventilated

- b. 1st floor Cafeteria – This is an interior room that does not have windows. The supply vents were moving air and working. There are 4 rooftop air handlers serving the cafeteria and these provide a significant amount of ventilation.

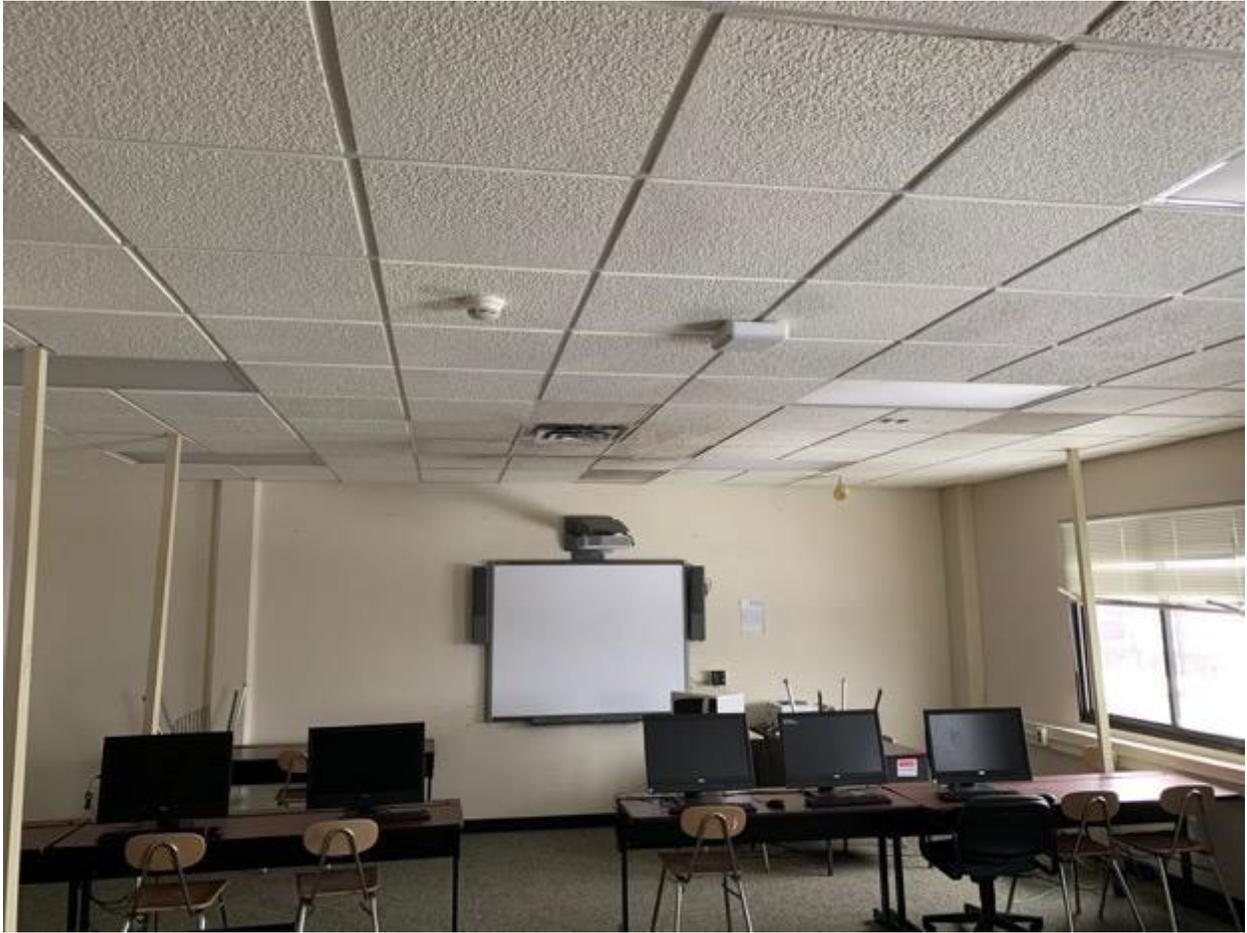
Typical classroom has operable windows and mechanical ventilation

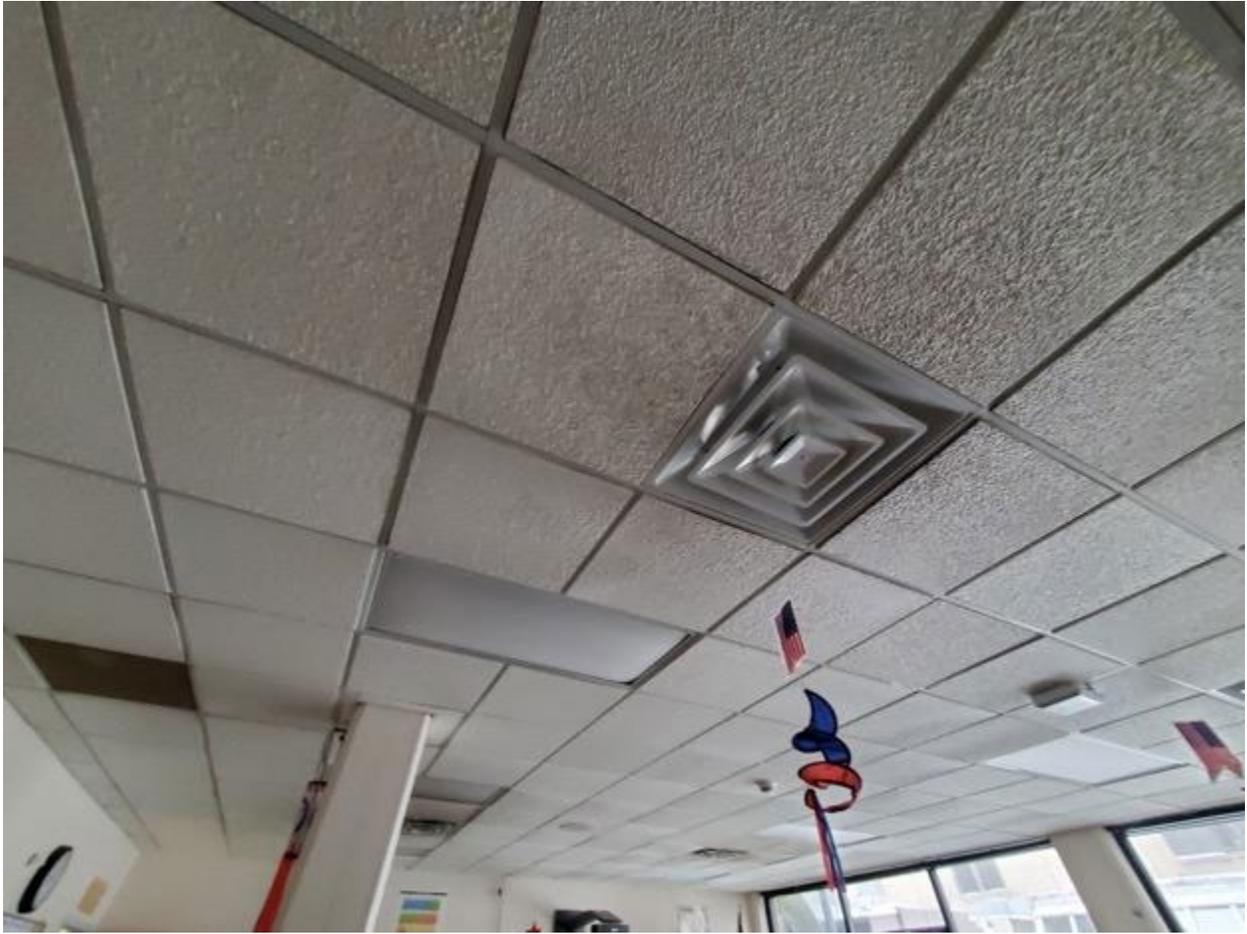
Typical drop ceiling and supply vent in classroom

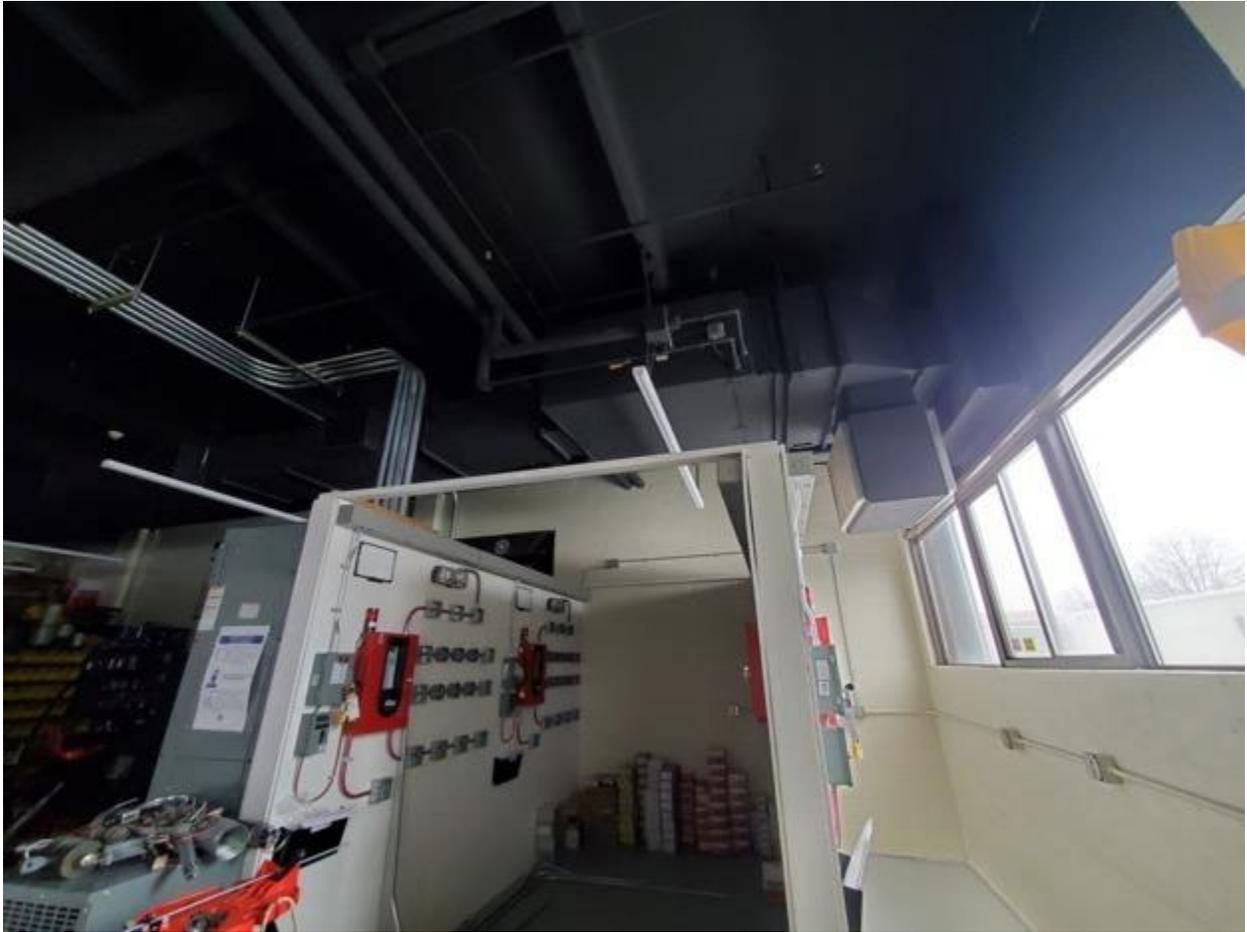
Shop area ventilation unit

3. The shop areas have a ceiling mounted air handler that has an outside air duct. The air handler has MERV 8 filters.
4. Most classrooms have windows, which can be opened for outside air. If MERV 13 filters are installed opening windows is not necessary since the ventilation units provide efficient filtration of recirculated air. There are some classrooms that do not have windows and rely on the mechanical ventilation for outside air.

5. Windows were checked in some classrooms and found to be working.
6. Classroom inspections revealed the following:
 - a. 1st floor shops (room 144) - The windows are not openable in the shops. The mechanical ventilation system was operated and found to work well. The system provides sufficient ventilation air. The two supply vents are 12 square feet in area and the velocity flow was 400 feet per minute (fpm). This is over 8000 cubic feet per minute (cfm) of ventilation air. The system is set to draw 10% outside air. The shop area is well ventilated. It is recommended that MERV 13 filters be installed on the air handler.
