OLMSTED ENVIRONMENTAL SERVICES, INC.

Date: February 5, 2021

Subject: **Ventilation Screening**
Roberto Clemente School No. 8
1180 St Paul St, Rochester, NY 14621

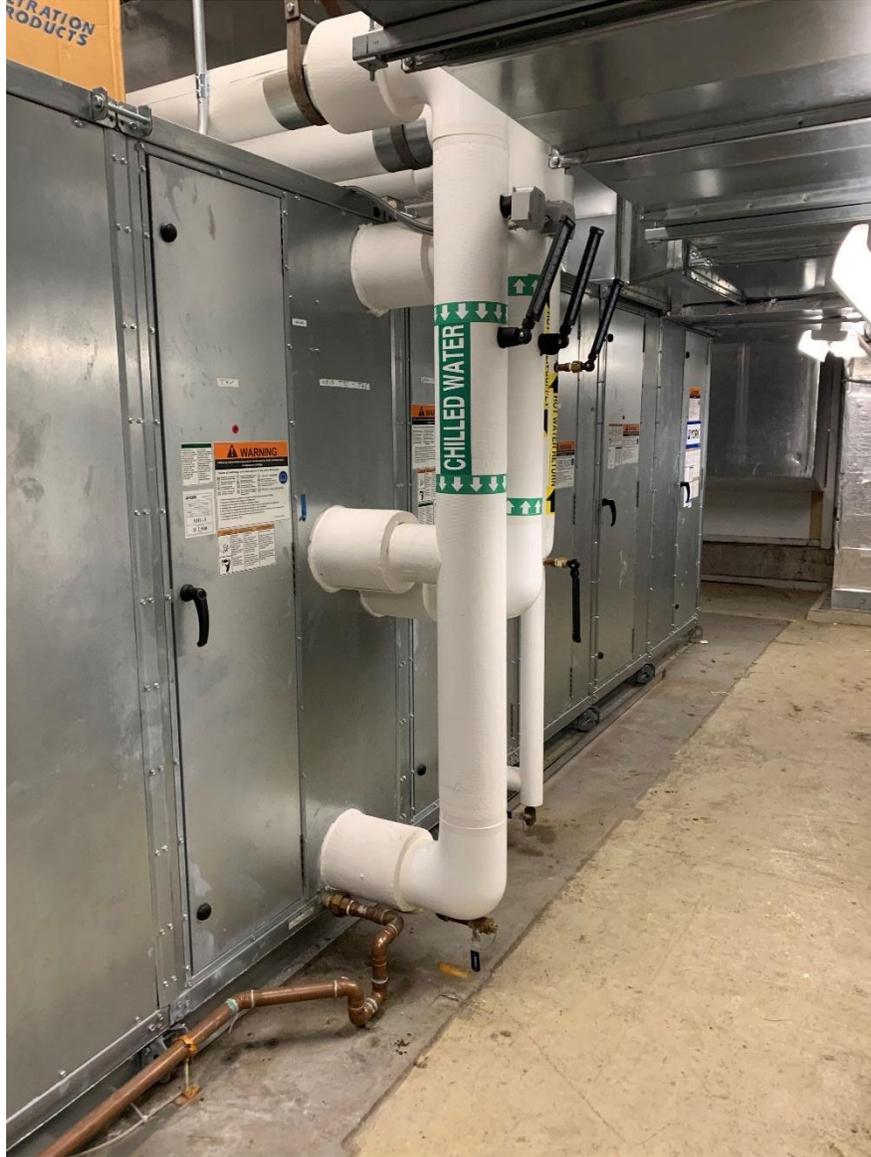
2. The central air handler units are located in mechanical rooms in the penthouse level. There are 4 total that serve the entire building. The units appear modern and well-maintained.

Standard air handler unit serving the building.

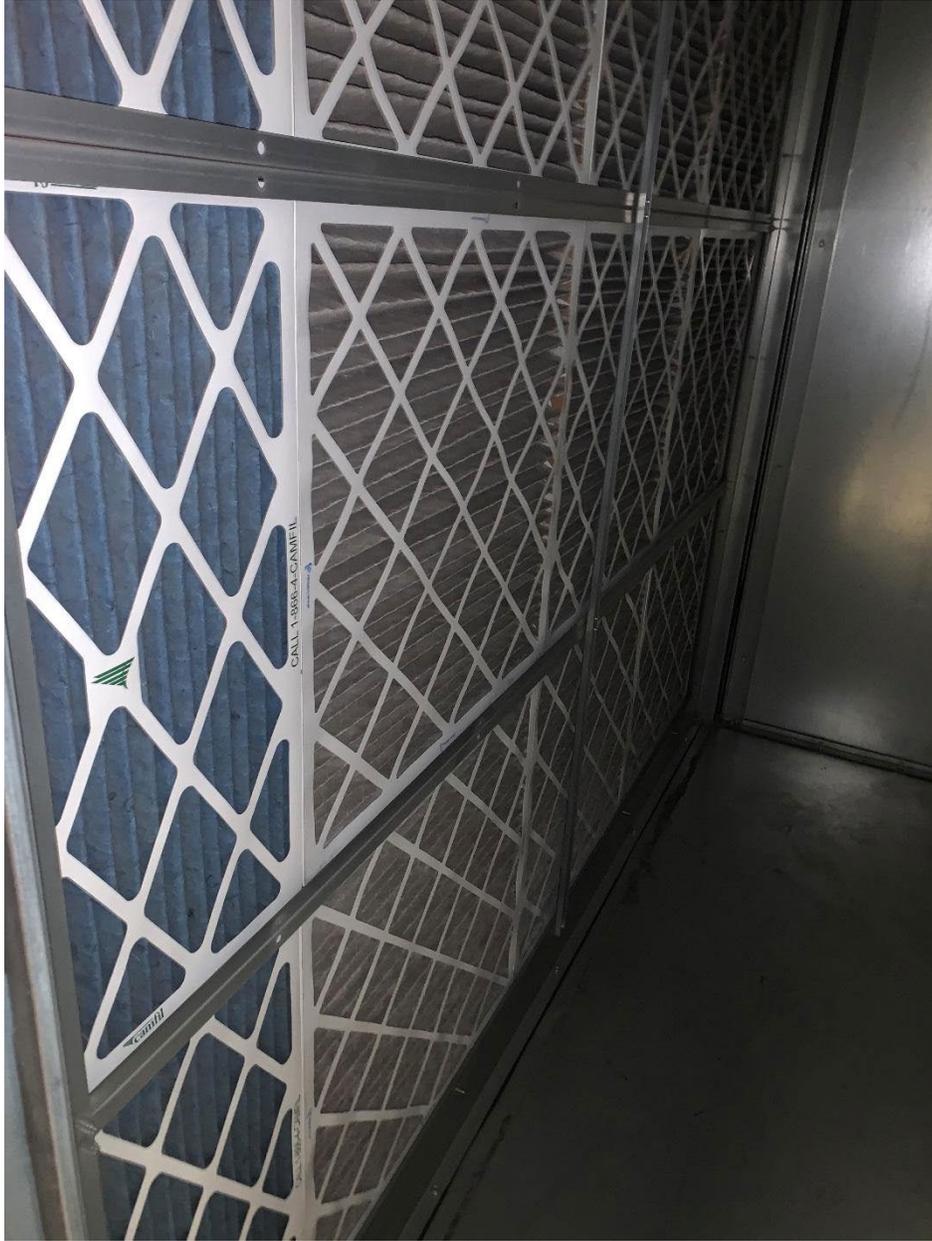
3. The air handler units consist of supply air fans that can provide heating or cooling. There is also a return fan associated with each supply fan that draws return air from a duct riser serving all floors. Return air is drawn back through a ceiling plenum above the drop ceiling. The supply fans provide a mixture of outside air and return air modulated by dampers. Mixed air is filtered through MERV 8 filters and heated or cooled in fan coils in the unit.

Mixing box inside air handler units. MERV 8 filters installed.

5. As previously mentioned, the air handler units that serve the newer wing were noted to have been fitted with MERV-8 filters. Boxes of new MERV 13 filters were observed in the school and RCSD Facilities were ready to install the MERV 13 filter shortly. In the meantime, the air handlers not fitted with MERV-13 filters are to be operated with a maximum outside air setting and minimum recirculation of indoor air. Outside air is safe and does not require filtration for viral particles. However, recirculated (return) air may contain particles that contain the virus especially if there is an infected person in the building. Operating the system with maximum outside air and exhausting all or most of the return (recirculated air) can bypass the need for filtration until more MERV-13 filters arrive and can be installed in the unit. This was observed and confirmed in the examination of the supply and return dampers in the units.

Overall, the school's ventilation can help reduce the risk of exposure to SARs-CoV-2 and meets the published guidelines. The mechanical ventilation system is capable of ventilating the building. Replacing the existing MERV 8 filters and installing MERV 13 filters may also reduce the risk of exposure to SARs-CoV-2. Until the MERV 13 filters have been installed and for the building to be safely occupied, RCSD Facilities should continue to adjust and operate the building's ventilation system so that it minimized or as closely as possible eliminate the amount of recirculated air mixed with the outside air.

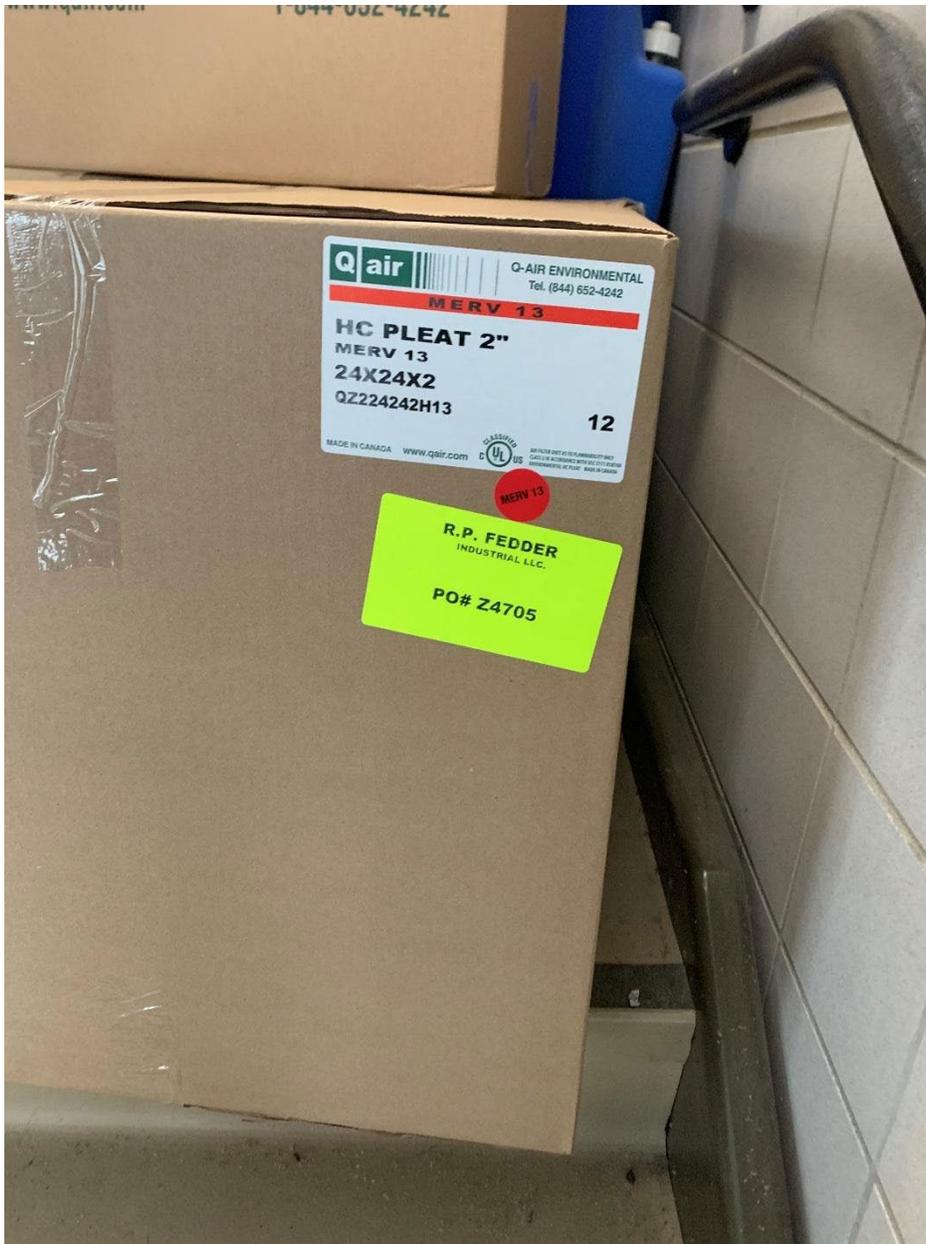
MERV 13 filters shipment at the school. To be installed.

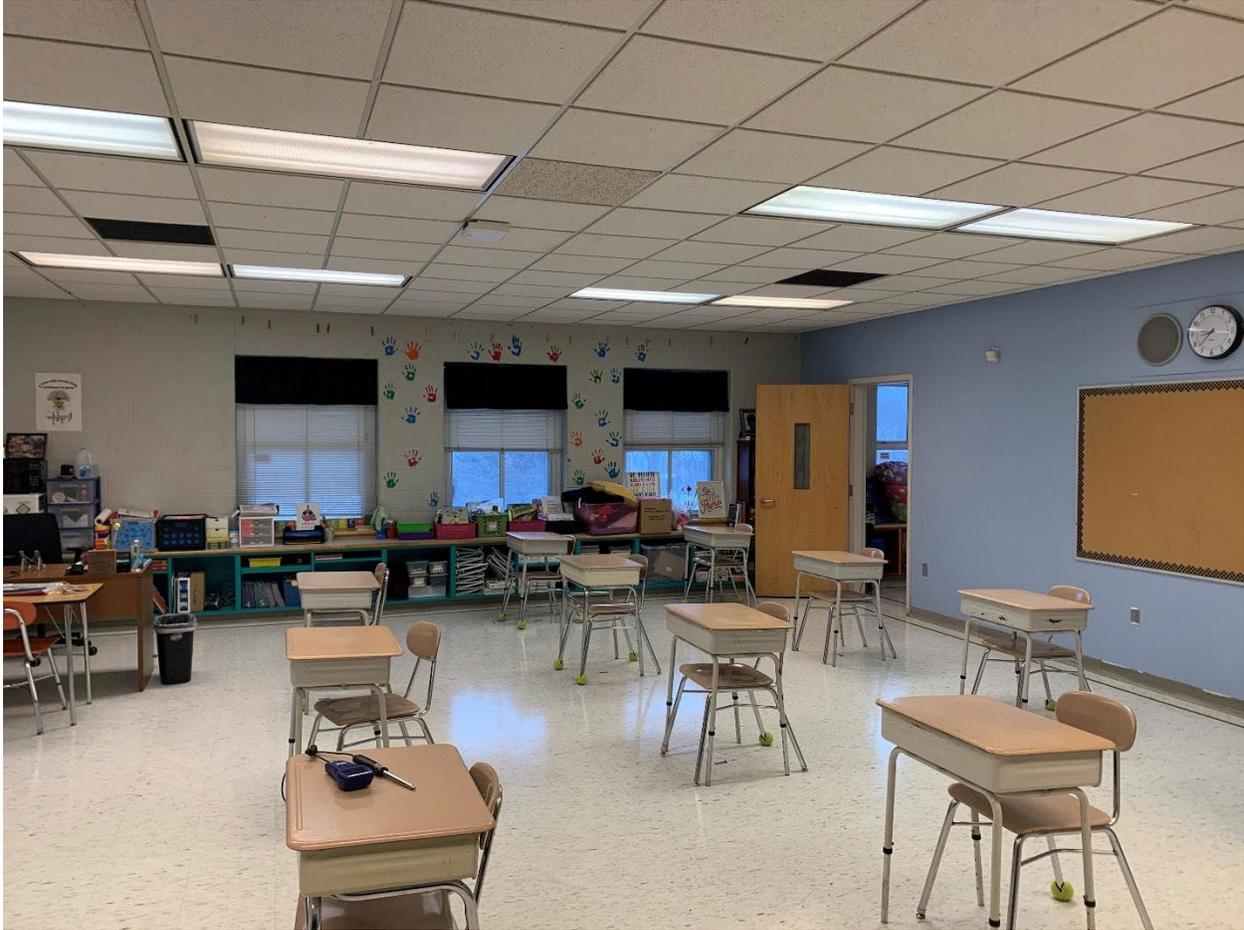
4. The ventilation supply system is ducted and terminates in a classroom or office at linear slot diffuser located along the light fixtures on the ceiling. Return air from the classrooms or offices is returned via a passive return egg crate grille into the space above the drop ceiling.

Standard ventilation scheme in classrooms. Operable windows for natural ventilation with mechanical ventilation supply located around the light fixtures and passive return into the ceiling.

In addition, most classrooms also have operable windows that can be used to provide natural ventilation. Where possible and if necessary, teachers can open two windows in each room to an opening of two inches. This will provide natural ventilation without causing the room to become cold. Lastly, ensure other safety and health precautions, such as mask-wearing, social distancing,
