# **OLMSTED ENVIRONMENTAL SERVICES, INC.**

Date: March 5, 2021

Subject: **Ventilation Screening**  
**Benjamin Franklin Lower and Upper Schools**  
**950 Norton Street, Rochester, NY 14621**

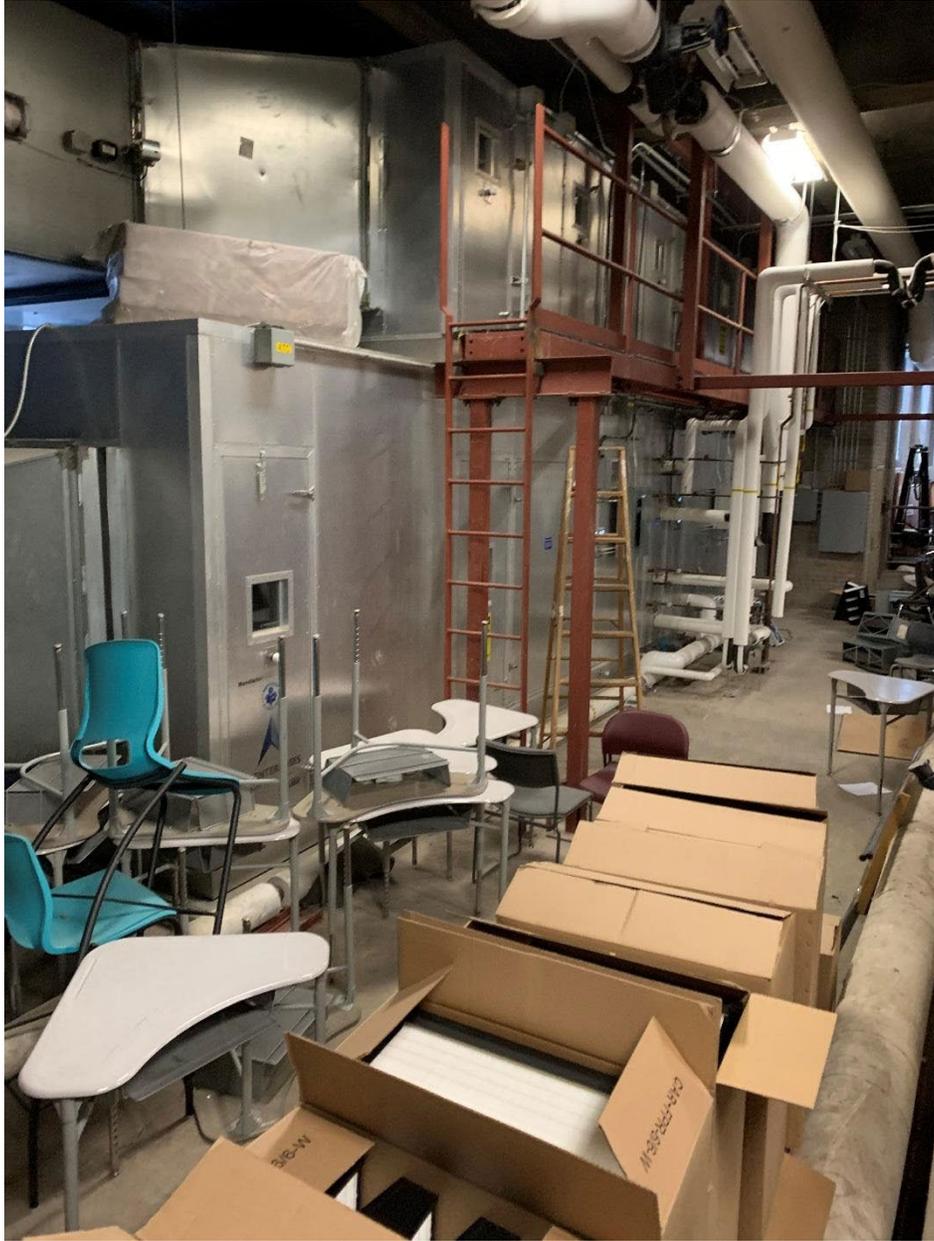
Air handler unit in Franklin Campus

2. The central air handler units are located in mechanical rooms throughout the building. The units are in good condition and modern. The air handler units are designed to provide a mixture of outside air and return air modulated by dampers. Each supply fan has an associated return fan. Mixed air is filtered through MERV 14 filters and heated in fan coils in the unit. Filters with MERV-13 or higher ratings are recommended for HVAC systems due to their ability to filter smaller particles, including viruses. Filters with MERV-13 or higher ratings can trap smaller particles, including viruses. As such, upgrades to a MERV-13 rated filter, or the highest-rated filter in HVAC systems have been recommended by the American Society of Heating, Refrigerating and Air-Conditioning Engineers (ASHRAE) as a method to reduce the transmission of the SARS-CoV-2 virus in recirculated air.<sup>1</sup>

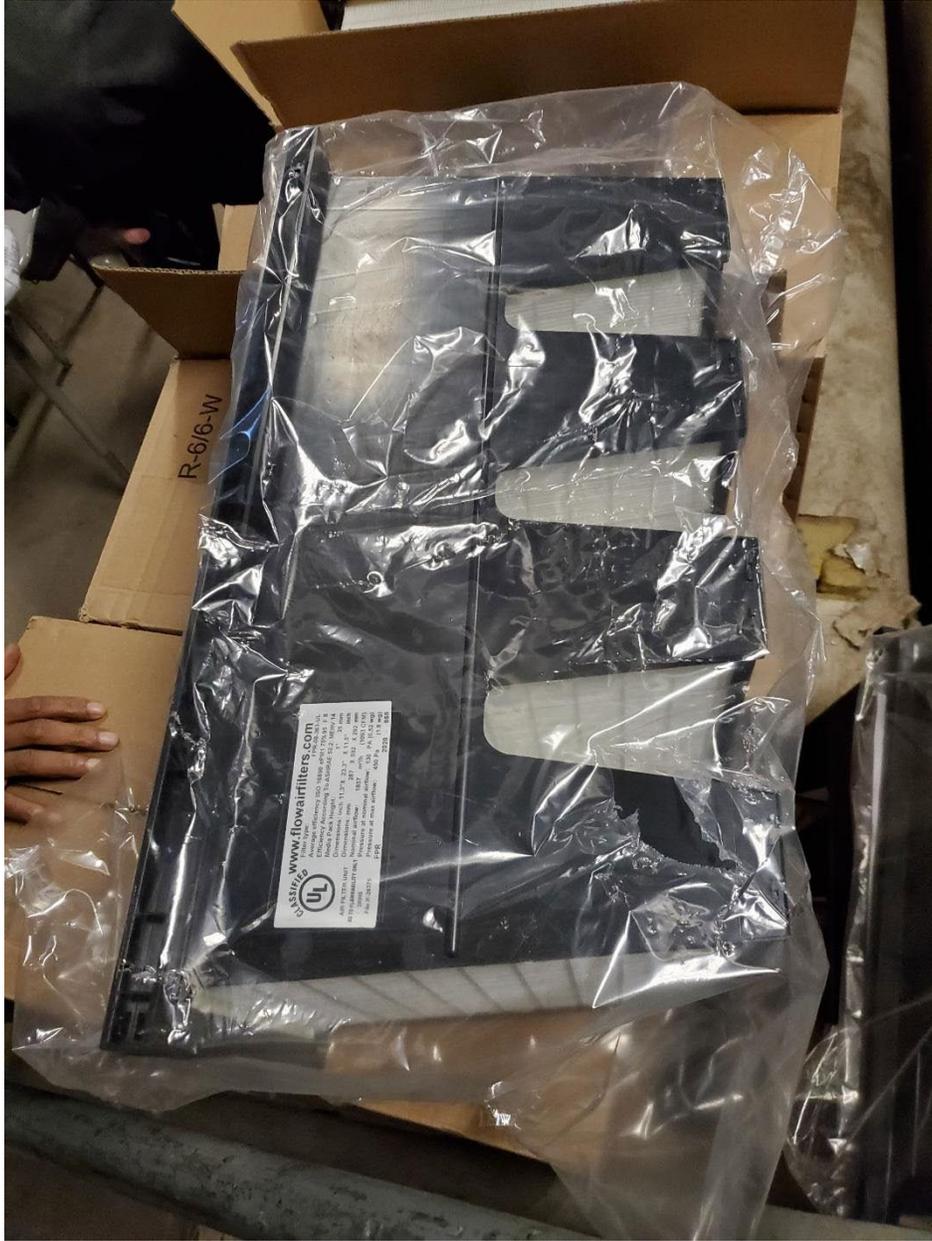
New MERV-14 filter

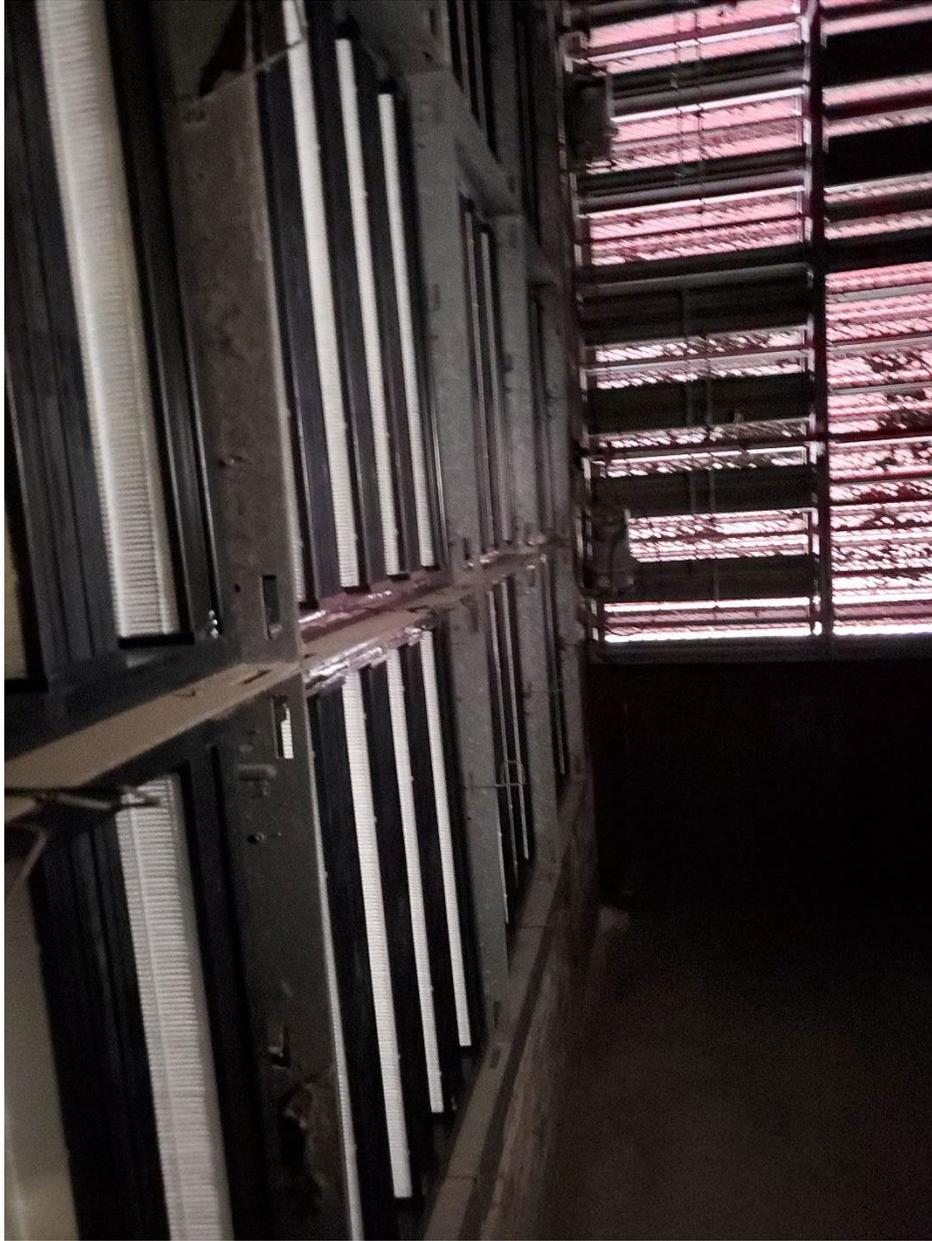
MERV-14 filters in filter bank. The outside air dampers are opened.

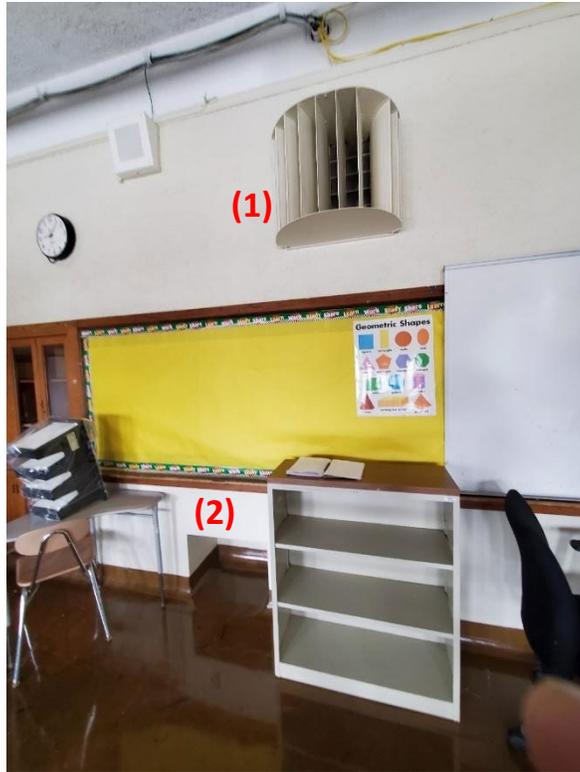
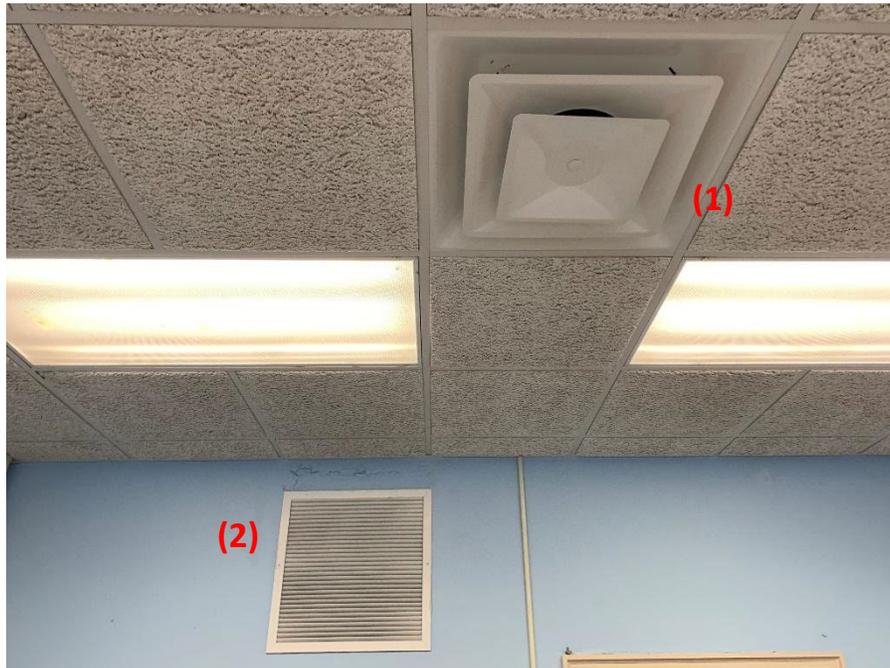
Typical mechanical ventilation setup in different classrooms with (1) supply air diffuser at top of the wall or on the ceiling, and (2) exhaust ventilation located in a small alcove at the base of the wall or on the wall.

1. The Franklin Campus has a central heating ventilation system that serves all classrooms. The classrooms are also heated by perimeter steam radiators. There are also exhaust fans on the roof that pull air from the classrooms and bathrooms. Exhaust ventilation in classrooms appears to be located in small alcoves at the base of the wall and work to exhaust air to the roof. Each classroom has operable windows that can be opened for outside air. The building is also heated by perimeter radiators.
