# **OLMSTED ENVIRONMENTAL SERVICES, INC.**

Subject: **Ventilation Screening**  
**Monroe Lower and Upper Schools**  
**164 Alexander Street, Rochester, NY 14607**

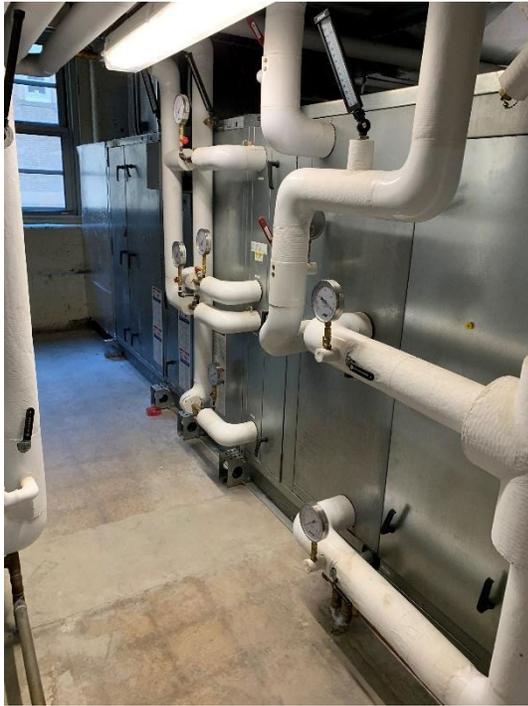
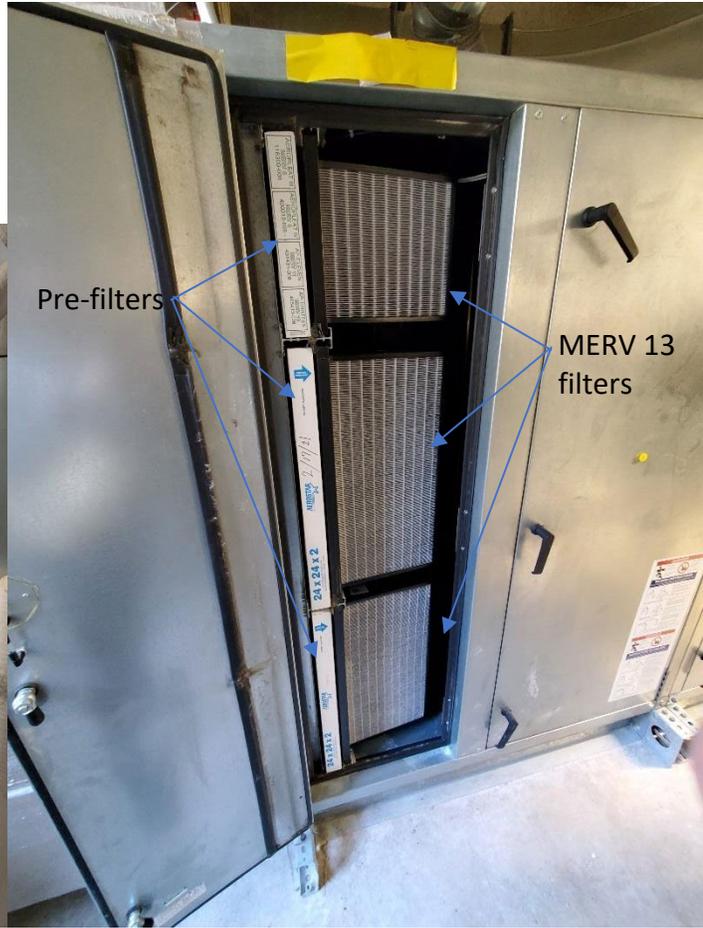
Pre-filter and MERV 13 filter in air handler units

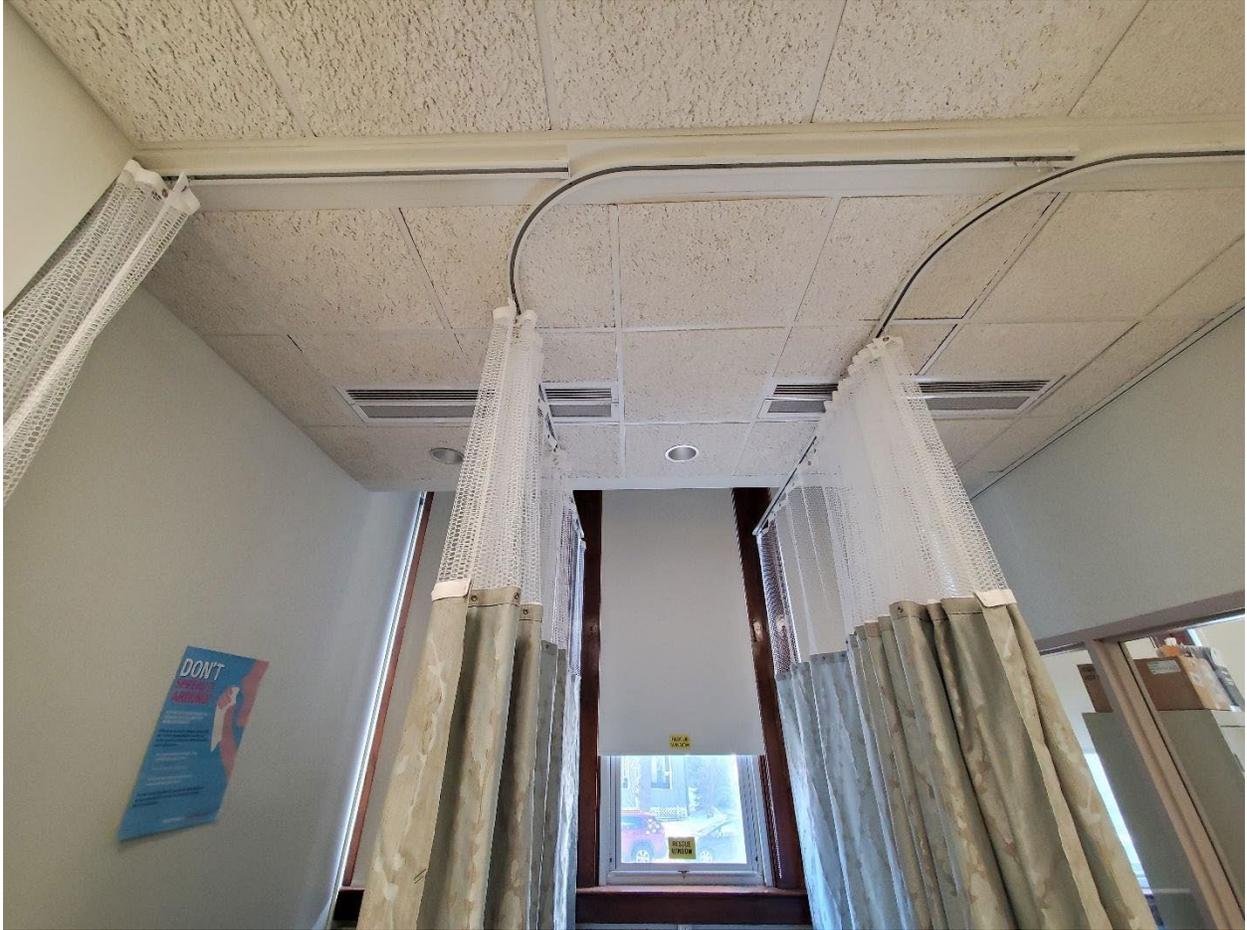
Chill beam system in the nurses' office. Outside air is delivered out the slots and return air through adjacent egg crate grilles.

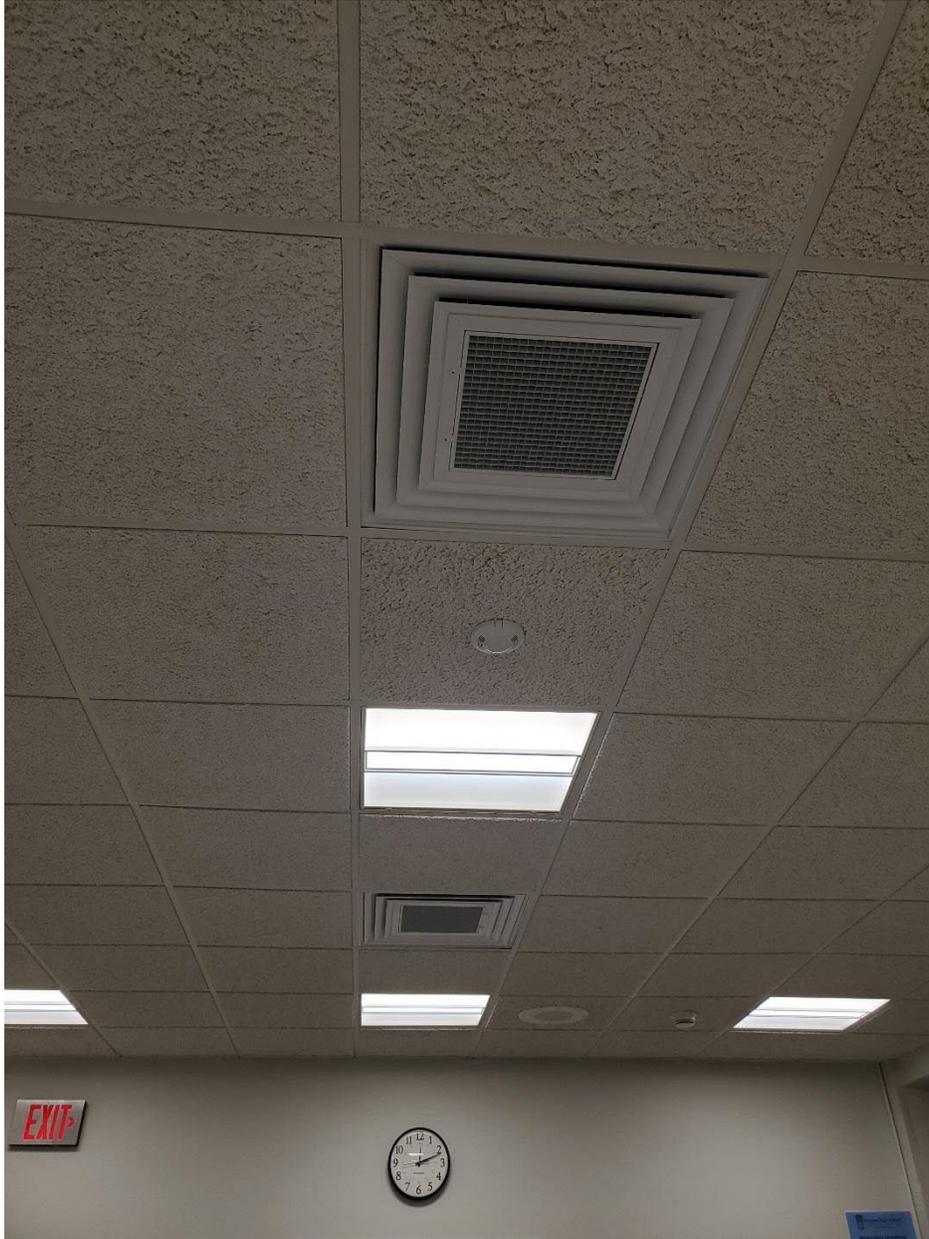
Chill beam system in a classroom. Outside air is delivered out the perimeter and return air through center egg crate grilles.
