Date: March 6, 2021

Prepared by: Ed Olmsted, CIH, CSP

Subject: **Ventilation Screening**  
**Northwest Junior High at Douglass & Northeast College High School**  
**940 Fernwood Park, Rochester, NY 14609**

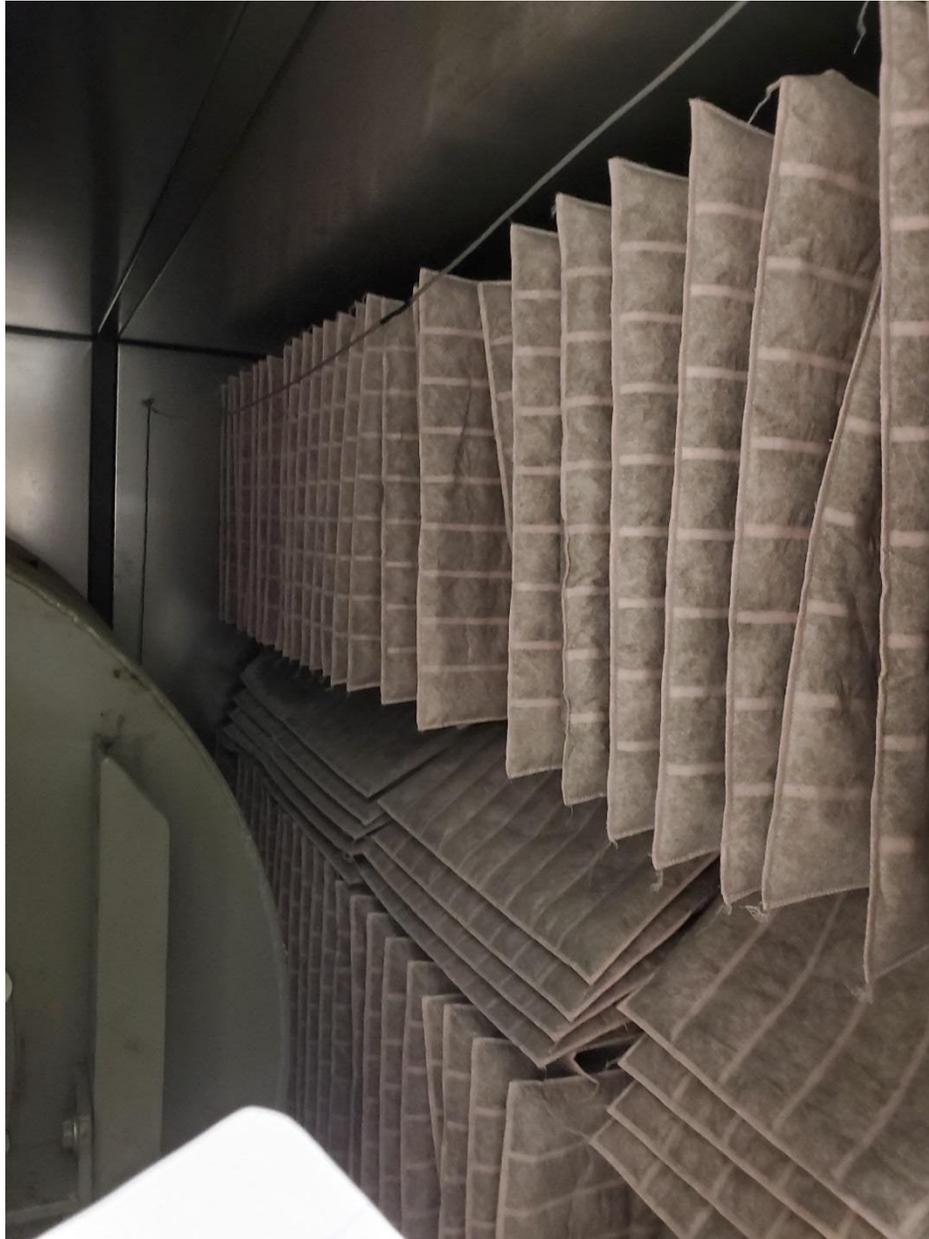
2. The central air handler units are designed to provide a mixture of outside air and return air modulated by dampers. Each supply fan has an associated return fan. Mixed air is filtered through a pre-filter and then MERV 13 filters and heated or cooled in fan coils in the unit. Filters with MERV-13 or higher ratings are recommended for HVAC systems due to their ability to filter smaller particles, including viruses.

MERV13 bag filters inside central air handler unit

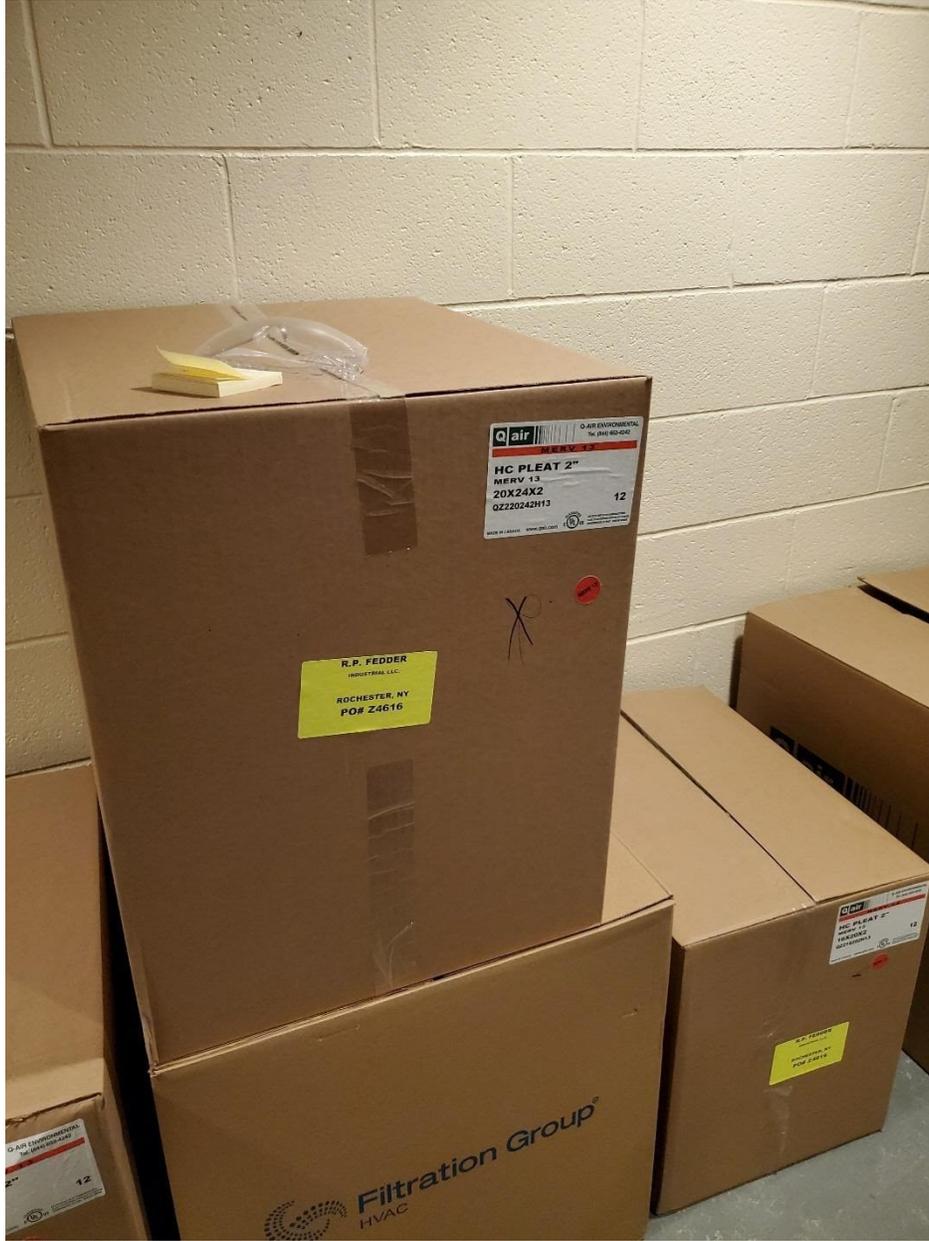
Boxes of new MERV 13 filters

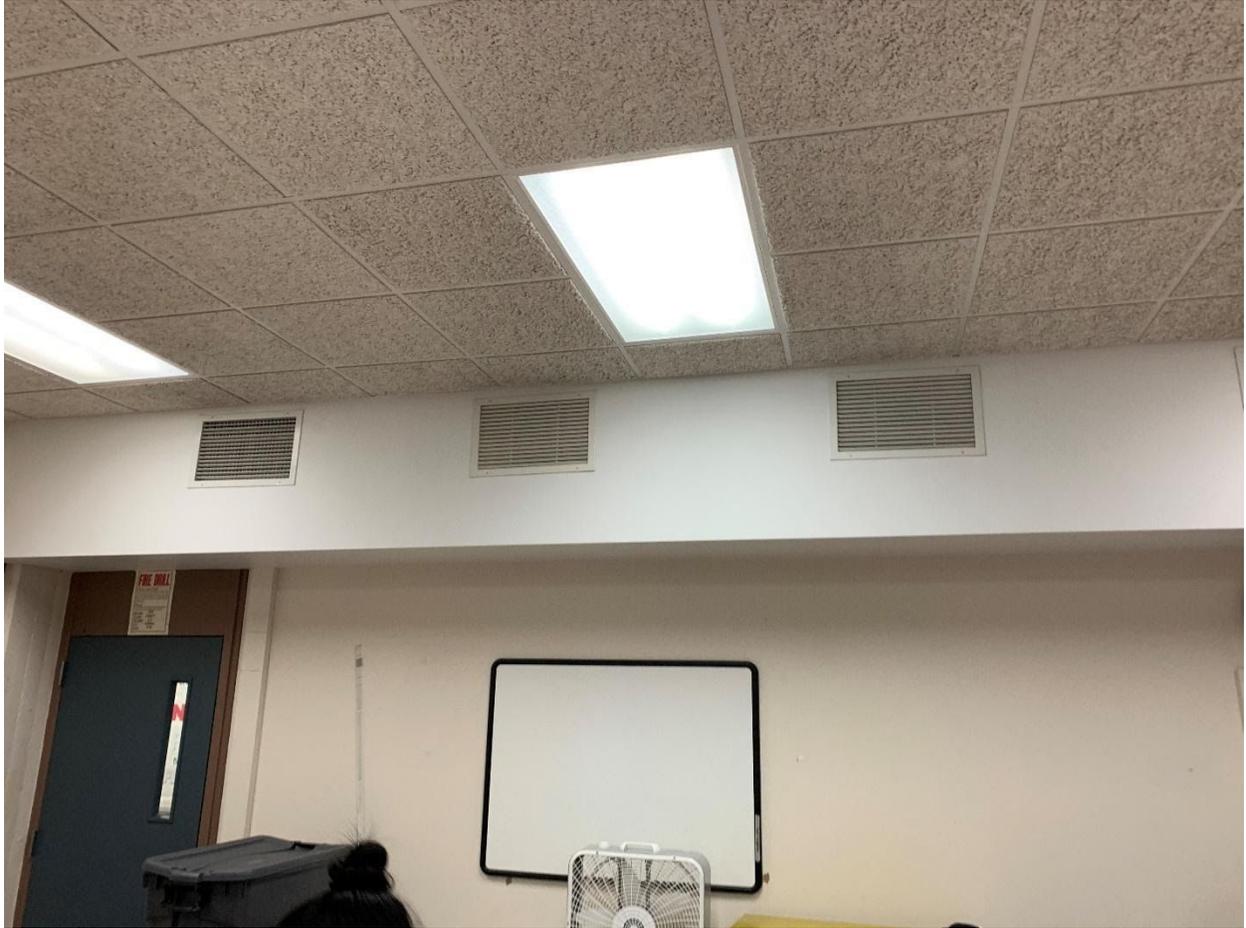
3. From these air handler units, that tempered and filtered air is distributed via a system of ductwork. The ductwork terminates in an occupiable space at square supply diffusers located on the ceiling or in rectangle supply grilles located on soffits near the ceiling. In addition, the space above the drop ceiling serves as a return air plenum.

Rectangle supply grille located in soffit near the ceiling.
