OLMSTED ENVIRONMENTAL SERVICES, INC.

Subject: **Ventilation Screening**
Pinnacle School No. 35
194 Field St, Rochester, NY 14620

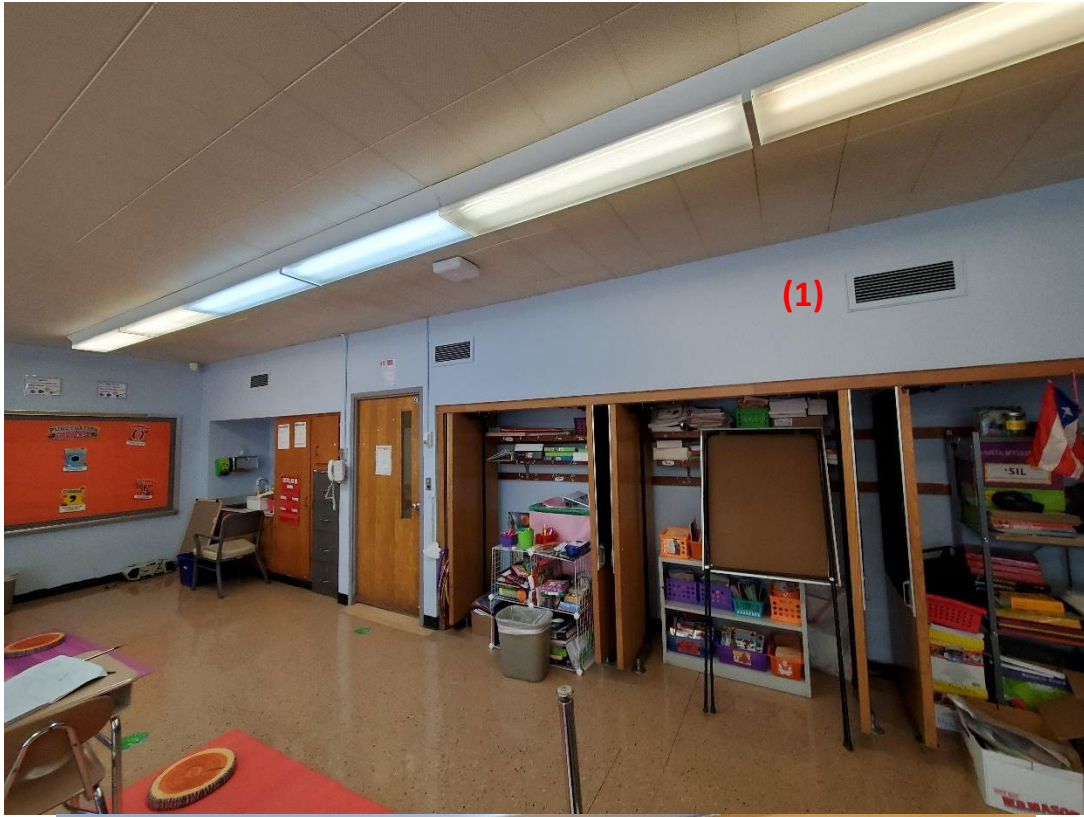
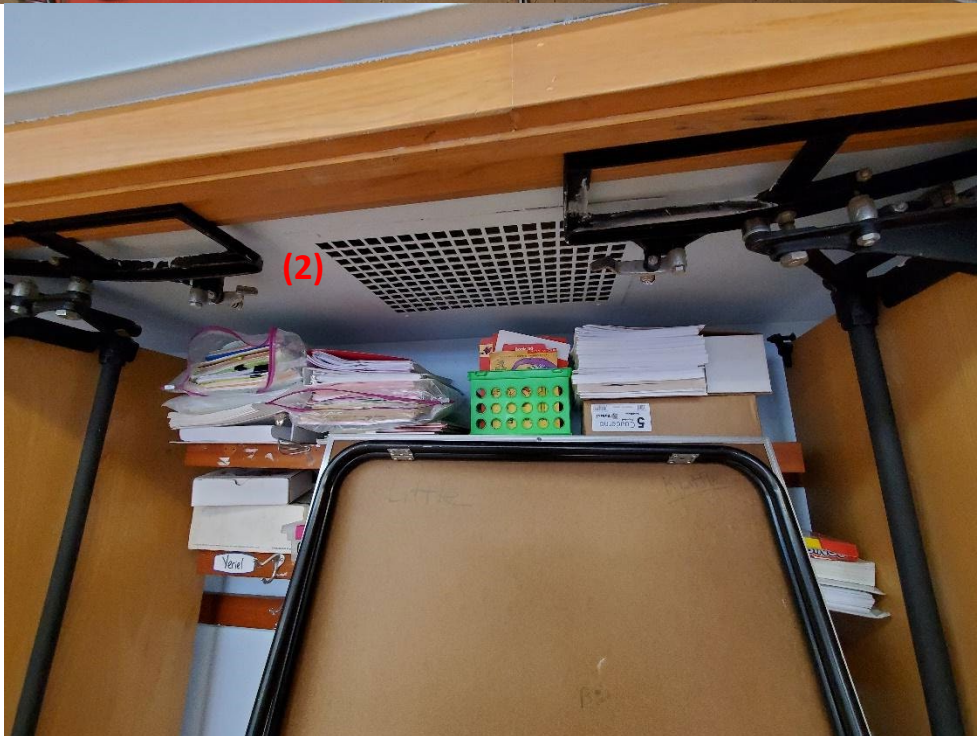
Typical mechanical ventilation setup in classrooms with (1) supply air vents on the soffit above the student closets and (2) a return located inside the student closet.

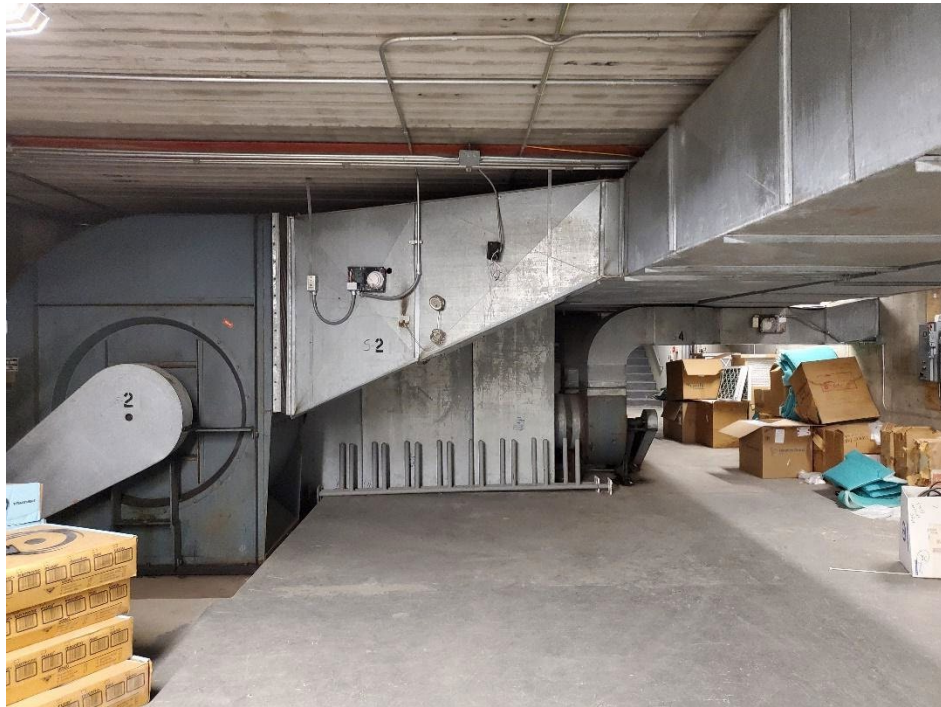
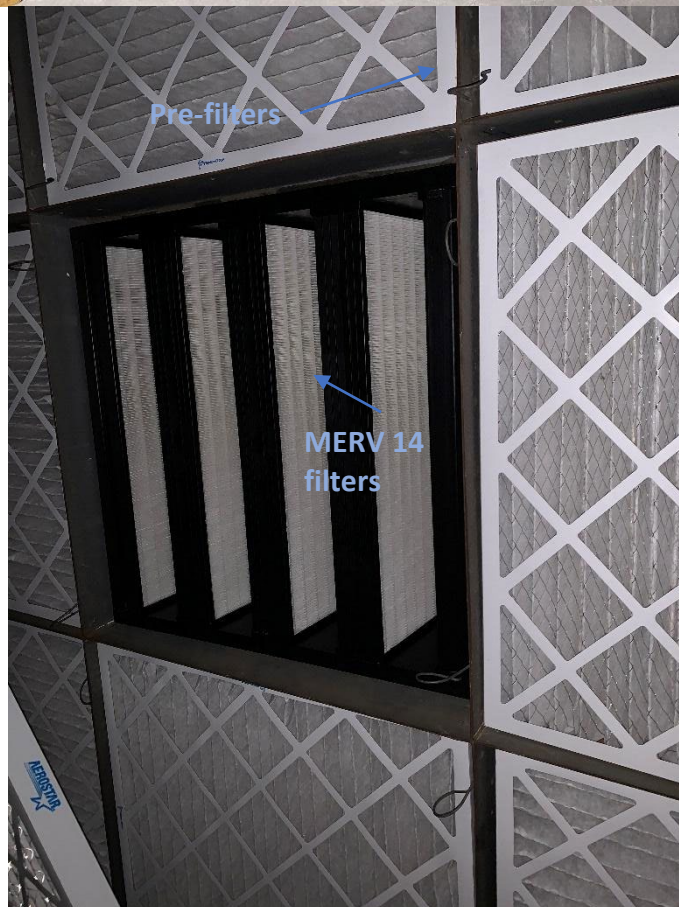
MERV 14 filter behind bank of pre-filters in air handler units
