# **OLMSTED ENVIRONMENTAL SERVICES, INC.**

Subject: **Ventilation Screening**  
**Rochester International Academy at Jefferson**  
**1 Edgerton Park, Rochester, NY**

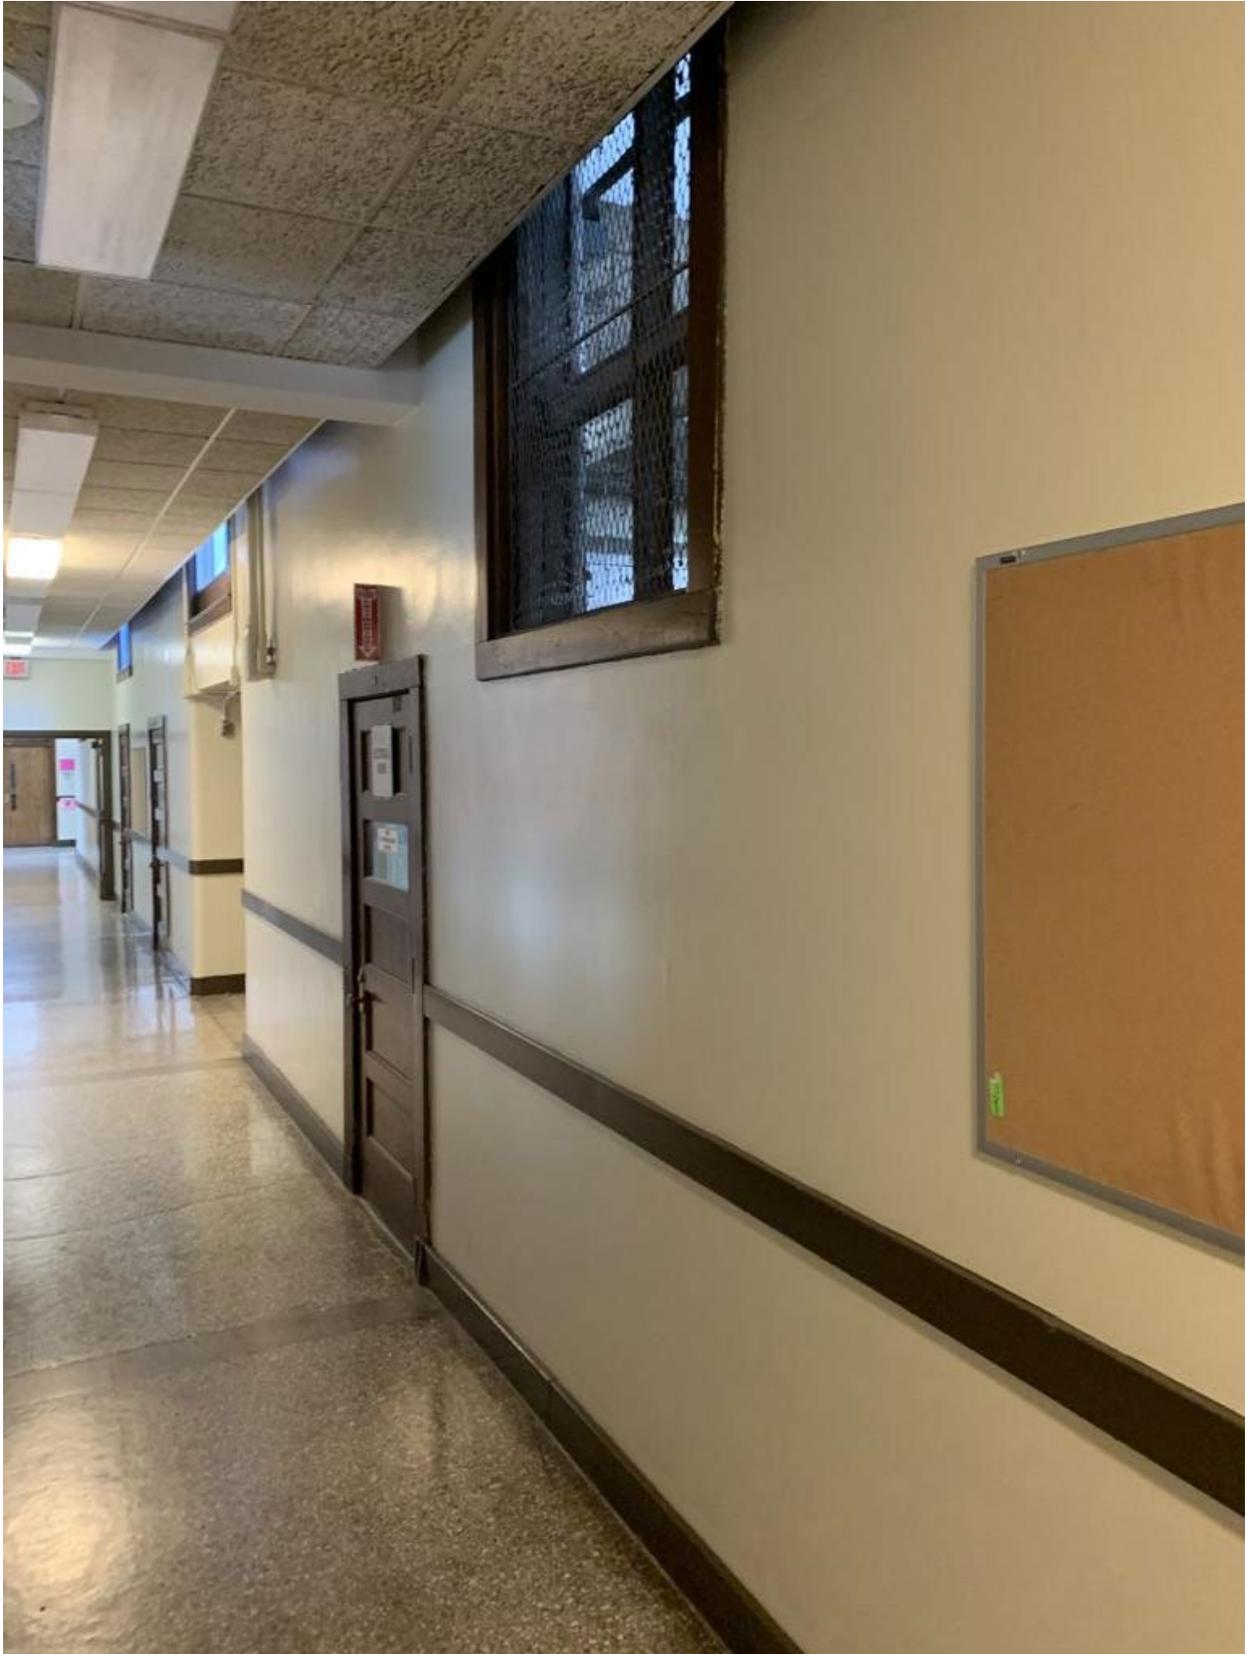
hallway return grill

2. Return air is drawn through the central return grill in the hallway on each floor.
3. There are exhaust fans on the roof that pull air from the classrooms, common areas, and bathrooms.

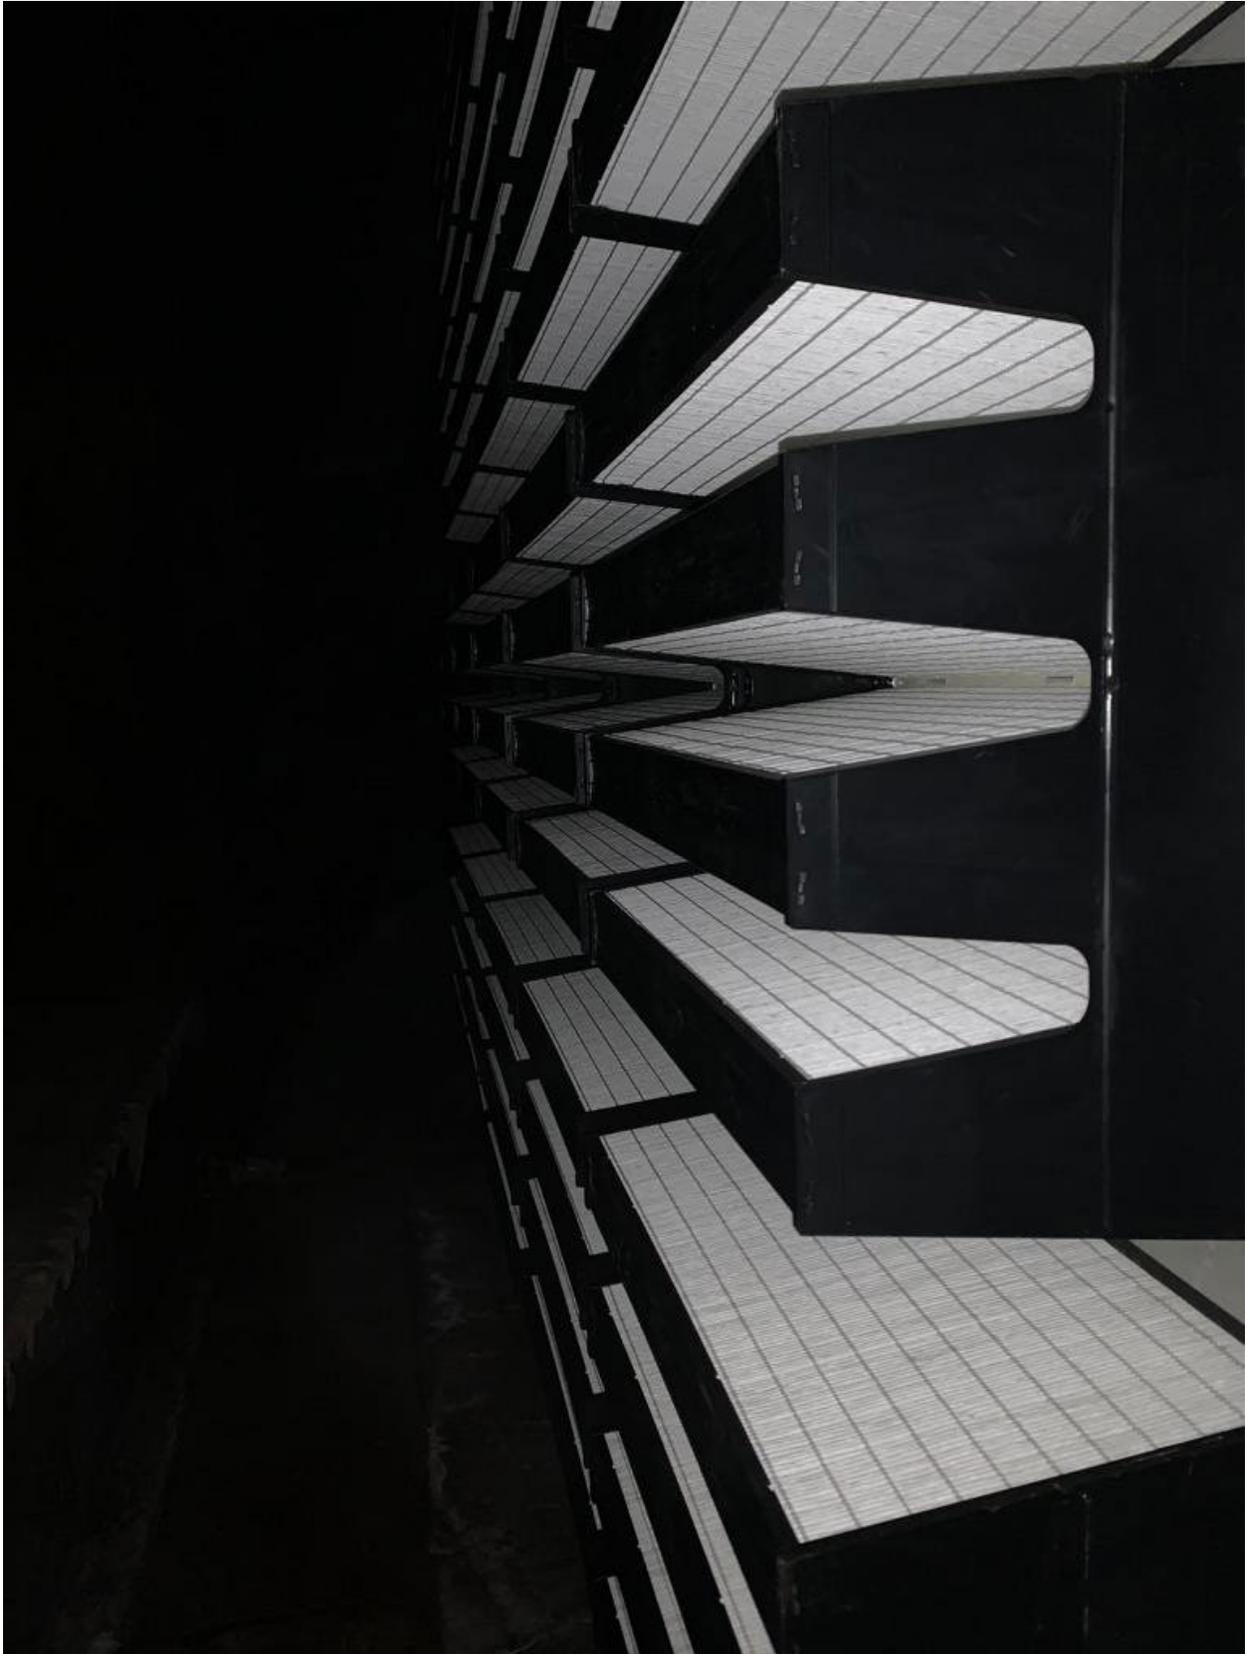
MERV 13 final filters in the house air handler

4. Mixed outside and return air are filtered through MERV 8 pre-filters and MERV-13 final filters. MERV 13 or higher ratings are recommended for HVAC systems due to their ability to filter smaller particles, including viruses. As such, upgrading to a MERV-13 rated filter, or the highest-rated filter in HVAC systems have been recommended by the American Society of Heating, Refrigerating and Air-Conditioning Engineers (ASHRAE) as a method to reduce the transmission of the SARS-CoV-2 virus in recirculated air.<sup>1</sup>

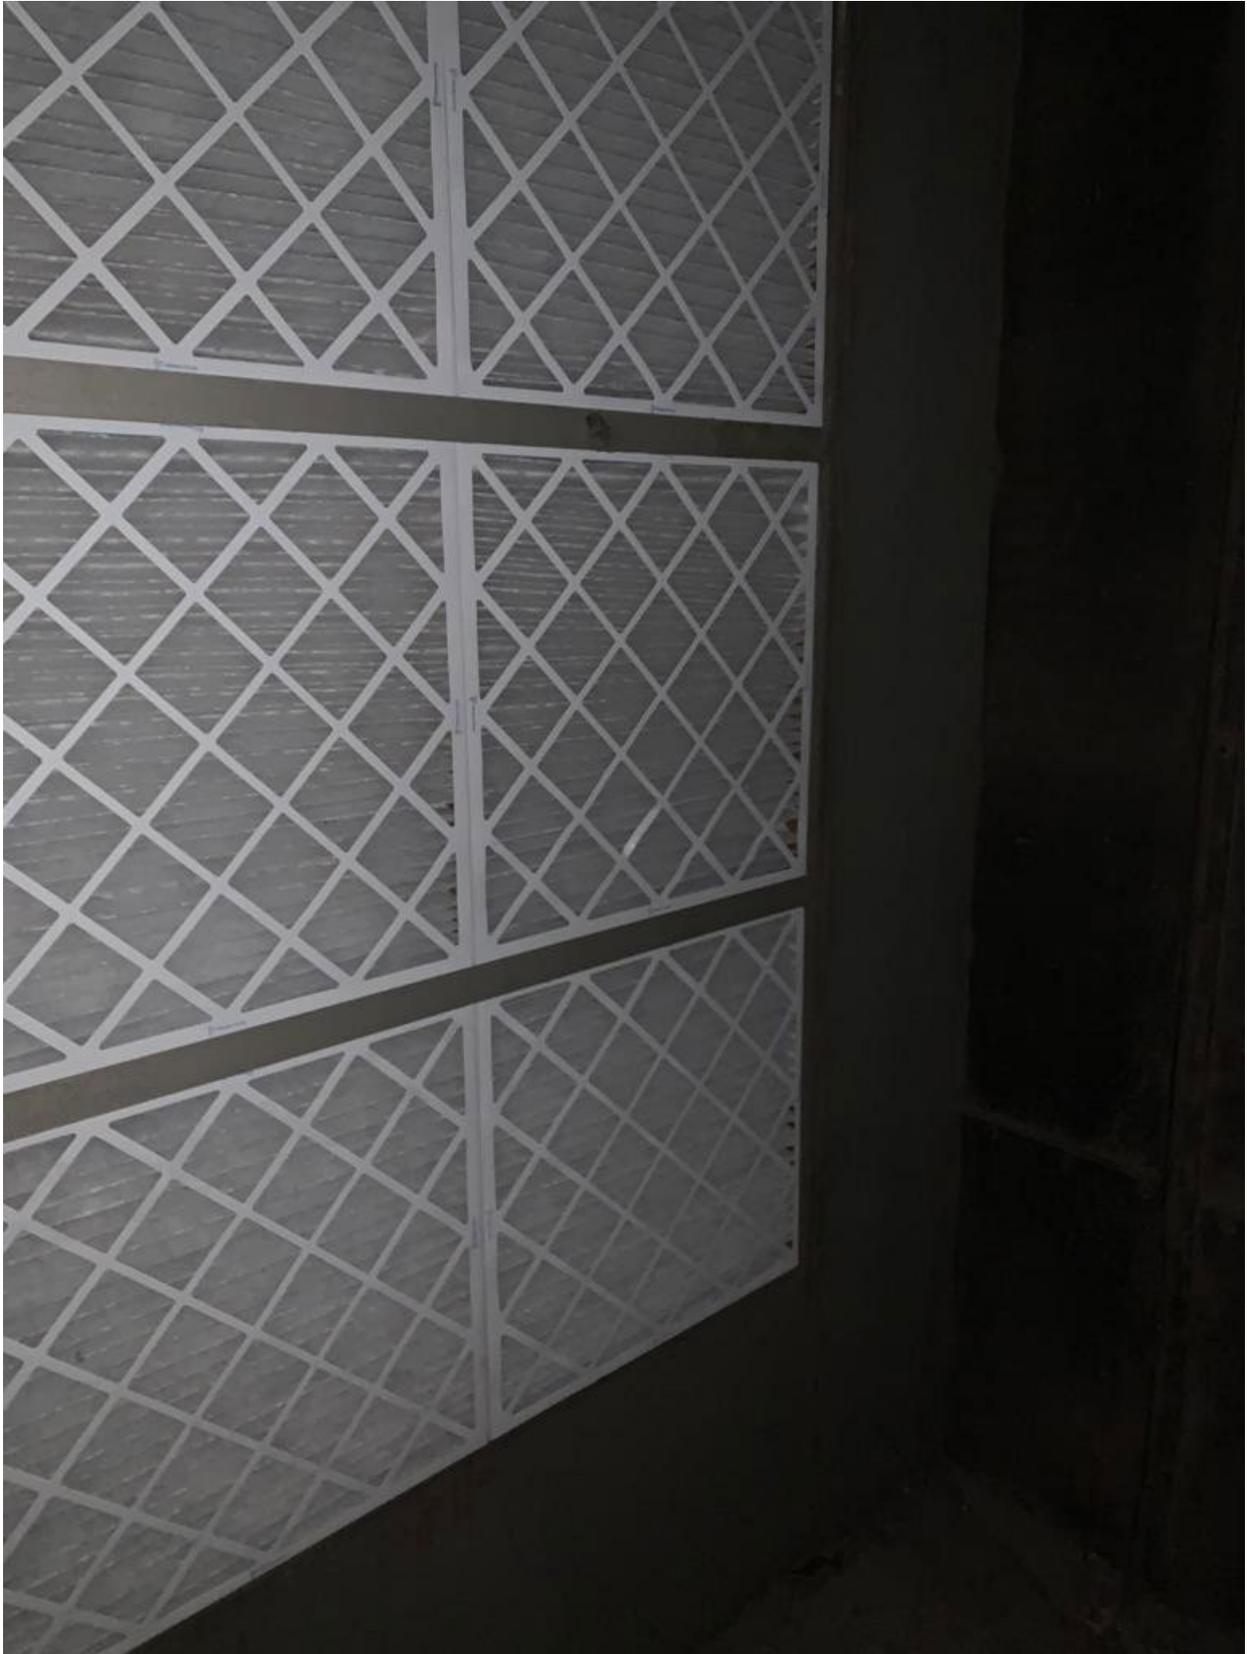
MERV 8 prefilters in the house air handler

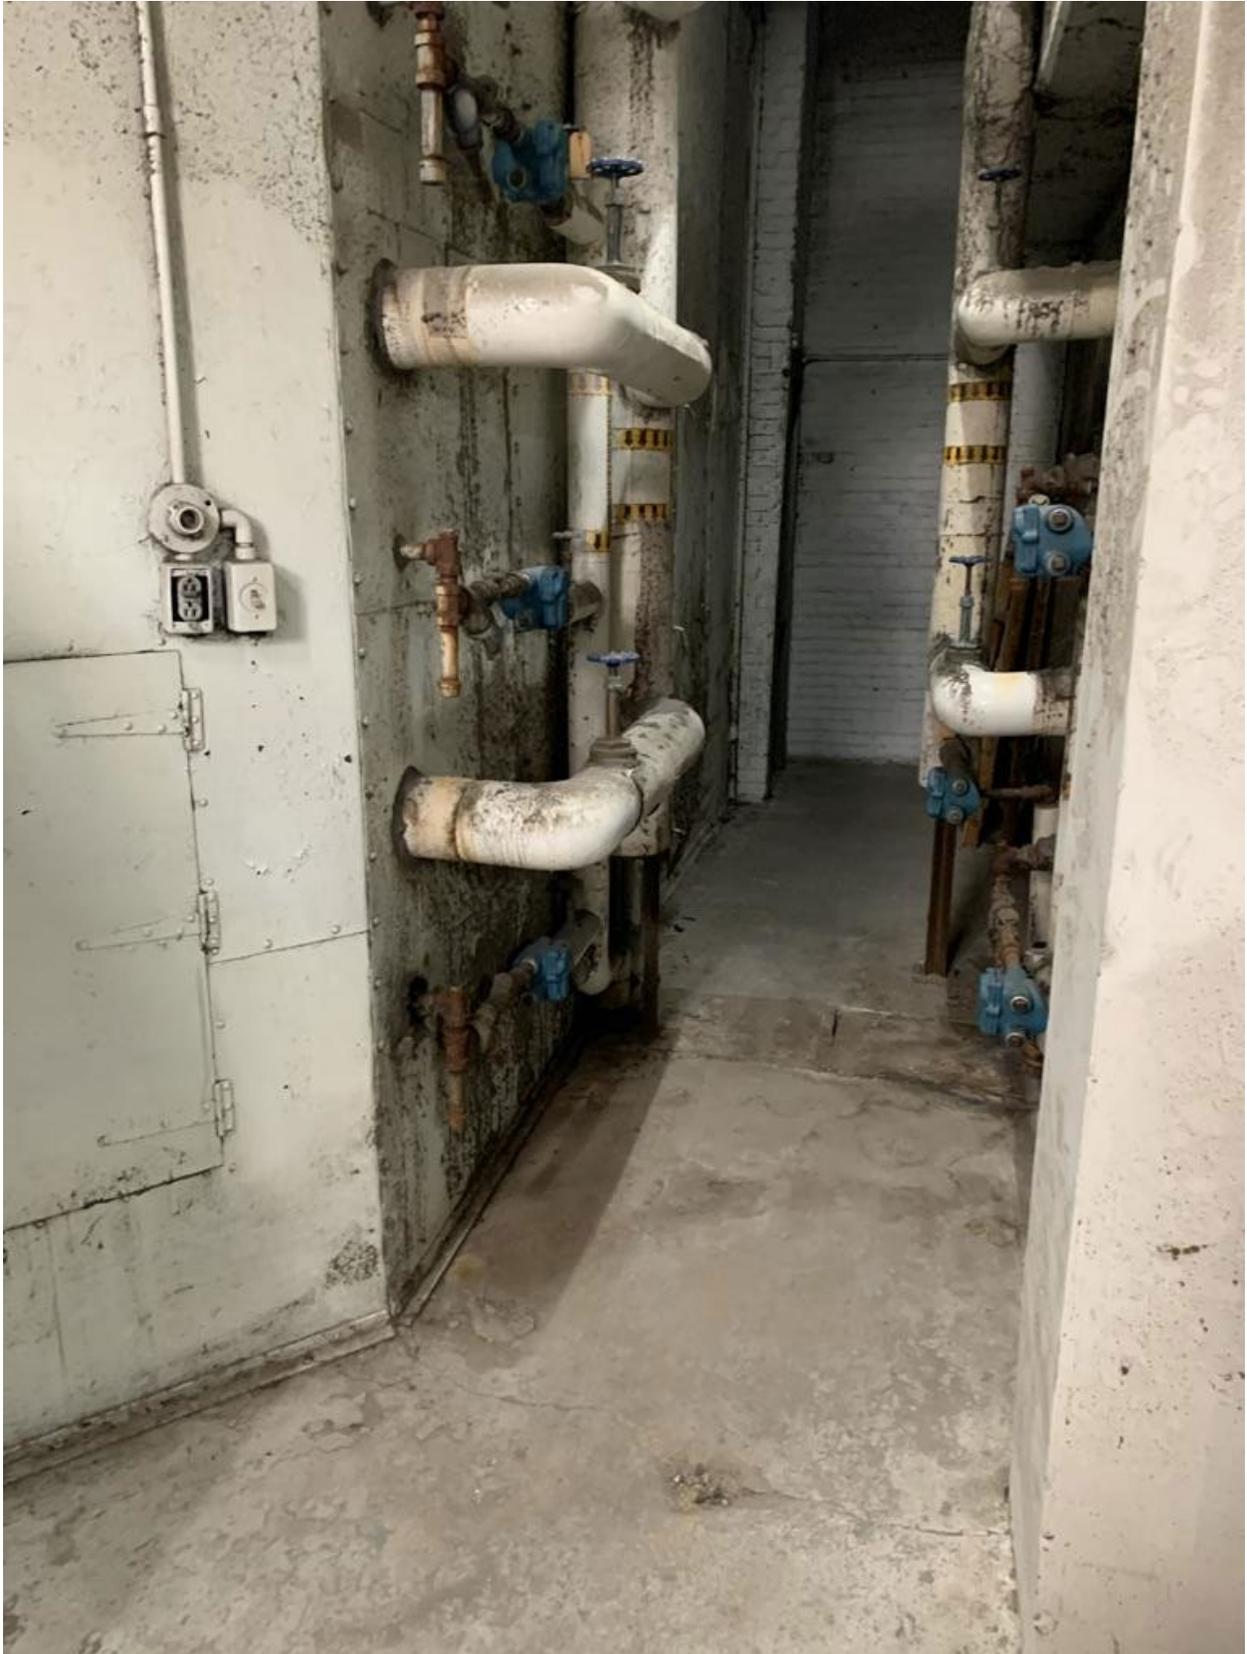
Air handler unit

1. The Rochester International Academy is an older pre-war building that has central ventilation blowers in 2 fan rooms in the basement mechanical rooms. The air handlers were upgraded in the last few years and have MERV 8 prefilters with MERV 13 bag filters as final filters. The air handlers provide a mixture of outside air and return air controlled by dampers. The mixed air is filtered and heated by a steam coil. The return grill is located in the main corridors of the school. Supply air is ducted and provided through a wall-mounted diffuser in each classroom. There is also a supply fan that serves the auditorium, which also has MERV 13 bag filters. There is also a small air handler, which serves the cafeteria. This is a newer air handler that is part of a variable air volume system (VAV).

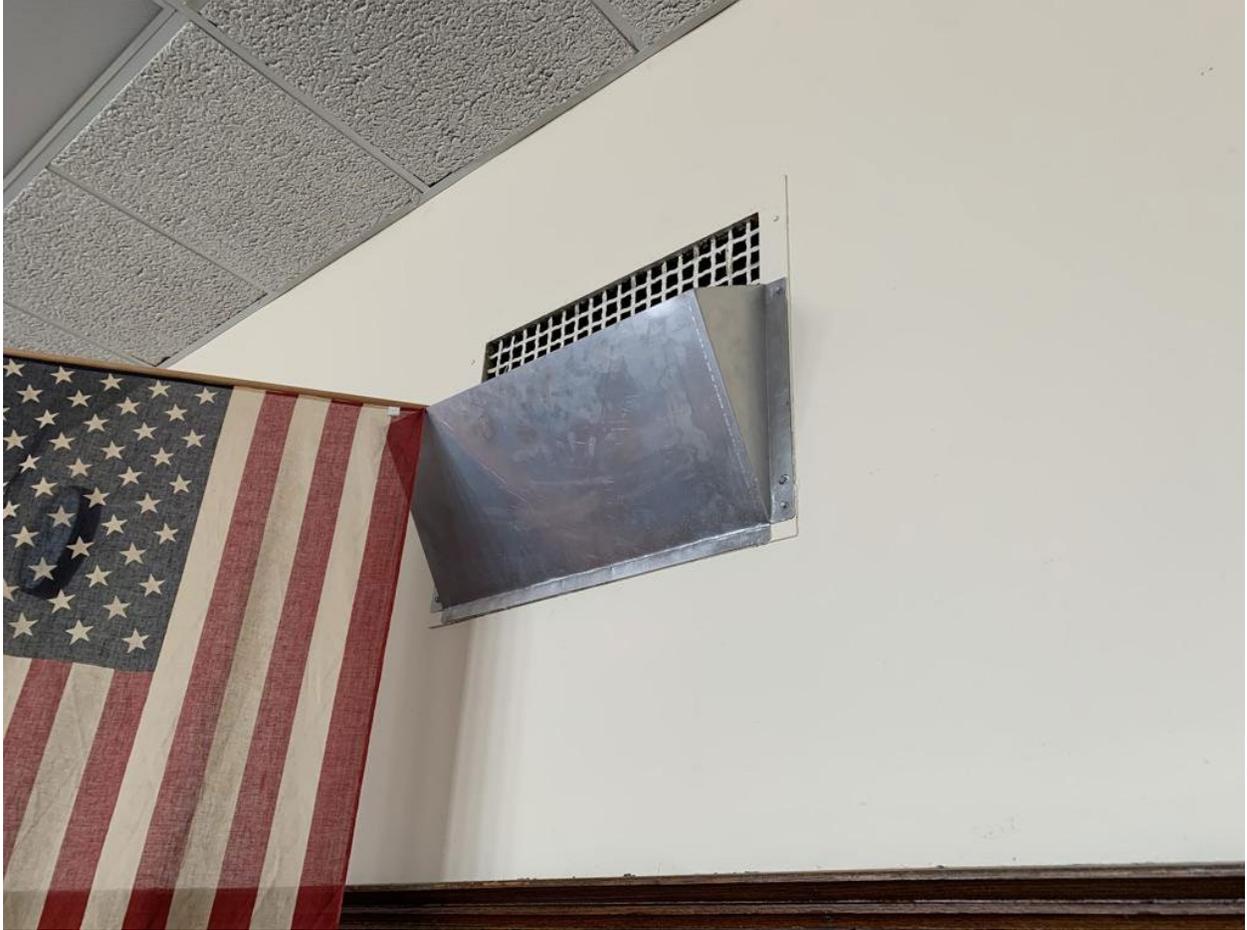
Supply diffuser

8. Not all rooms could be inspected but a representative number was included in the inspection. The supply outlets were screened with a thermal anemometer to determine whether supply air was discharging from the outlet. All rooms visited were found to have a good flow of ventilation air from the ceiling supply diffusers.

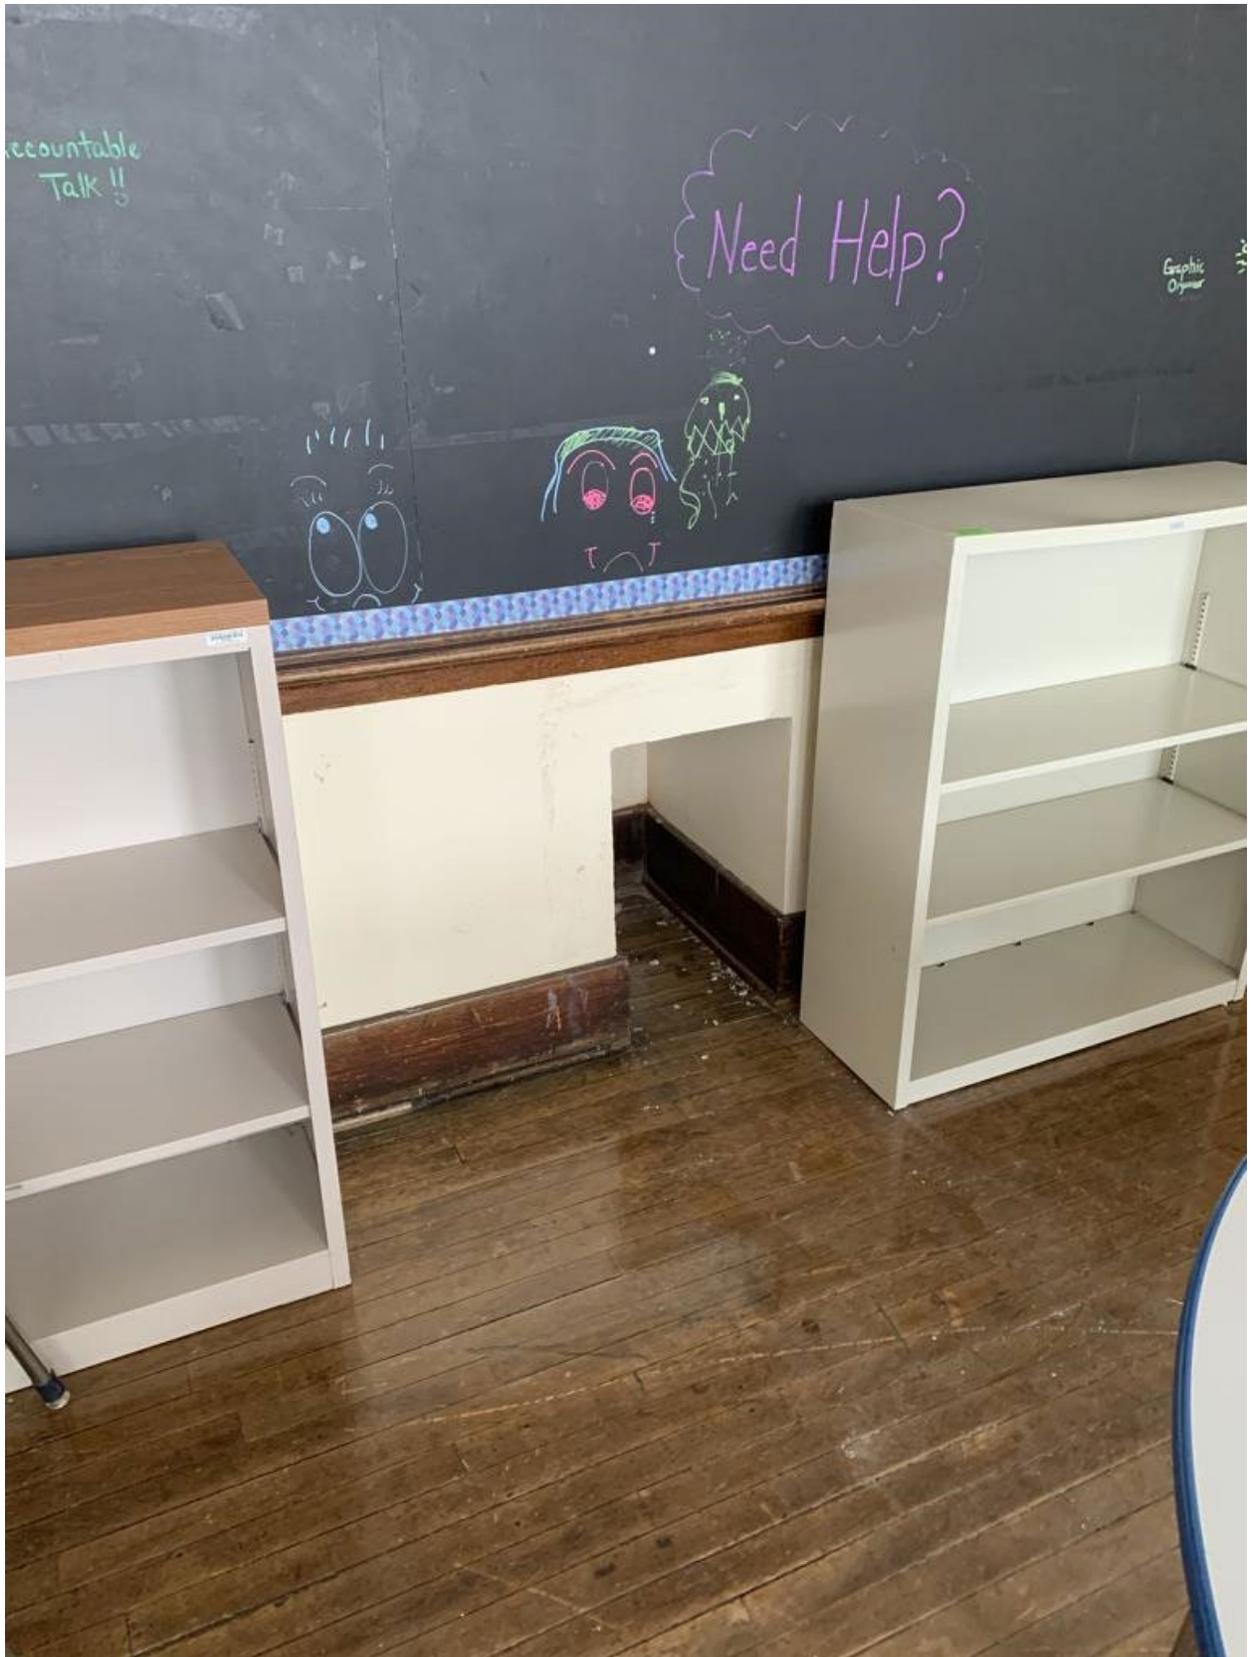
Exhaust vent

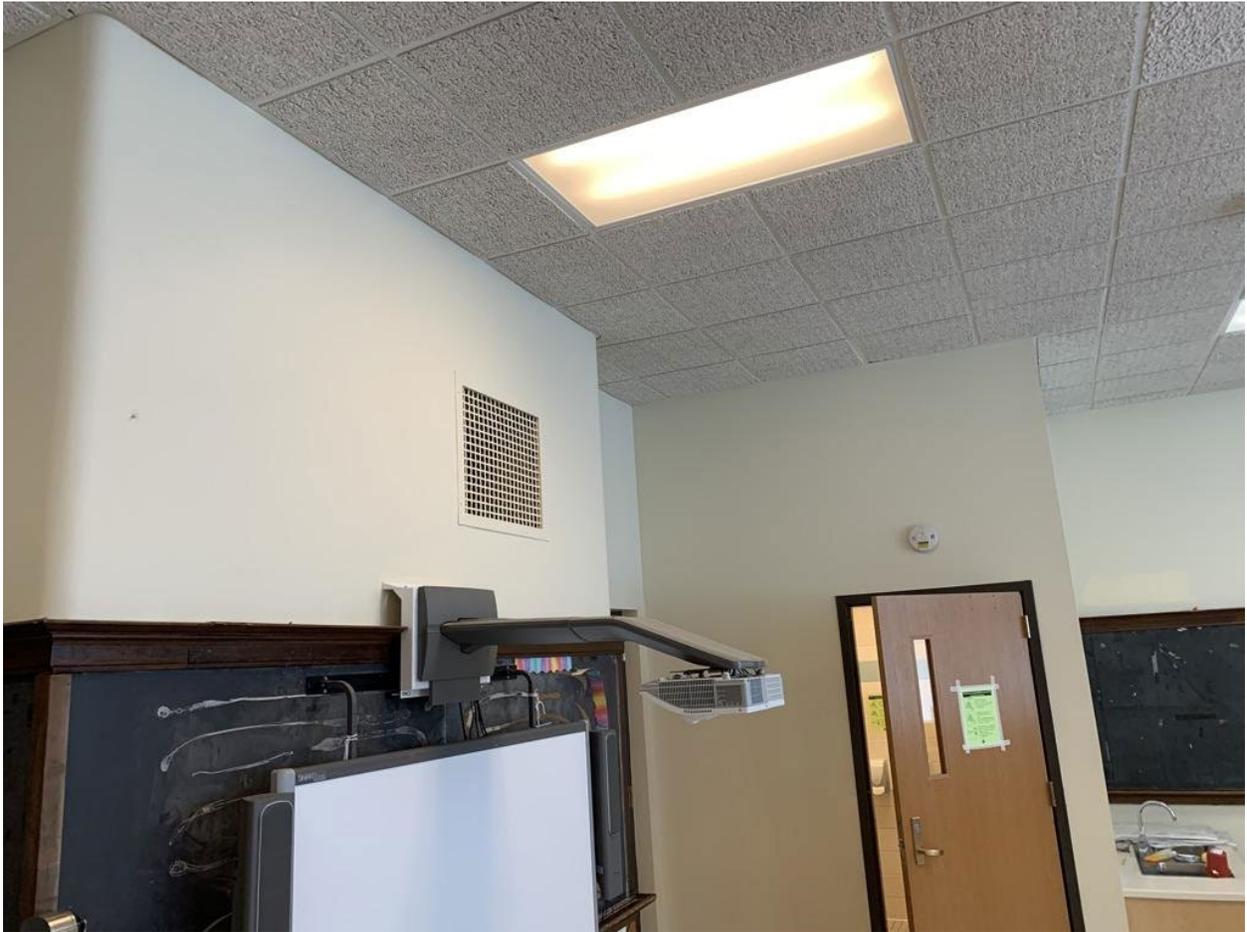
Supply diffuser
