OLMSTED ENVIRONMENTAL SERVICES, INC.

Date: March 6, 2021

Subject: **Ventilation Screening
School 20
Northstar Program
54 Oakman Street, Rochester, NY**

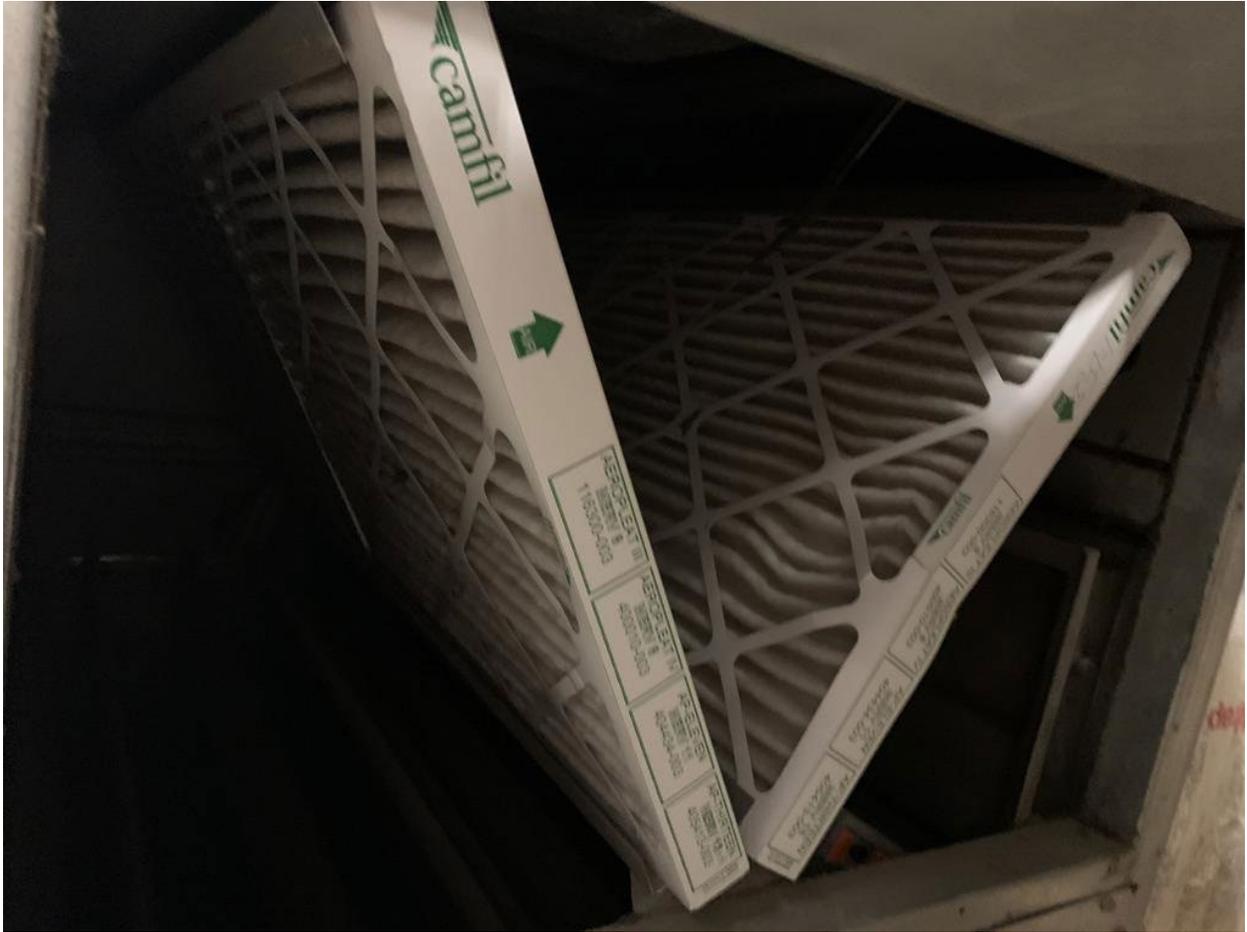
4. There are exhaust fans on the roof that pull air from the classrooms, common areas, and bathrooms.
5. Mixed outside and return air are filtered through MERV-13 final filters. MERV 13 or higher ratings are recommended for HVAC systems due to their ability to filter smaller particles, including viruses. As such, upgrading to a MERV-13 rated filter, or the highest-rated filter in HVAC systems have been recommended by the American Society of Heating, Refrigerating and Air-Conditioning Engineers (ASHRAE) as a method to reduce the transmission of the SARS-CoV-2 virus in recirculated air.¹

MERV 13 filters in the air handlers
