OLMSTED ENVIRONMENTAL SERVICES, INC.

Subject: **Ventilation Screening**
Dr. Walter Cooper Academy School No.10 Rochester, NY
353 Congress Ave, Rochester, NY 14619

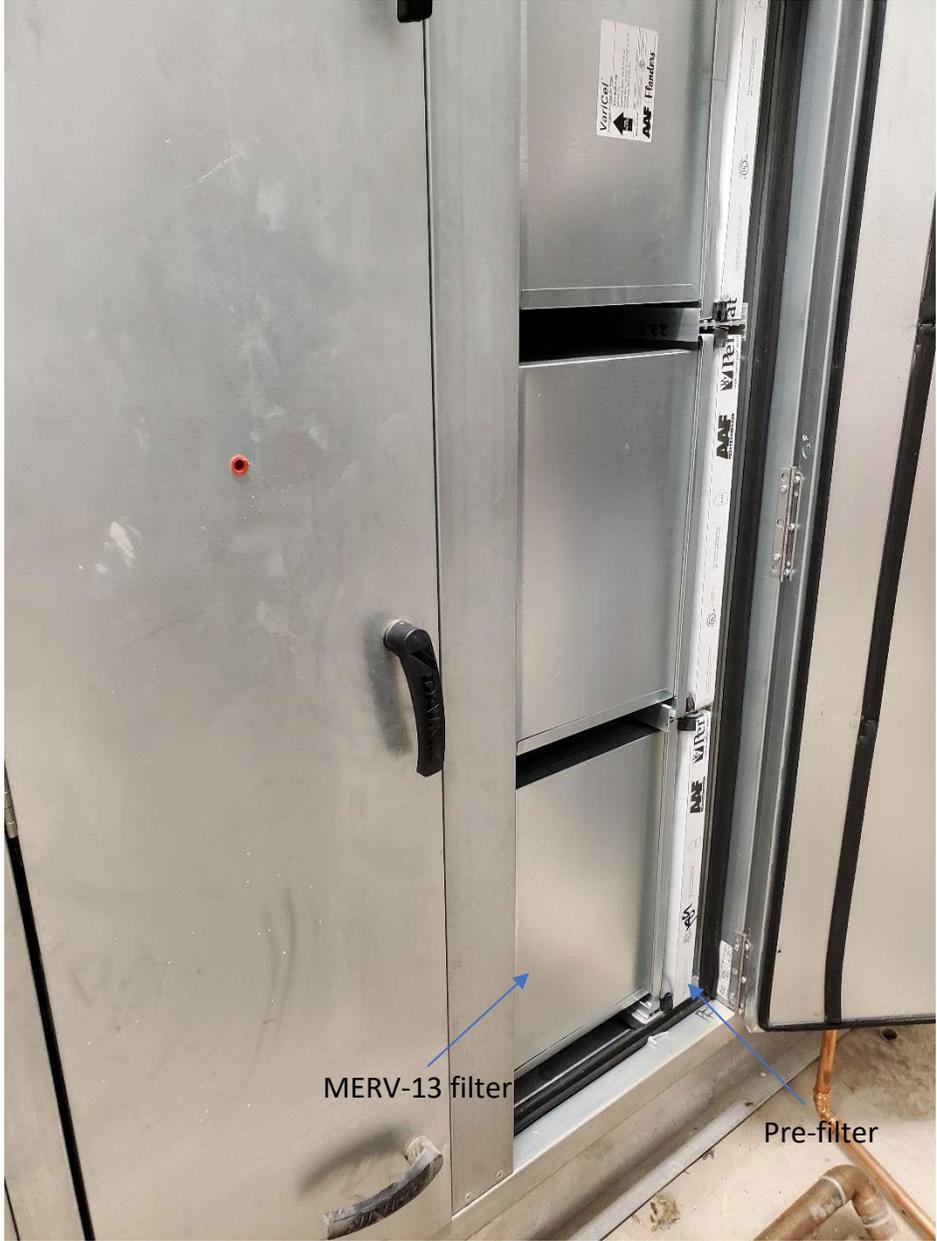
2. The central air handler units are located in mechanical rooms throughout the building. The units are hot deck / cold deck units that were rebuilt and appear to be in good condition and well-maintained. The air handler units are designed to provide a mixture of outside air and return air modulated by dampers. Each supply fan has an associated return fan. Mixed air is filtered through MERV 8 pre-filters and then MERV 13 filters and heated or cooled in fan coils in the unit. Filters with MERV-13 or higher ratings are recommended for HVAC systems due to their ability to filter smaller particles, including viruses.

MERV 8 pre-filters with MERV 13 box filter in air handler unit

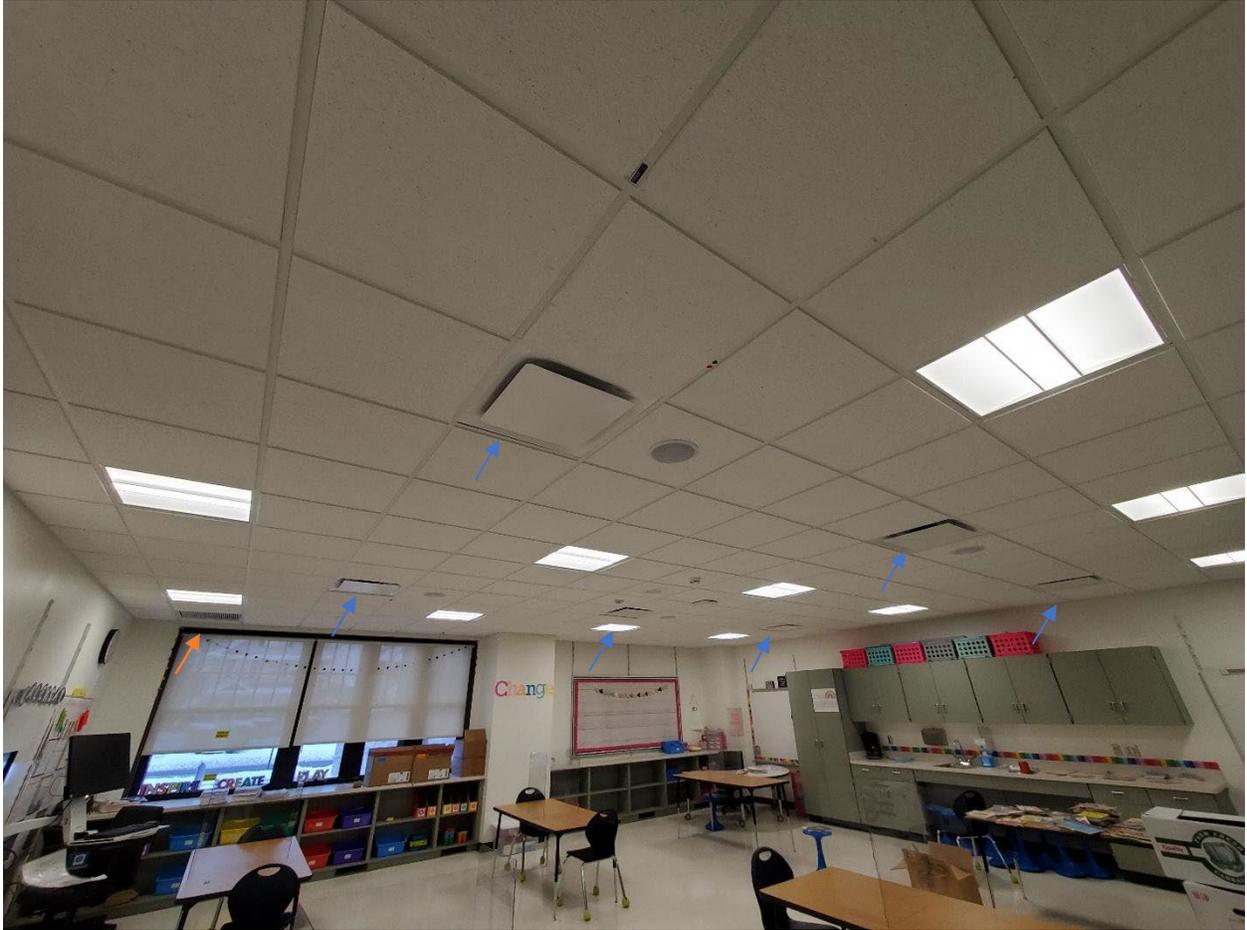
3. From these air handler units, that tempered and filtered air is distributed via a system of ductwork. The ductwork then terminates in an occupiable space at square diffusers located on the ceiling. In addition, passive return grilles were also observed in classrooms usually also located on the ceiling.

4. All the above-mentioned components of the school's central mechanical ventilation systems were examined and found to be working.
5. Not all rooms could be inspected but a representative number was included in the inspection. These rooms included Rooms 109, 113, 116, 213, 220, 222, and 226. The supply outlets were screened with a thermal anemometer to determine whether supply air was discharging from the outlet. All rooms visited were found to have a good flow of ventilation air from the supply diffusers.

Typical ventilation scheme with 6 supply outlets (blue arrows) and 1 return grille (orange arrow) located on the ceiling
