# **OLMSTED ENVIRONMENTAL SERVICES, INC.**

Date: February 2, 2021

Subject: **Ventilation Screening**  
**Clara Barton School No. 2 Rochester, NY**  
**190 Reynolds Street, Rochester, NY 14608**

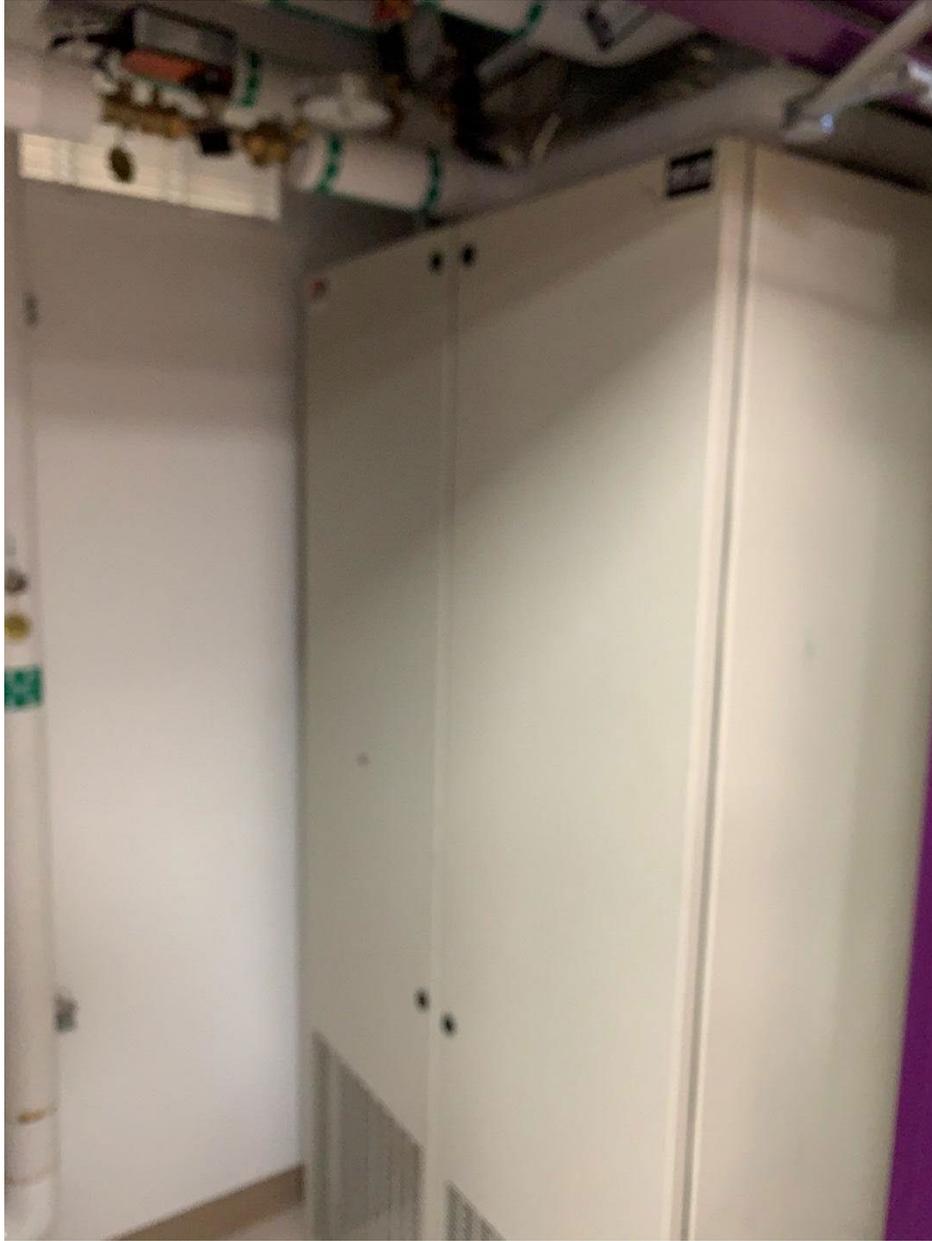
Vertical univent located in Room 254 that serves Room 252 and 254

- 1) The univents should be run continuously when the classroom is occupied. In addition, pedagogical staff should not tamper with the univent to turn them off, instead consult the building engineer to address excess temperatures.

- 2) Do not block exhaust intakes and keep the tops of the univents clear of stored materials.
- 3) The univents provide outside air in most classrooms. However, where possible and if necessary, teachers can open two windows in each room to an opening of two inches. This will provide natural ventilation without causing the room to become cold.

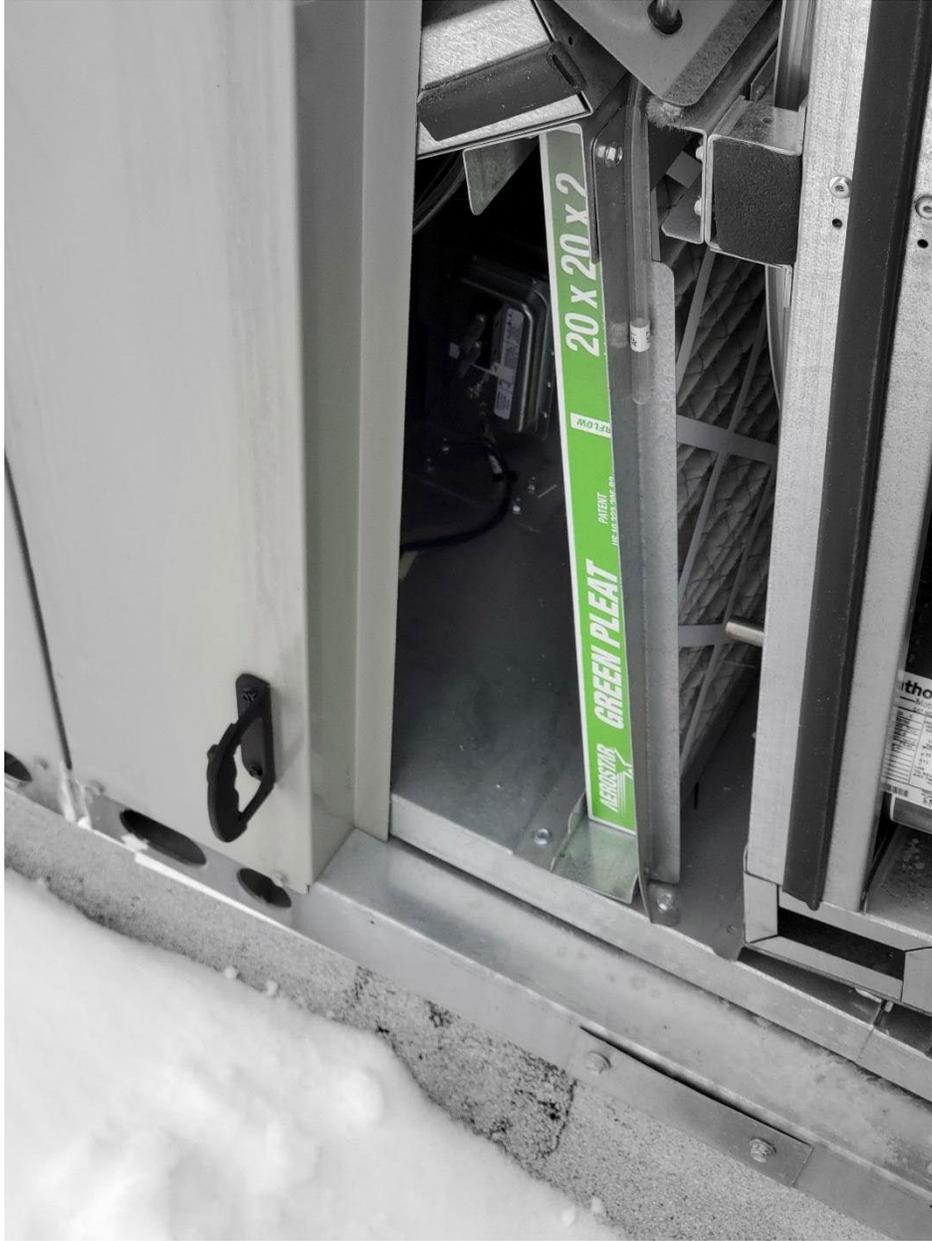
2. The air handler units that serve large public assembly spaces such as the cafeteria, kitchen and the Maker's Room, were noted to have been fitted with MERV-13 filters. RCSD Facilities is waiting for additional shipments of MERV-13 filters. In the meantime, the Dedicated Outside Air System (DOAS) air handlers are operated with all outside air and no recirculation of indoor air. Outside air is safe and does not require filtration for viral particles. However, recirculated (return) air may contain particles that contain the virus especially if there is an infected person in the building. Operating the system with maximum outside air and exhausting all or most of the return (recirculated air) can bypass the need for filtration until more MERV-13 filters arrive and can be installed in the unit.

MERV-8 filter inside DOAS, unit is operating to provide maximum outside air

- 4) Install MERV 13 filter as soon as they arrive. Until they have been installed and for the building to be safely occupied, RCSD Facilities should continue to adjust and operate the building's ventilation system so that it minimized or as closely as possible eliminate the amount of recirculated air mixed with the outside air.

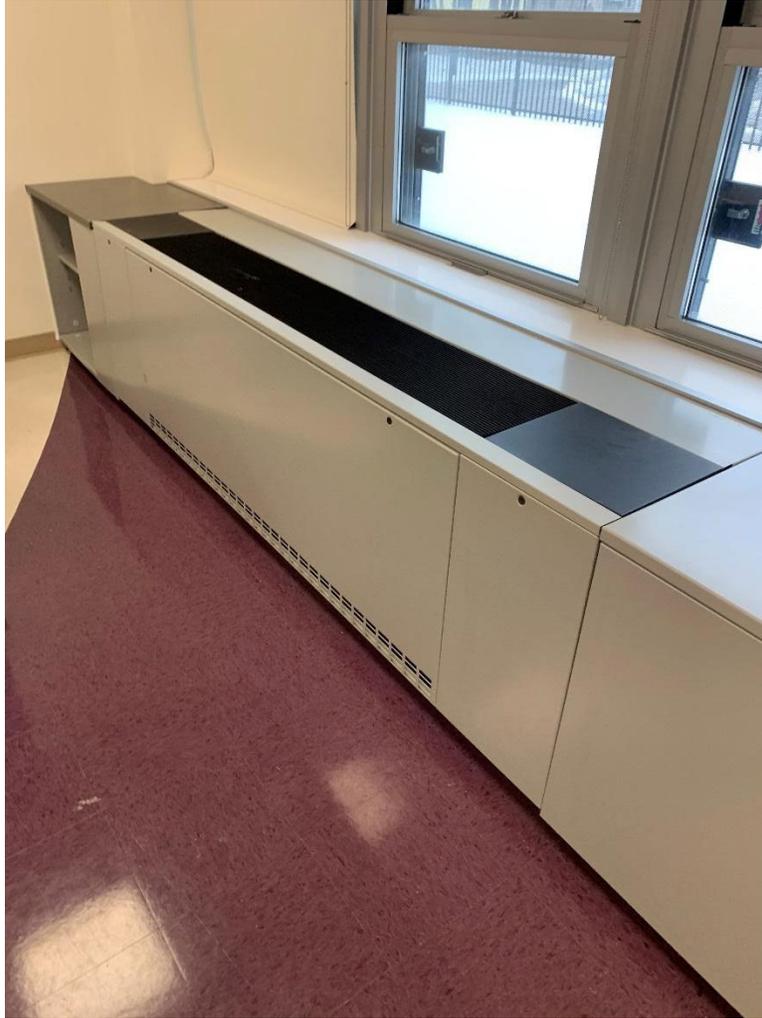
Univent located in Room 101

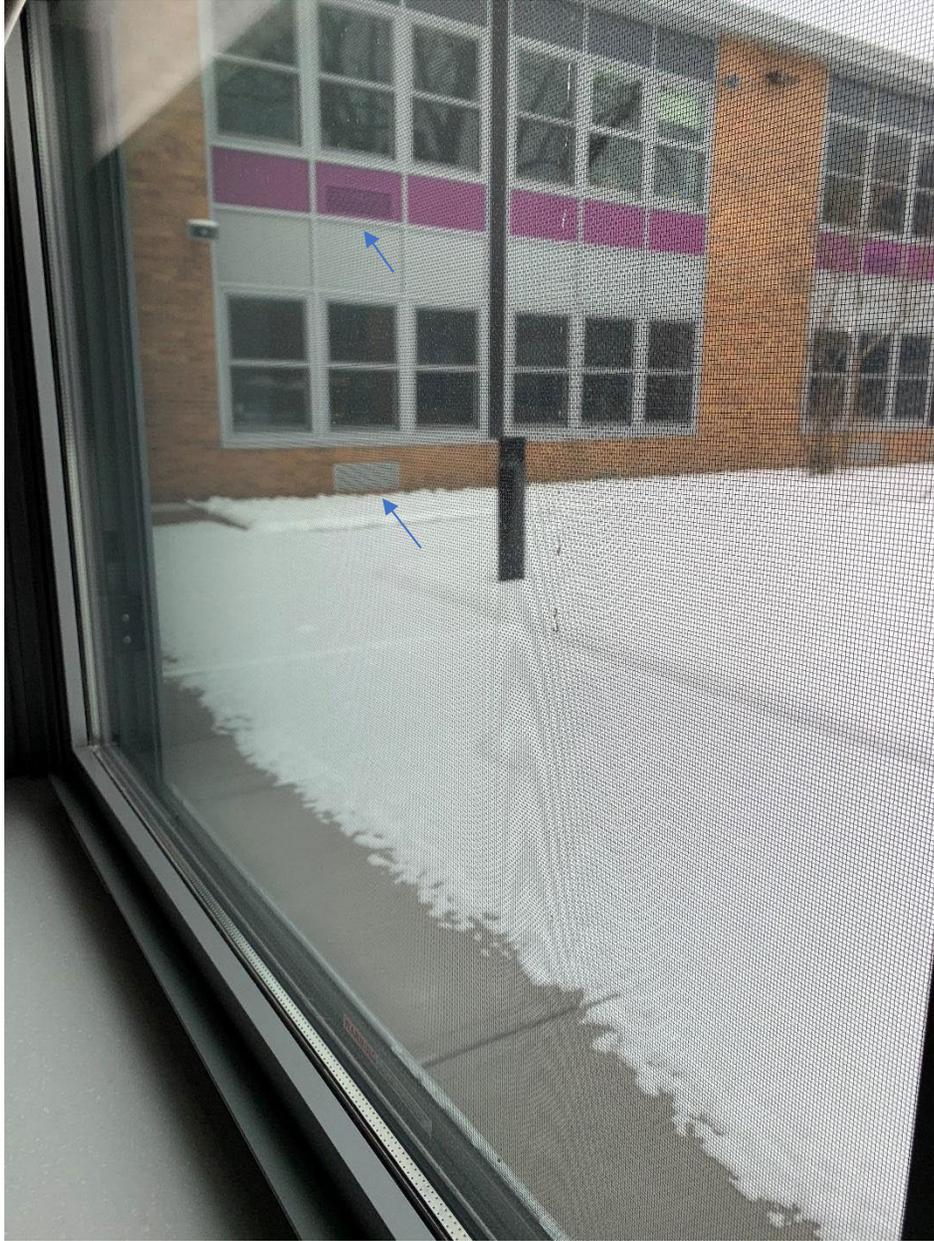
Exterior outside intake grilles seen underneath the windows
