OLMSTED ENVIRONMENTAL SERVICES, INC.

Date: March 6, 2021

Subject: **Ventilation Screening
East Lower & Upper Schools
1801 E Main St, Rochester, NY 14609**

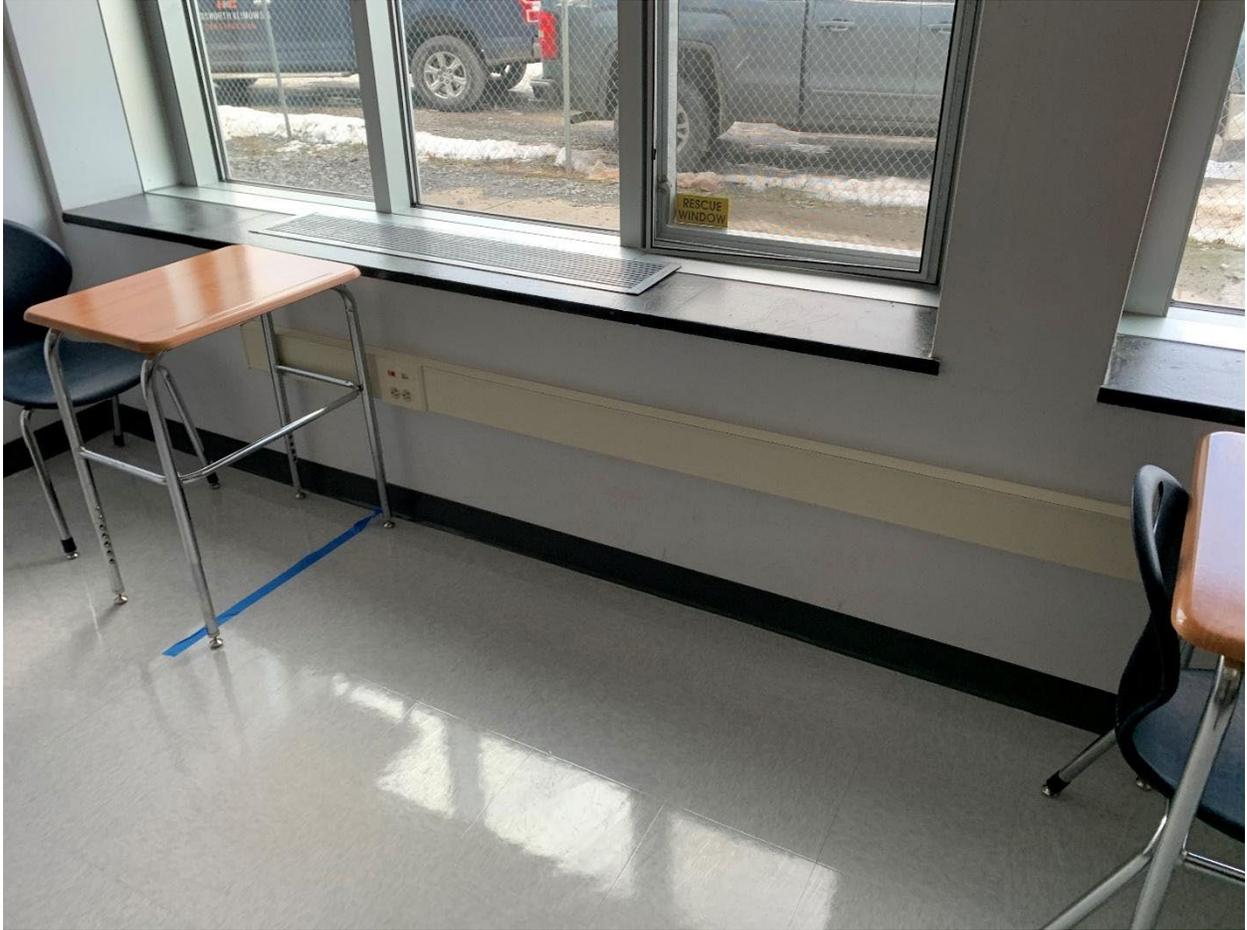
Supply vent located under the window

2. From these air handler units, that tempered and filtered air is distributed via a system of ductwork. The ductwork terminates in an occupiable space at units located under the windows. Staff should take care not to store too many items on slot vents located under the window. In addition, the space above the drop ceiling serves as a return air plenum.

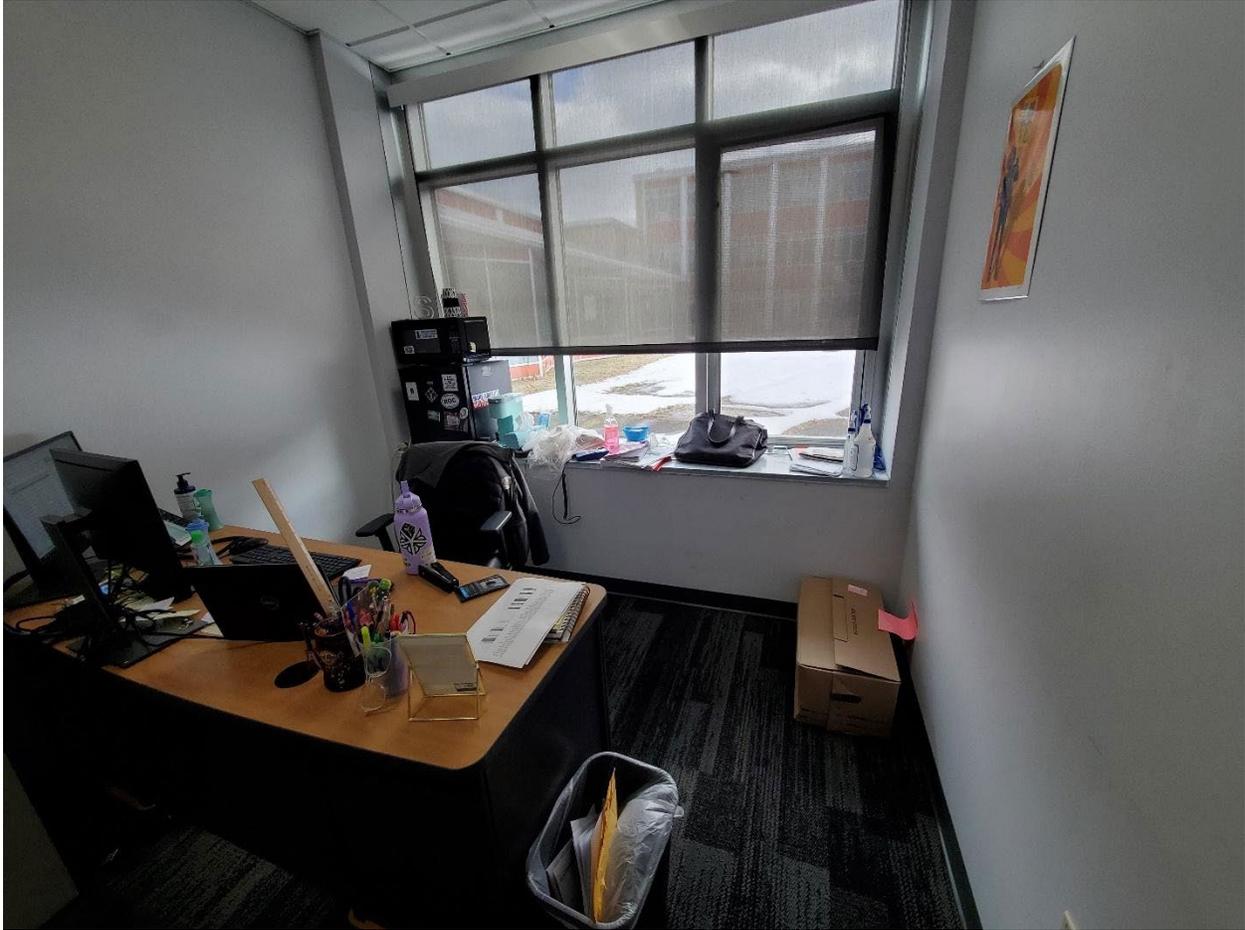
Keep the supply vents under the window clear

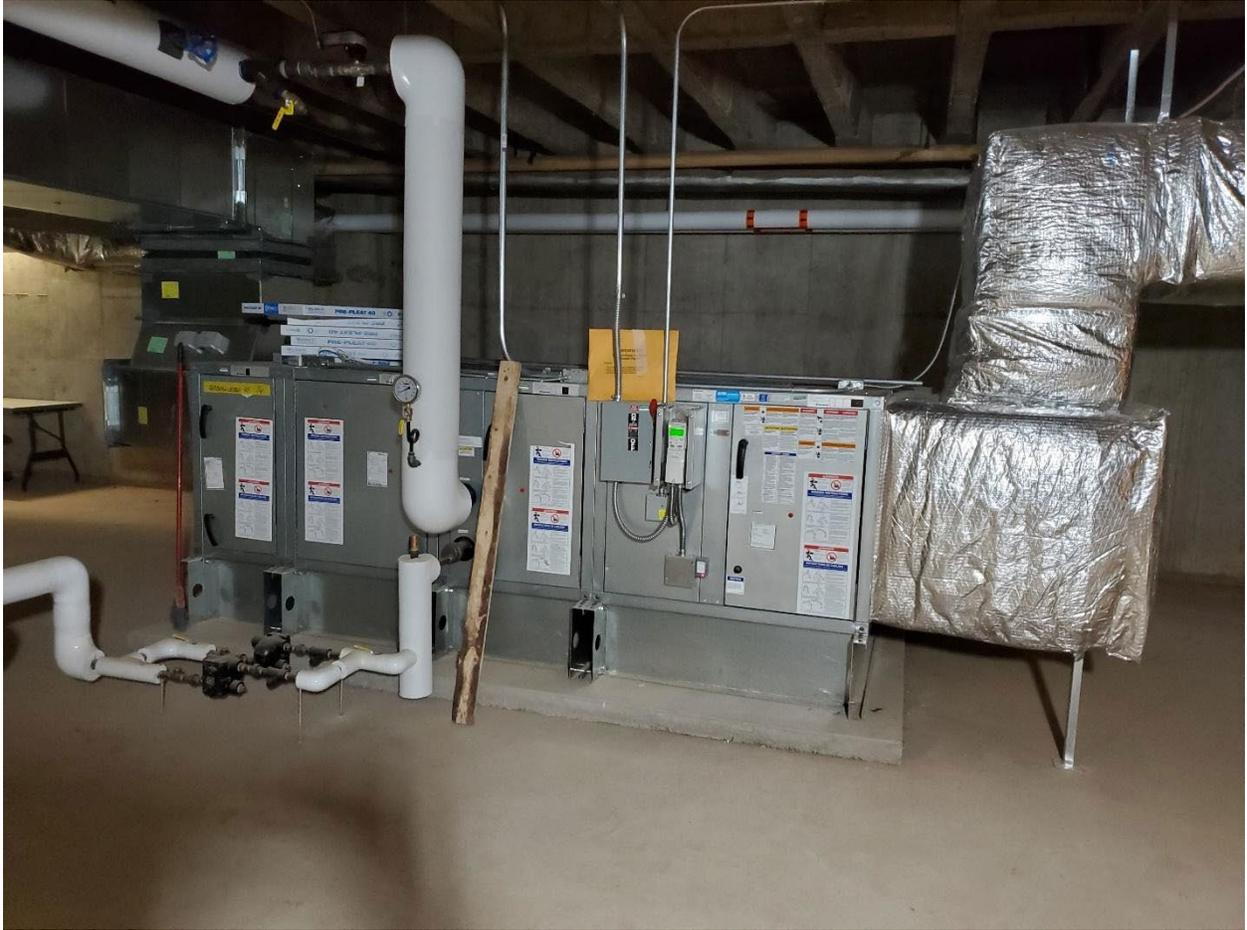
An air handler unit

1. The East Campus has a modern central heating and air conditioning ventilation system that serves all classrooms. The units are located in mechanical spaces in the basement level. The central air handler units are designed to provide a constant volume of a mixture of outside air and return air. Each supply fan has an associated return fan. Depending on the unit, mixed air is filtered through either MERV 13 or MERV 14 filters and heated or cooled in the unit. Filters with MERV-13 or higher ratings are recommended for HVAC systems due to their ability to filter smaller particles, including viruses. As such, upgrades to a MERV-13 rated filter, or the highest-rated filter in HVAC systems have been recommended by the American Society of Heating, Refrigerating and Air-Conditioning Engineers (ASHRAE) as a method to reduce the transmission of the SARS-CoV-2 virus in recirculated air.¹

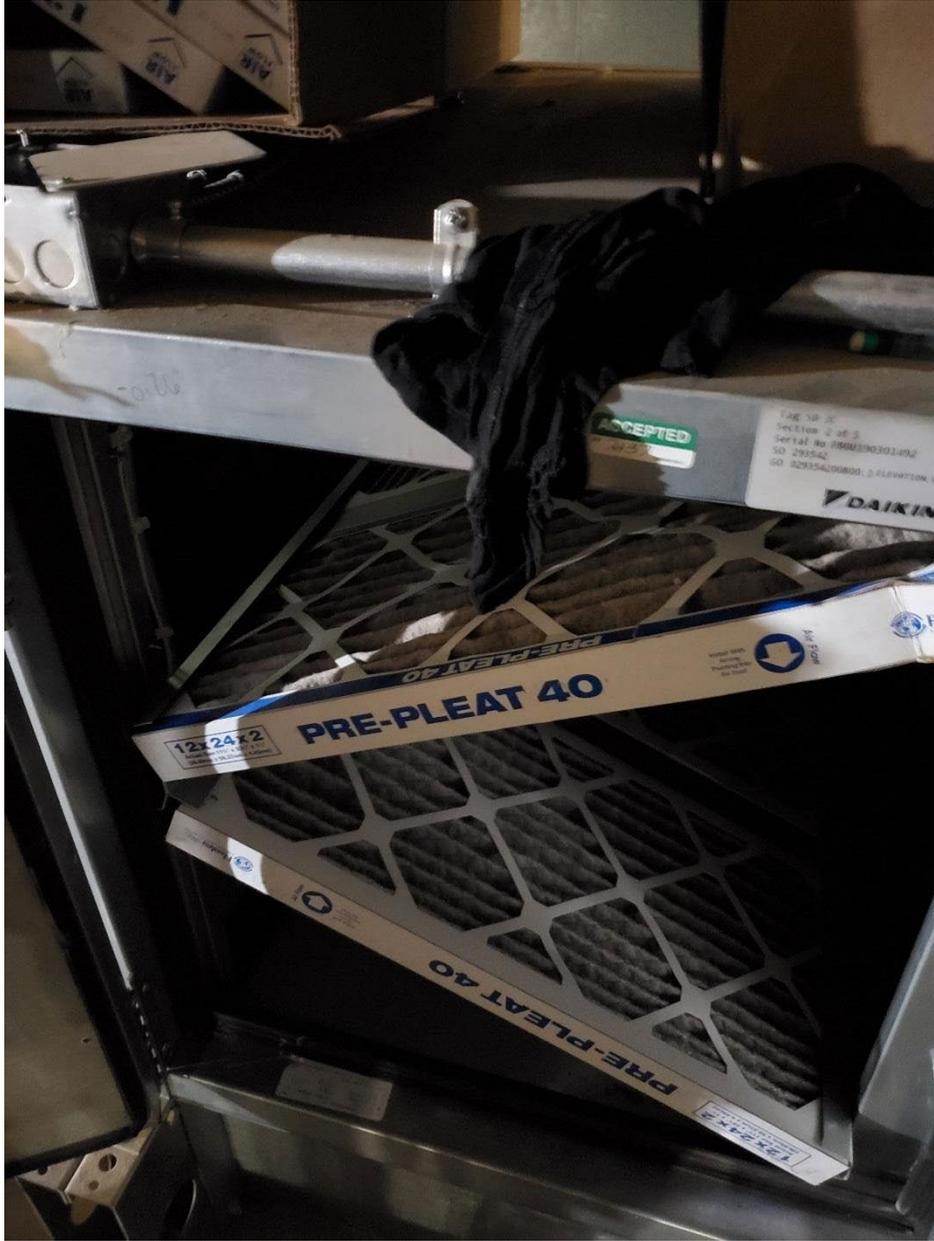
MERV 13 filters in the air handler unit

Overall, the school's ventilation can help reduce the risk of exposure to SARs-CoV-2 and meets the published guidelines. The mechanical ventilation system is capable of providing at MERV 13 filtered mixture of outside air and return air. In addition, most classrooms also have operable windows that can be used to provide natural ventilation. Where possible and if necessary, teachers can open two windows in each room to an opening of two inches. This will provide natural ventilation without causing the room to become cold and will provide 4 to 5 air changes per hour. Lastly, ensure other safety and health precautions, such as mask-wearing, social distancing, cleaning/sanitization, and routine handwashing, are also practiced to prevent the transmission of SARS-CoV-2.
